Gold Standard Car Parks

Car Park Accessibility Review and Inclusive Design Framework

MIMA recommendations

YAF – 19 September 2023

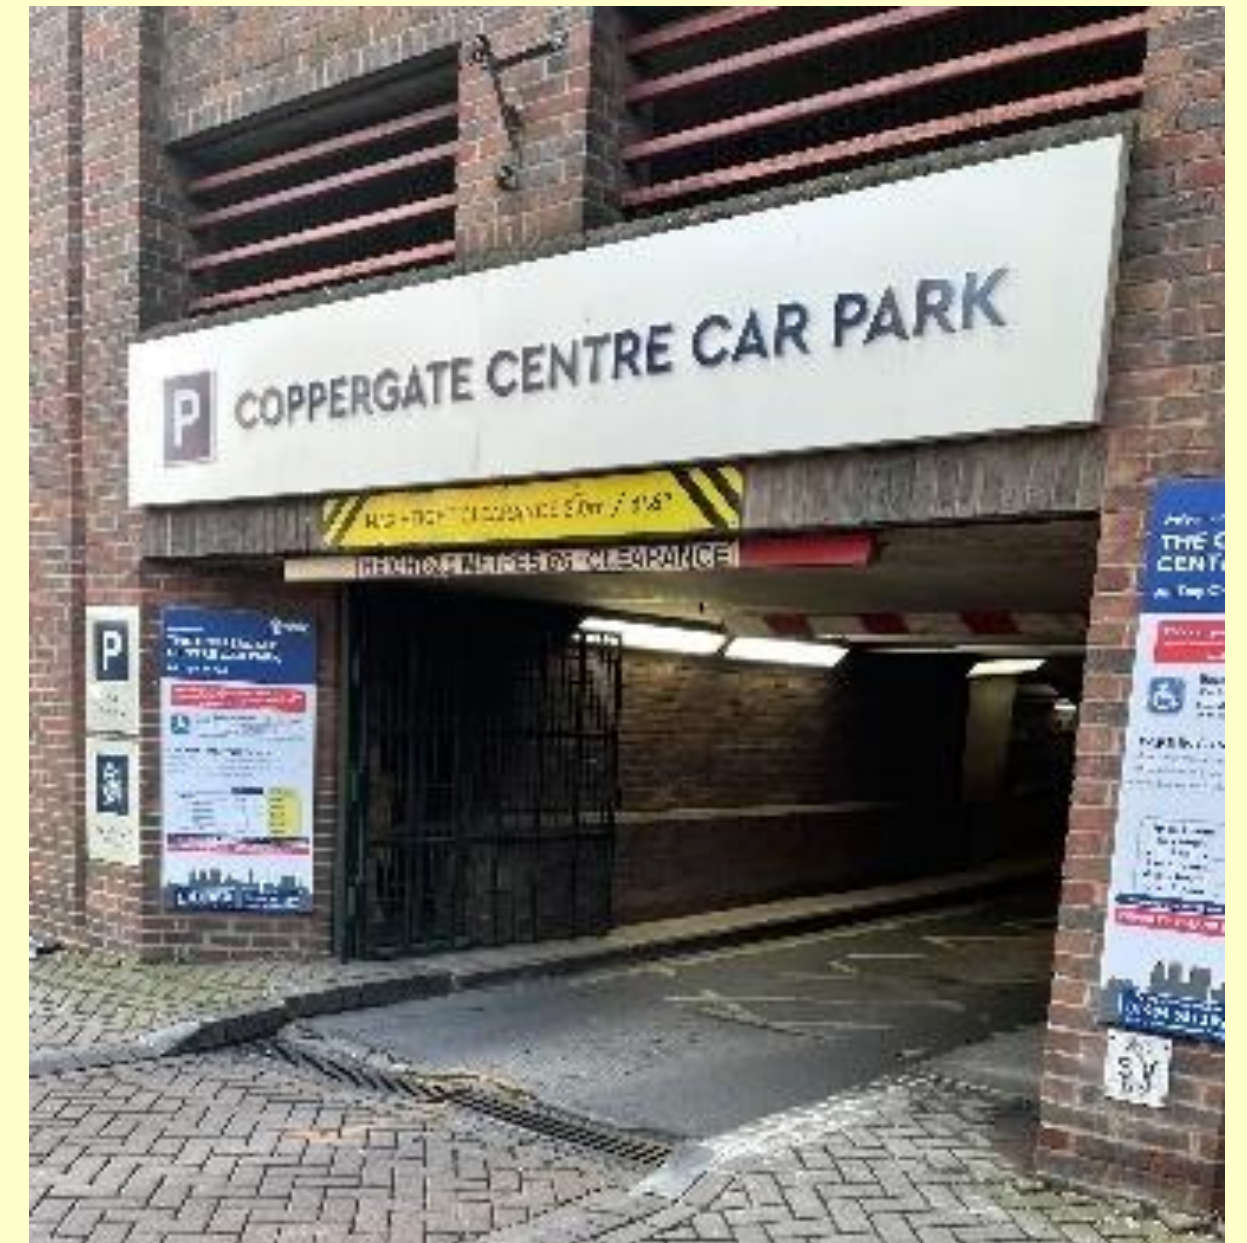
Issue – vehicle entrance

- The entrance height is restricted and too low for many WAVs and similar vehicles.

- Provide information online and at the entrance to indicate where the nearest non-height restricted accessible parking is.

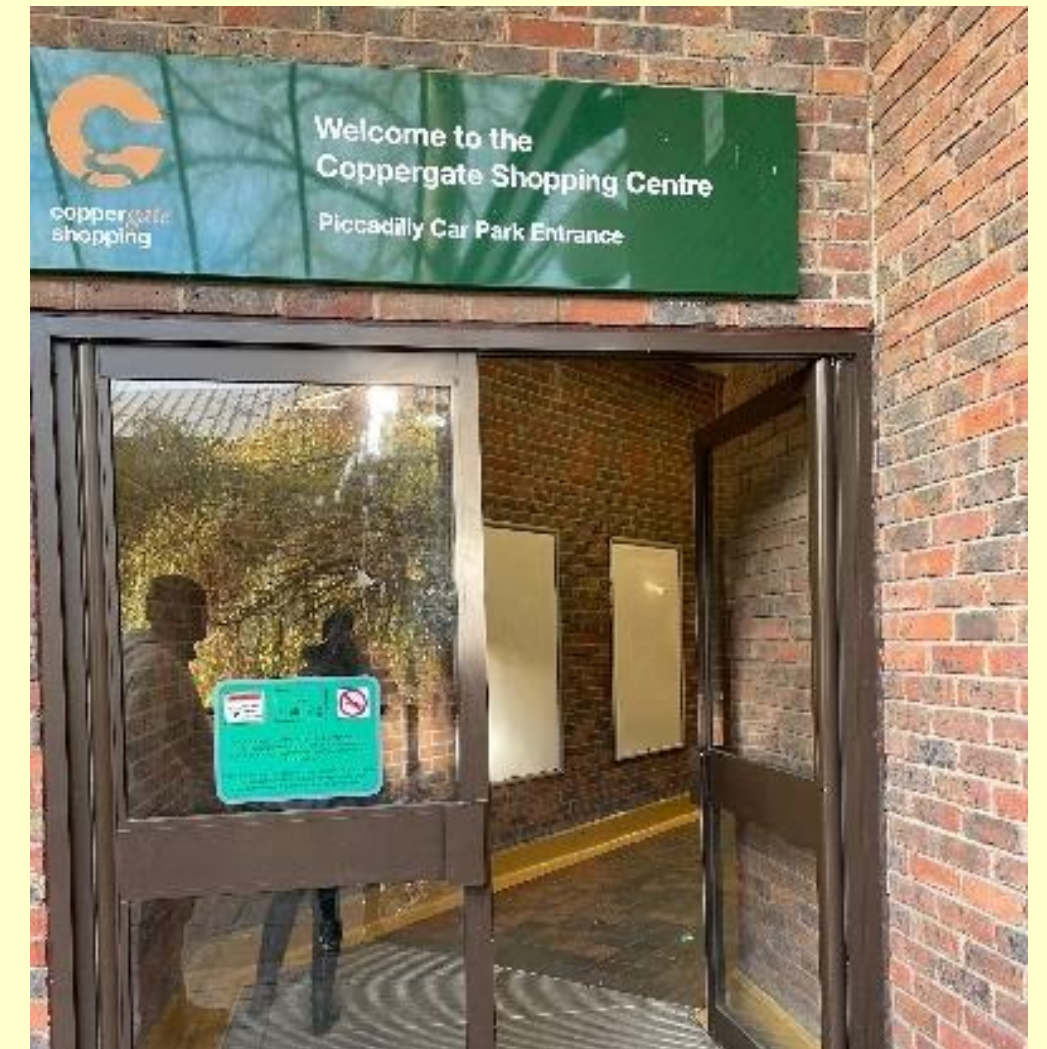
Issue – Pedestrian entrance

- The pedestrian entrance route is accessed via narrow double leaf manual doors.
- Sign above door references “Piccadilly Car Park”

- Ensure entrance doors to car parks meet current standards.
- Automatic doors are recommended.
- Update signage.

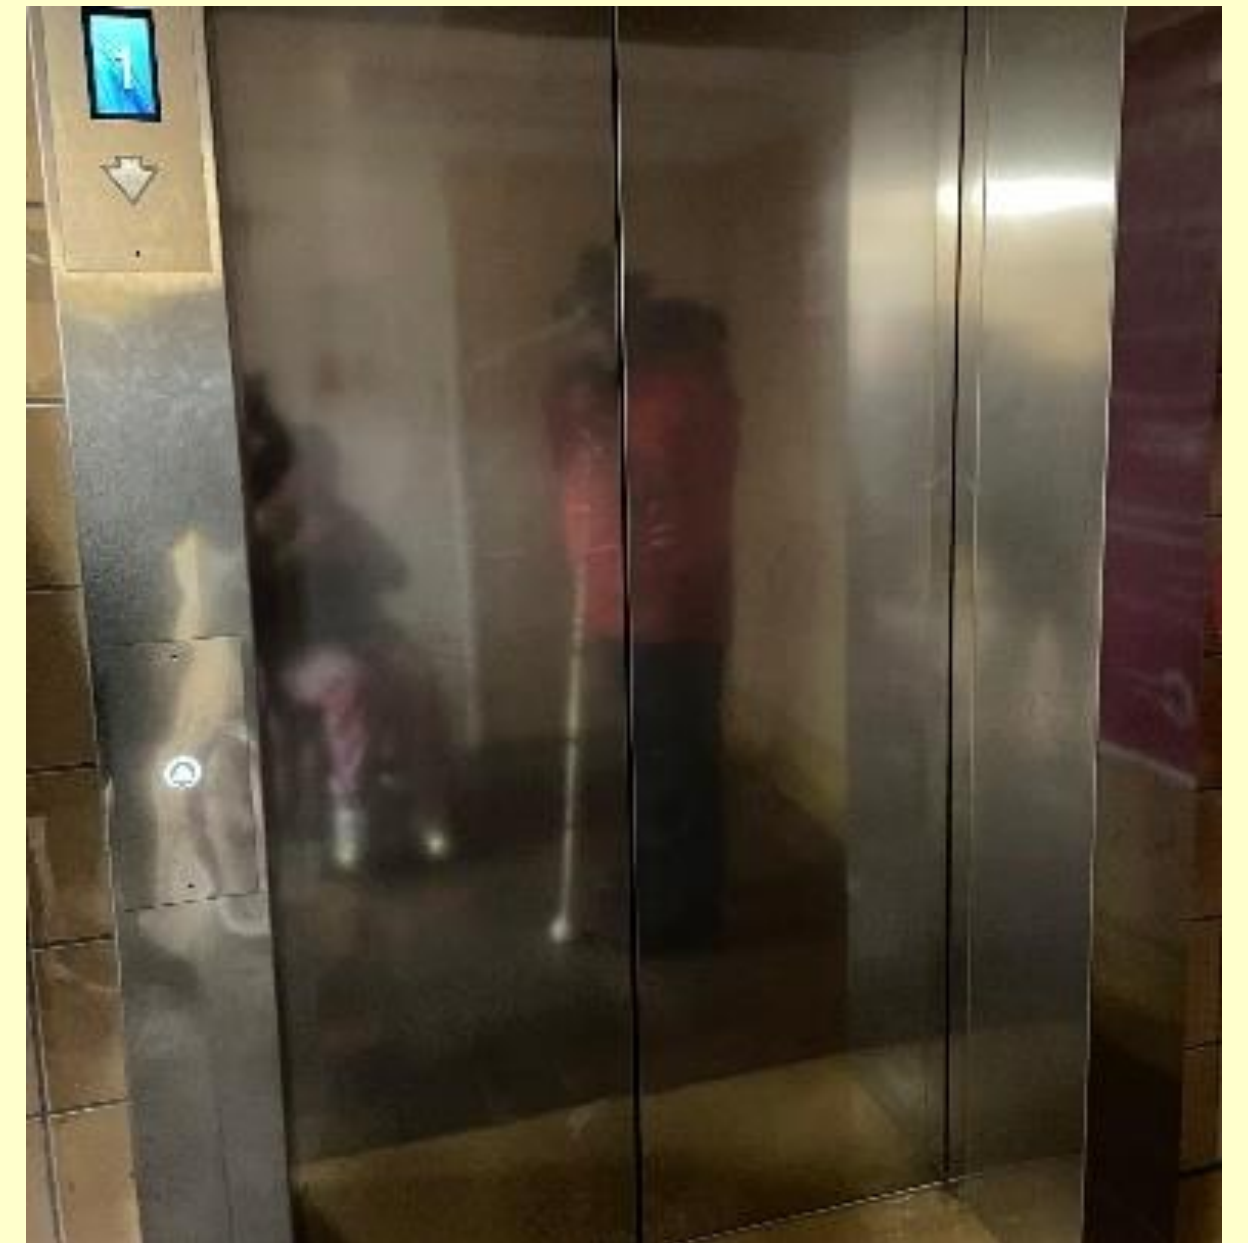
Issue – Lift access

- During MIMA's site visit, one of these lifts was out of order.

- Regularly maintain both lifts to ensure step-free access is provided to all levels of the car park at all times.
- In the event of the lift breaking down, ensure this is clearly communicated to visitors at the entrance of the car park.

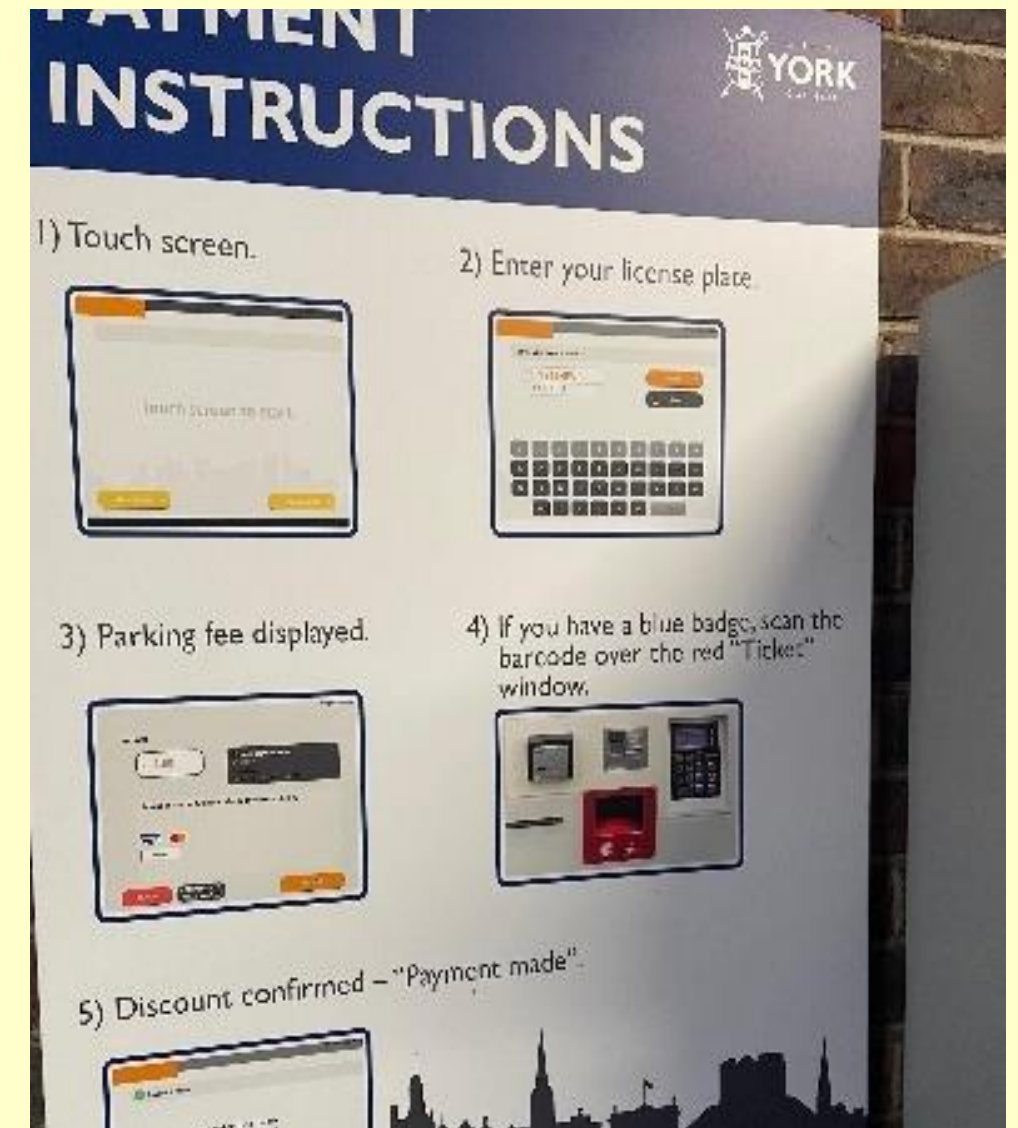
Issue – Payment machines

- Coin input is centred at 1300mm; slightly too high for seated users and those of shorter stature.
- The machine - and car park barriers/help points in general - do not offer D/deaf-friendly means of communication.

- Provide a coin slot or payment method between 750mm and 1200mm above floor level.
- Touch screen should have larger buttons and higher contrast.
- Induction loops, text numbers and/or video intercoms to be provided as standard on payment machines, help points and ticket barriers.

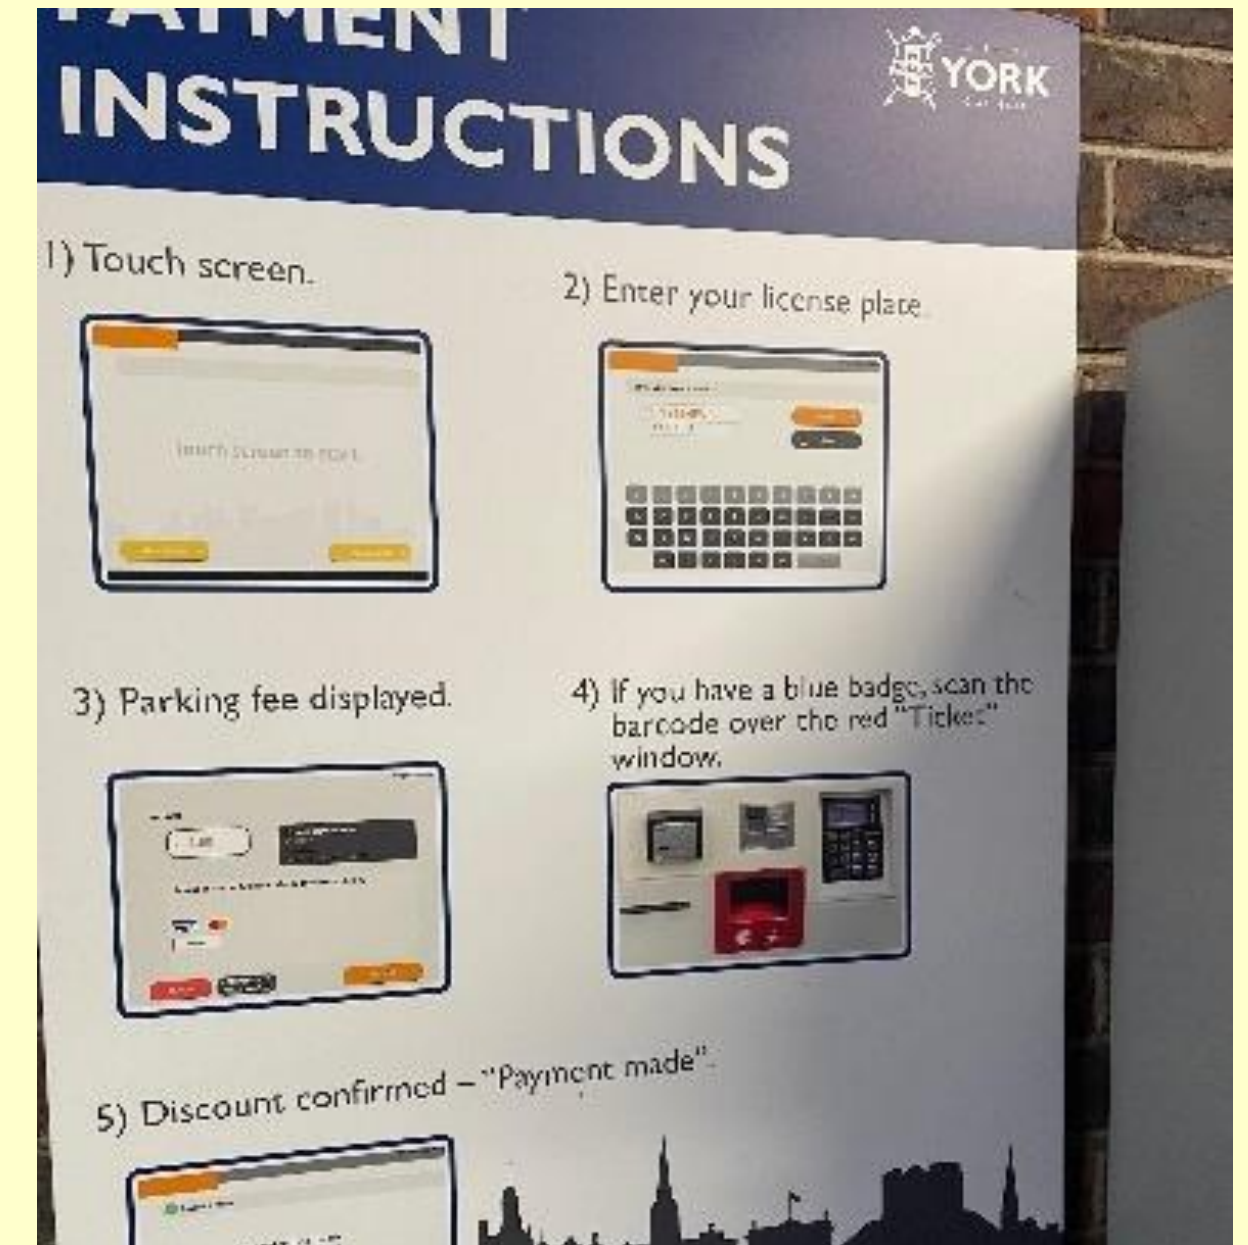
Issue – Payment machines (continued)

- Blue badge holders can scan their badge for free parking, however this means removing the blue badge from the car and returning it again.

- Review process to avoid additional journey.

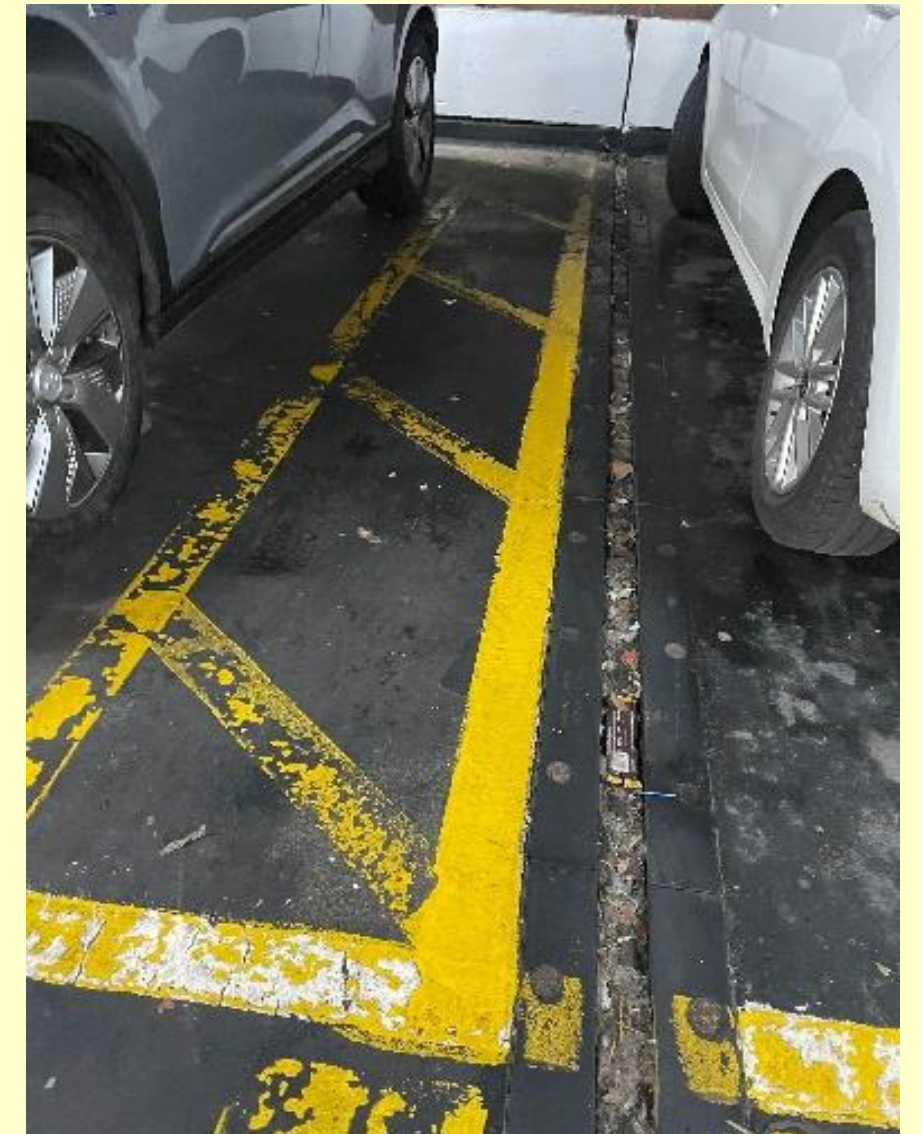
Issues – Accessible parking bays (Levels 1 and 2)

- Accessible bays and access zones are not to current access standards

- Accessible parking bays should be reconfigured to meet current access standards

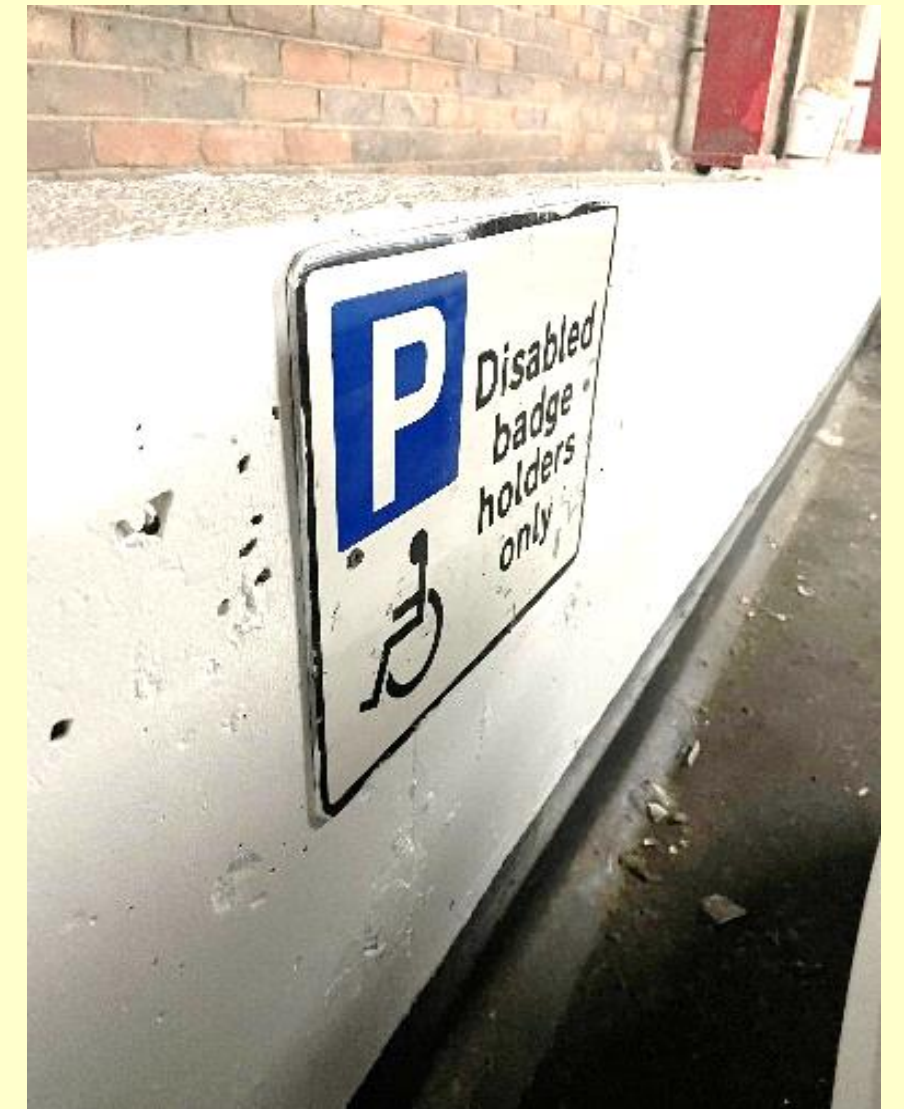
Issue – Accessible parking signage

- Lack of visibility of signage for blue badge holders, provided at 390mm-650mm above the ground.

- Provide signage at heights in which the lower edge is 1000mm above floor level.
- New signage should read 'Blue Badge Holders' rather than 'Disabled Badge Holders'

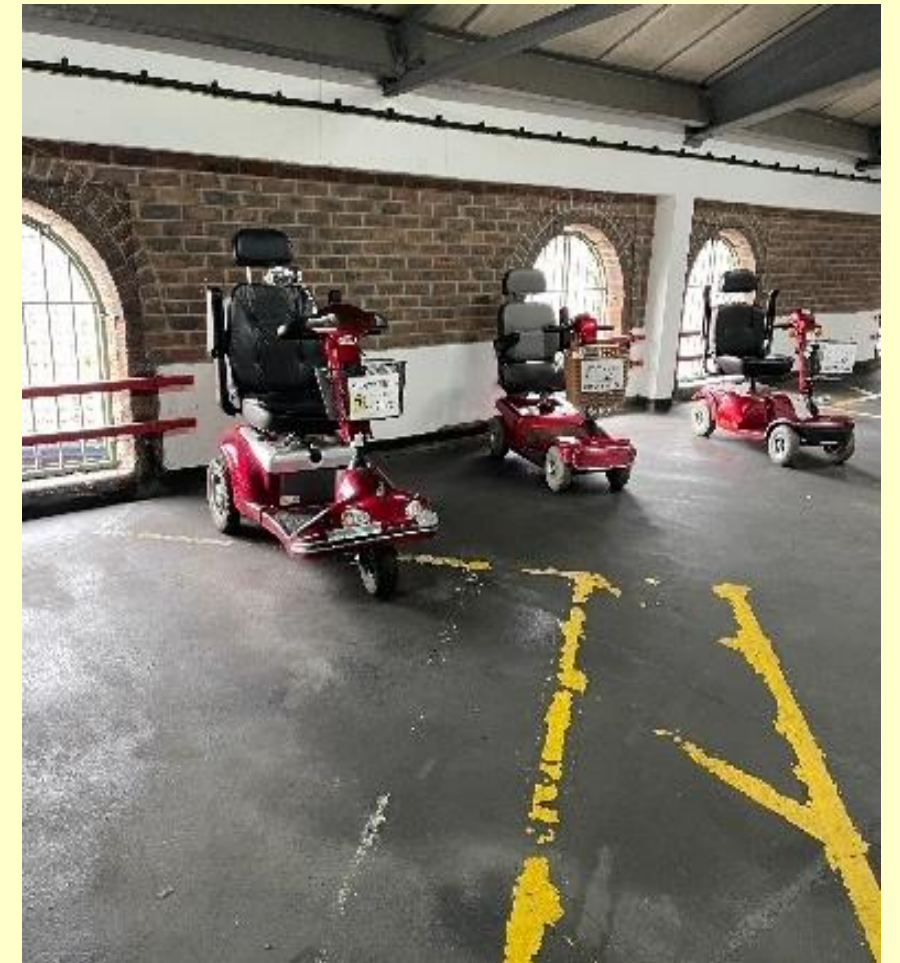
Issue – Shopmobility

- The service is currently underused, partly due to its location. This is not practical for many users as it requires vertical circulation and lift reliance

- Whilst Shopmobility is present in this car park, a ground floor, well-advertised and visible location would be more accessible and beneficial to many

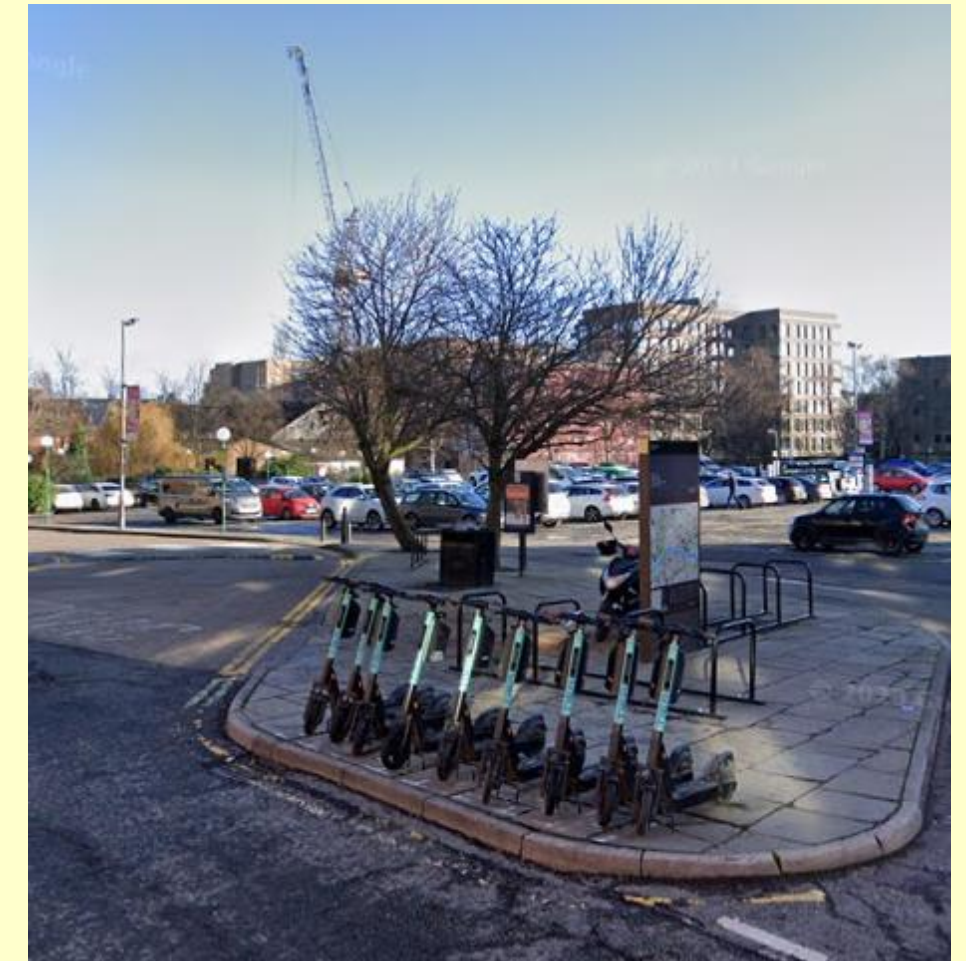
Issue – general layout

- Castle car park is open to the elements, with no shelter currently provided.
- Pedestrian and vehicular routes are narrow, resulting in an inaccessible and crowded experience.

- Provide sheltered dwell space within the car park.
- Where possible, widen vehicular access routes in addition to improving accessibility in pedestrian areas.

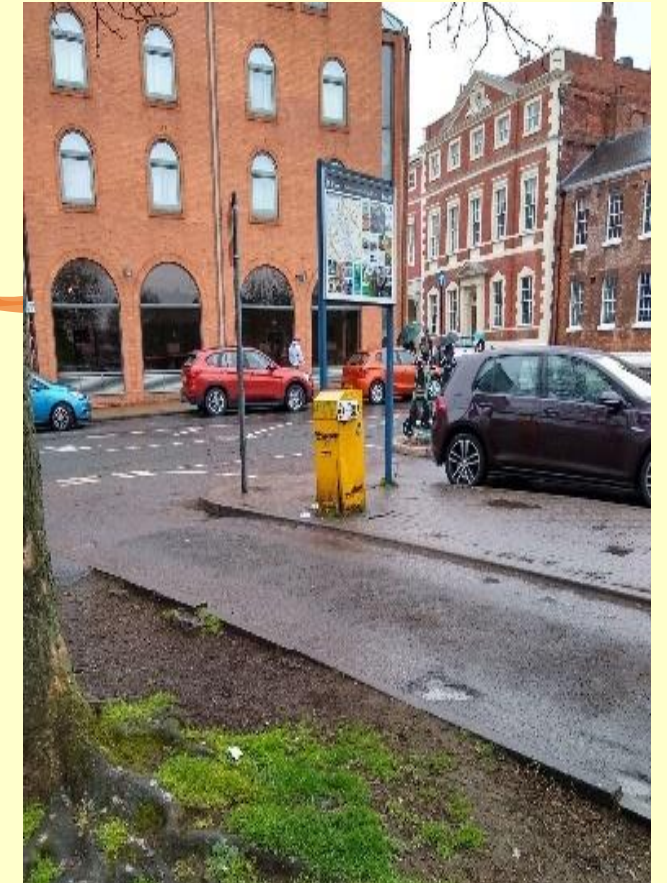
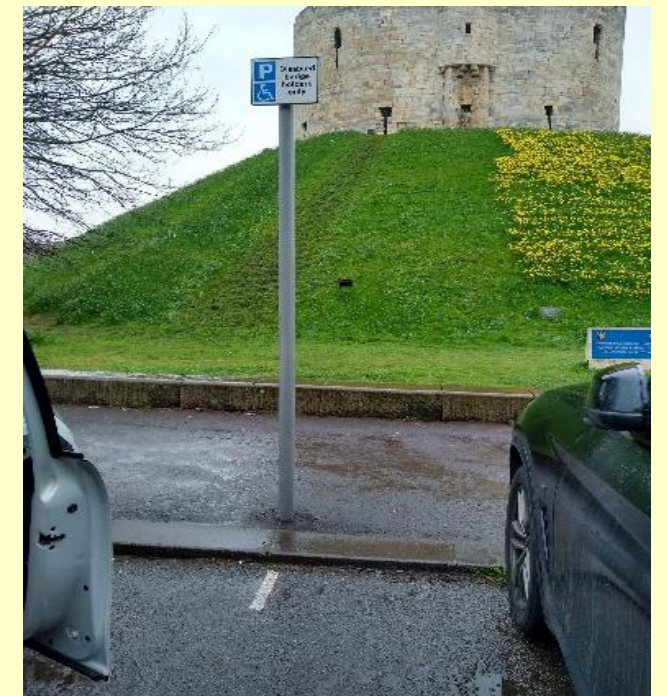
Issue – entrance

- Lack of accessible pedestrian routes into and out of the car park.
- No dropped kerbs from the on-street parking section onto the pavement and poorly located signage.

- Provide safe pedestrian routes and dropped kerbs
- Signage should be located in front of the parking bays to provide access onto the footway

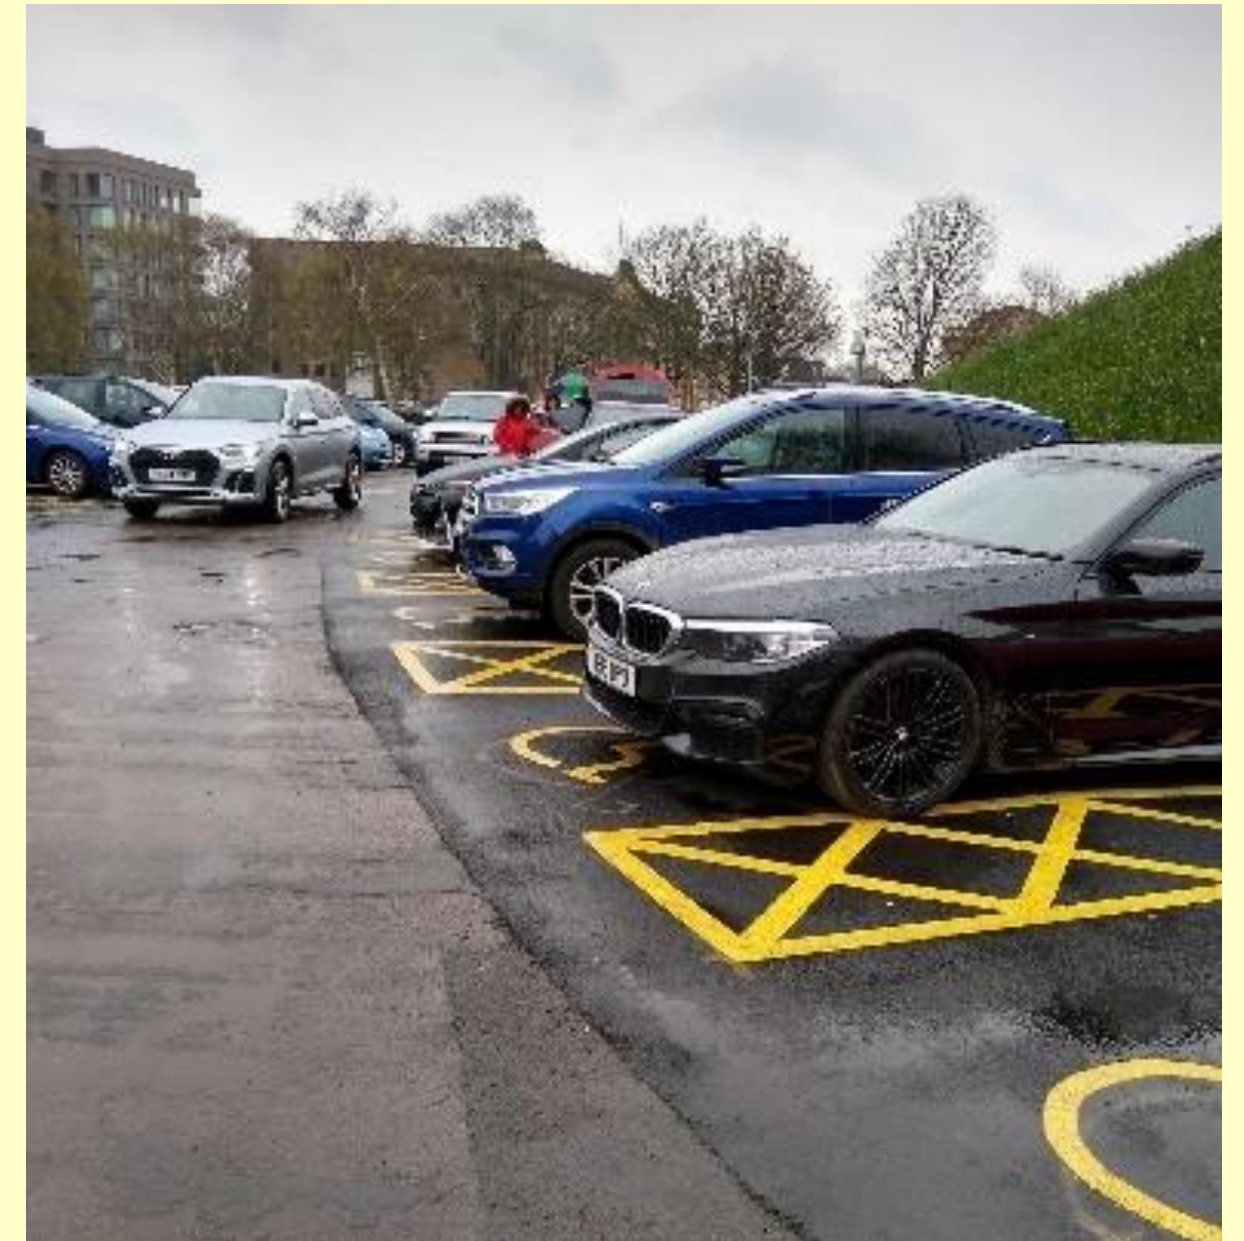
Issue – Surfacing

- The accessible parking bay area has recently been resurfaced but the rest of the car park is in poor condition.

- The remainder of the car park should be resurfaced to ensure an accessible end-to-end experience

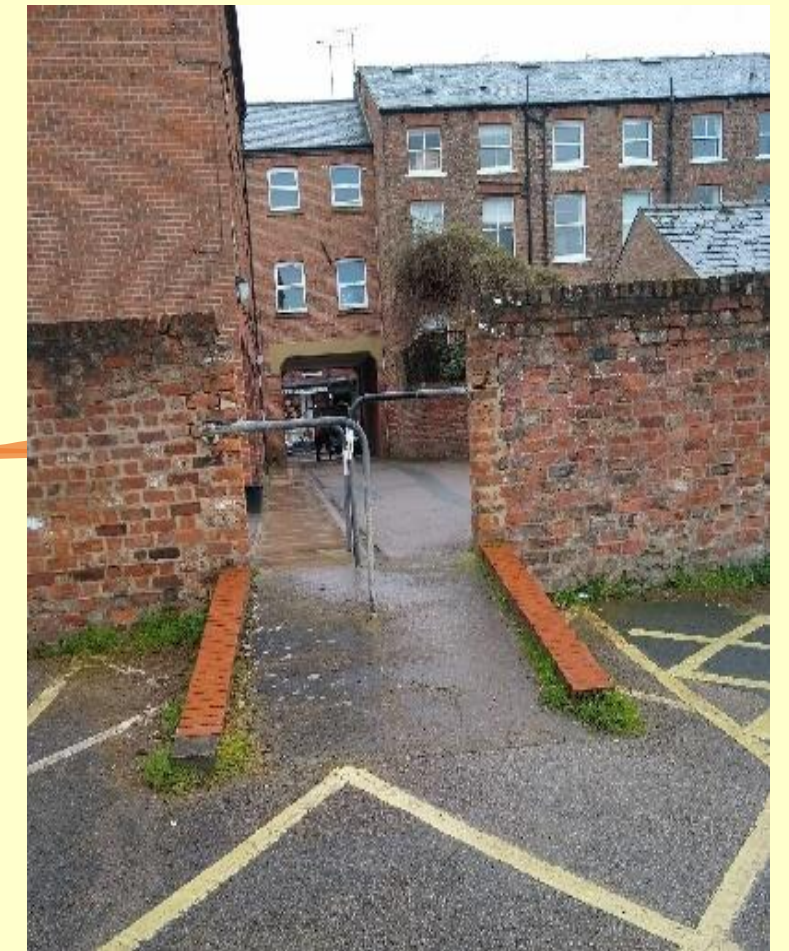
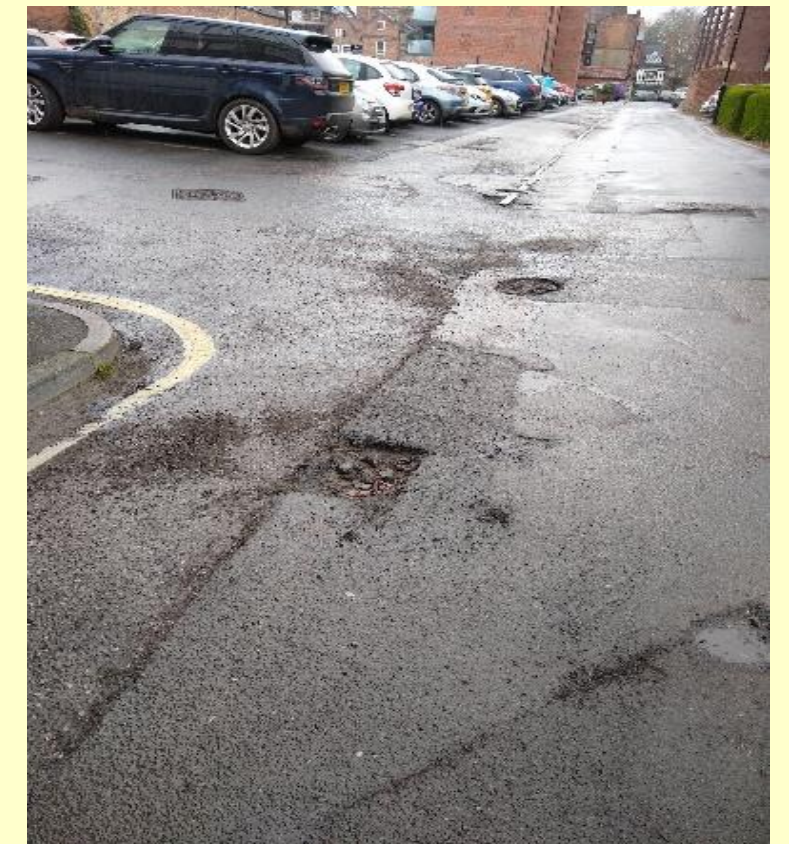
Issue – Pedestrian access

- Poor pedestrian access into the car park leading to many disabled people utilising the road in an unsafe manner
- Poor car park surface

- Gillygate access - Provide a suitable ramp and remove the railings
- Improve car park surfacing
- Main access road – Visually denote pedestrian walkways and provide signage to warn drivers of pedestrians using this space (limited options to widen the pavement on the access road)

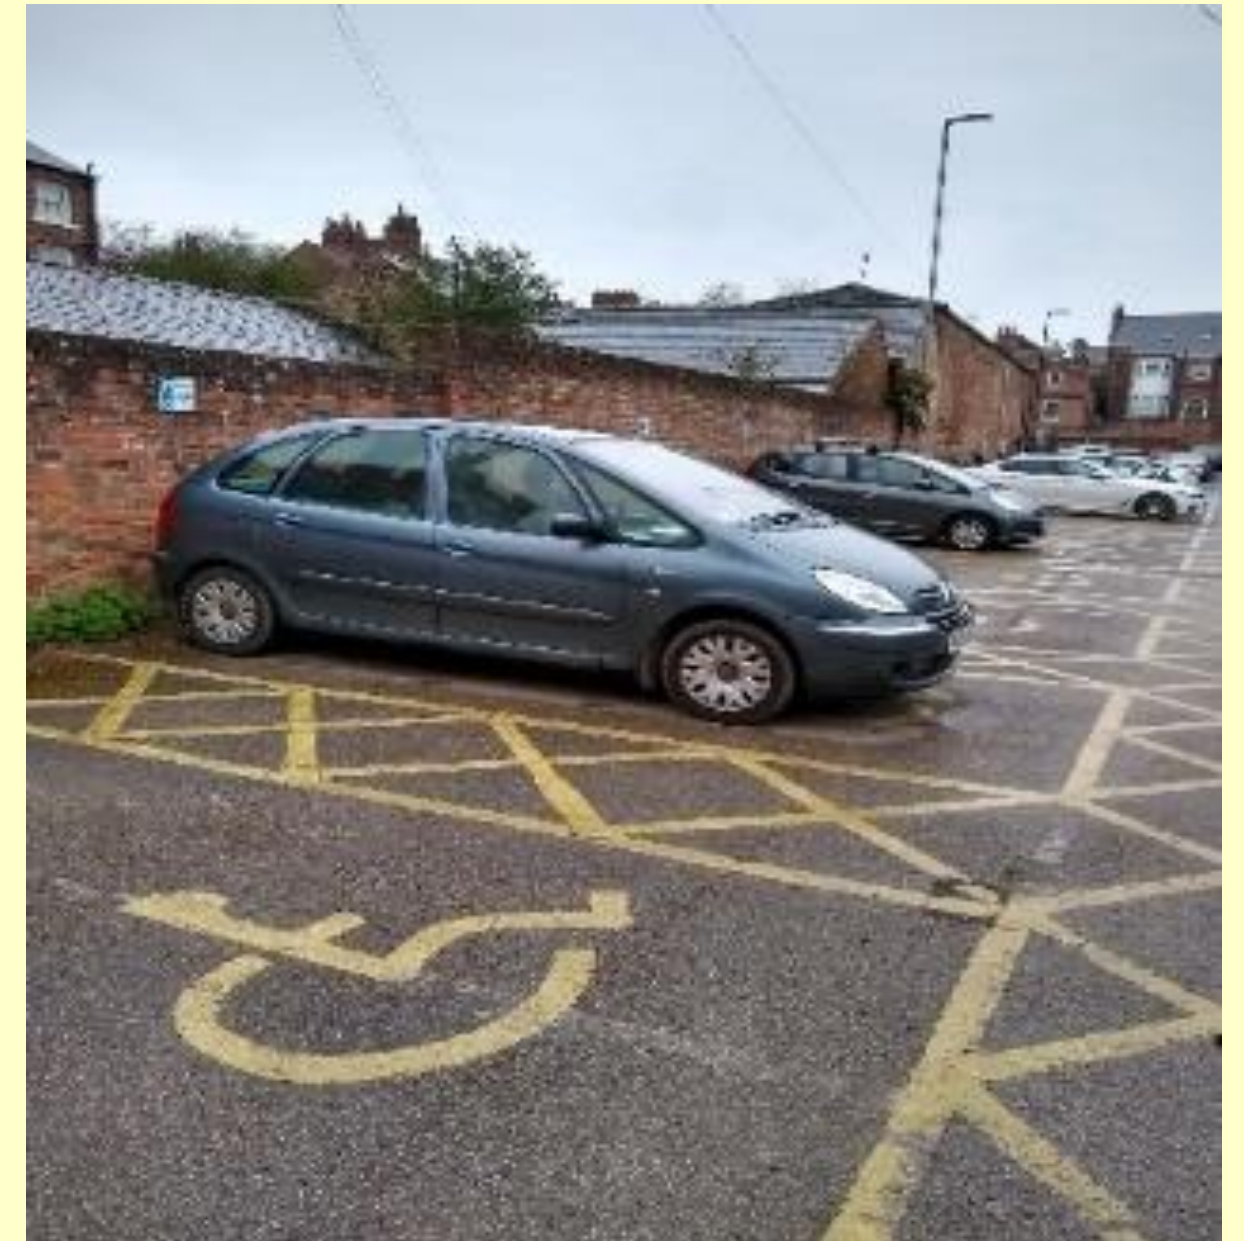
Issue – Information

- Place information relating to free parking by the blue badge bays, to avoid users having to navigate to the payment machine.

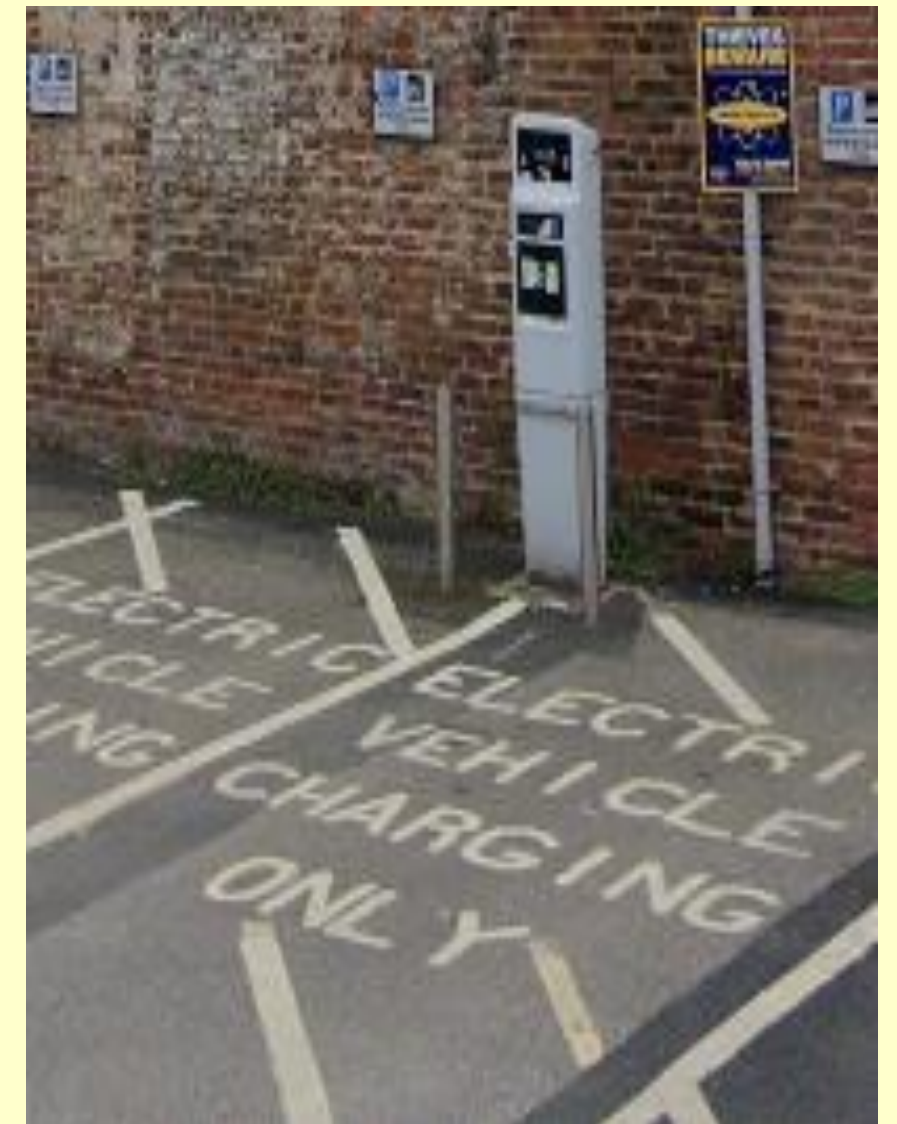
Issue – EV charging bays

- Charging points do not provide access zones on either side and so would not be accessible for many disabled people.

- Establish where accessible EV charging bays could be accommodated in the car parks nearest to the city centre (to PAS 1899:2022 standards)

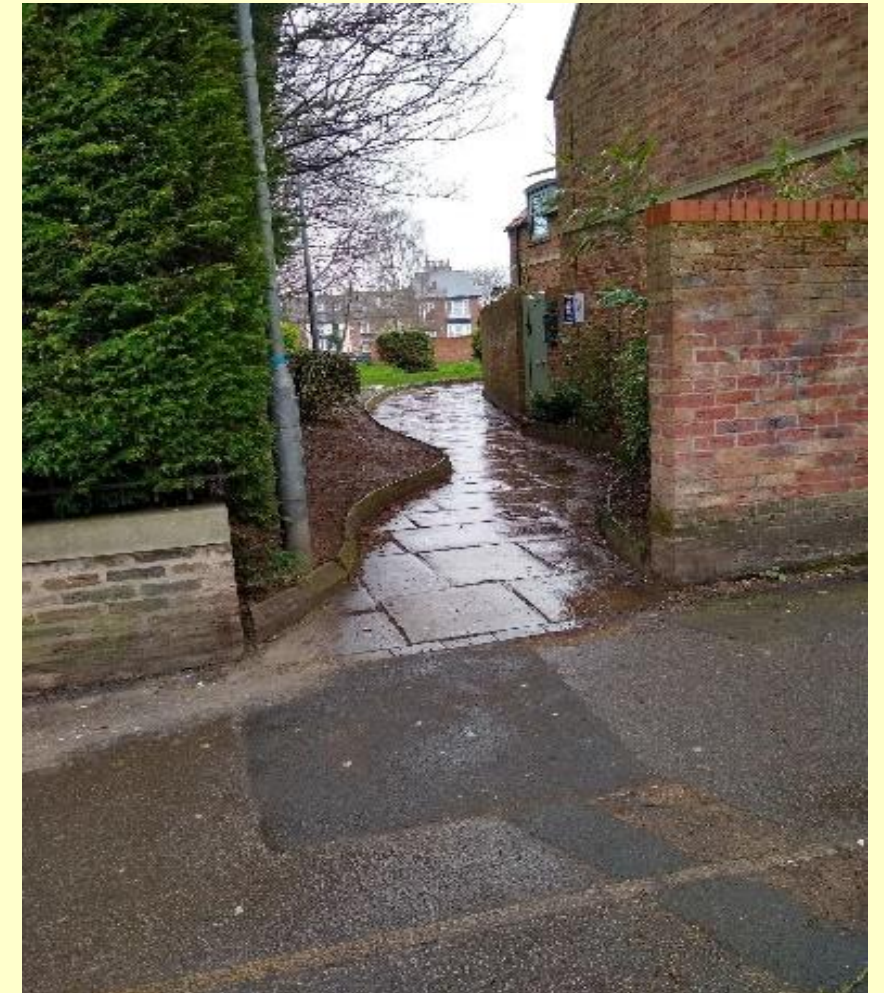
Issue – Access to/from the car park

- Narrow access routes to/from the car park.

- Improve access routes (minimum of 1.8m wide), remove obstructions.
- Inclusive dwell space should also be provided at every 50 metres along this route.

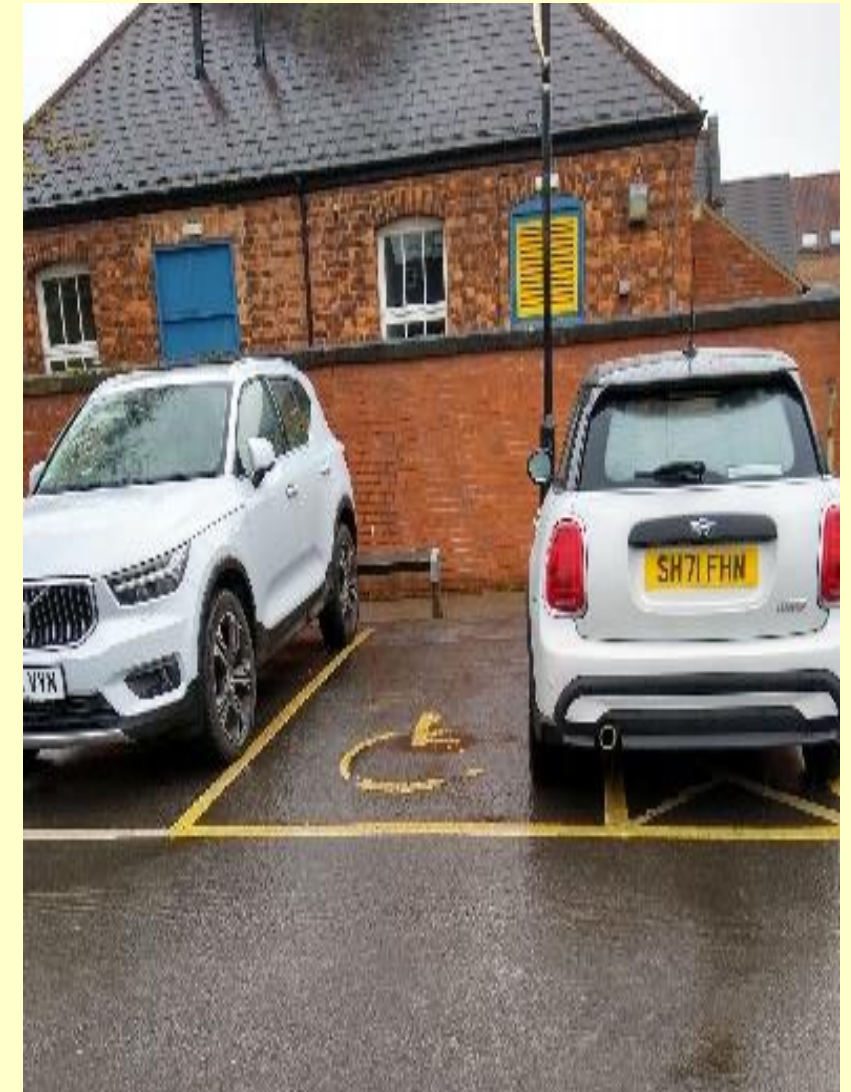
Issue – Accessible parking

- Accessible parking bays are not correctly demarcated with side and rear access zones.
- Not all space dimensions align with current accessibility guidance.

- Reconfigure accessible bays to meet current accessibility standards

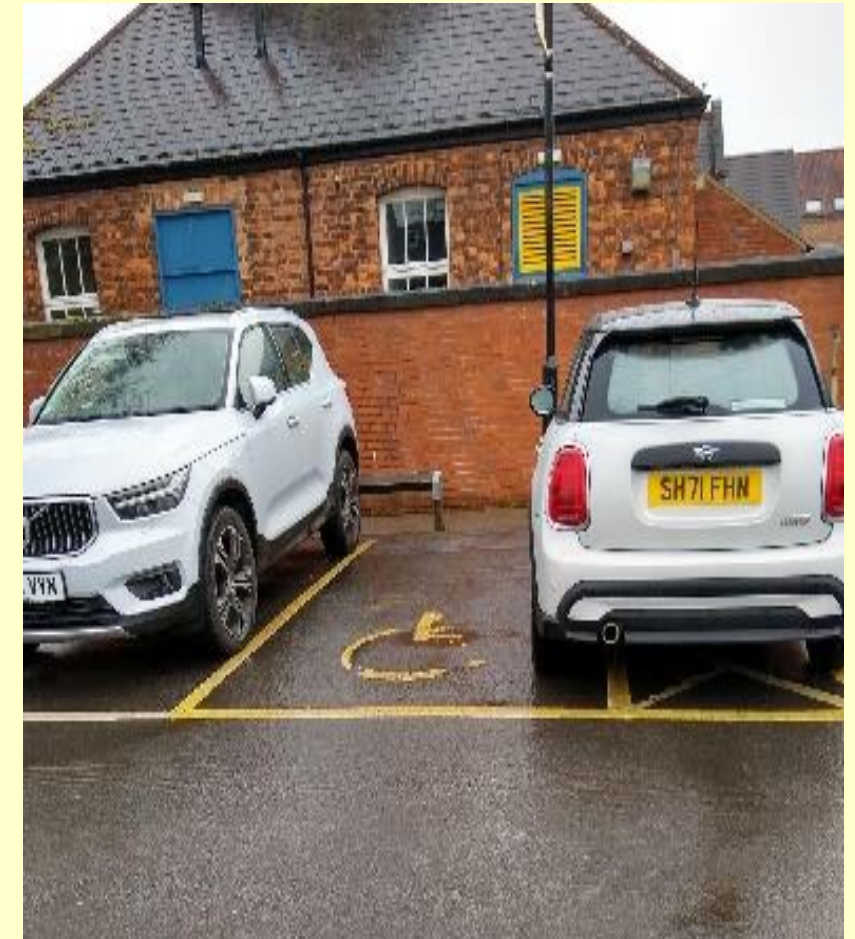
Issue – Signage

- No signage is present indicating blue badge parking is free, and this is only displayed at the ticket machines.

- Place information relating to free parking by the blue badge bays, to avoid users having to navigate to the payment machine.
- New signage should read 'Blue Badge Holders' rather than 'Disabled Badge Holders'.
