# ***THE GROVES LOW TRAFFIC NEIGHBOURHOOD, YORK***

Stage 3 Road Safety Audit

Including Designer response from City of York Council (27 May 2021)

**PROJECT NO. 70053766**

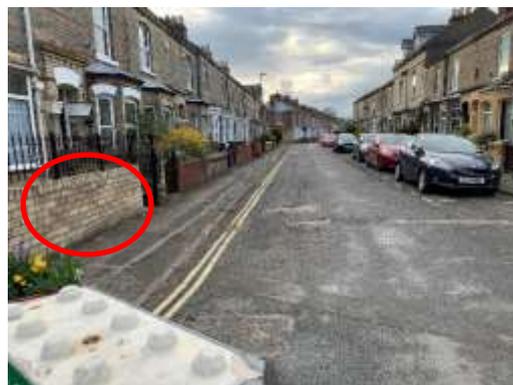
**Summary:** Lack of signing and provision of alternative route signing appears to be leading to injudicious vehicle manoeuvres due to scheme potentially causing collisions with pedestrians, vehicles and cyclists.

Throughout the scheme there appears to be a general lack of visible signing and provision of alternative routes for motorists entering “The Grove” area. This appears to be causing confusion with drivers, who, are possibly following their satellite navigation systems and then having to either carry-out three point turns or reverse into an adjacent side street. This was witnessed during the site visit. The situation is made worst by on-street vehicle parking leading to limited room for motorists to make these manoeuvres. The audit team are aware of the strike to the resident’s wall at 63 Brownlow Street/ Neville Terrace (Photo 1) and the audit team witnessed vehicles reversing into St Johns Crescent from Penleys Grove Street. These injudicious vehicle manoeuvres could potentially lead to collisions with pedestrians, vehicles, cyclists and properties.

Photo 1 - Damage to wall belonging to 63 Brownlow Street, which is in Neville Terrace.

It is recommended that additional signing and provision of alternative route signing be provided.

Adequate advanced signage was erected prior to the installation of the closures and associated measures. These signs are still in place.

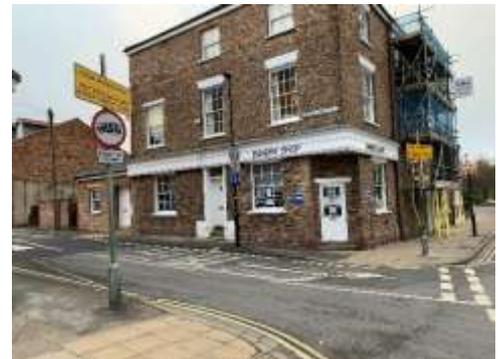
**Summary:** Signing at entrances to scheme are located too high for car driver visibility leading to injudicious vehicle manoeuvres.

At the street entrances to The Groves scheme, yellow warning signs 'Local Access No through route except cyclists' have been erected, however, whilst they have been located high to avoid cyclists striking them, they are not within the motorists eye-line, they also encroach into the carriageway. Therefore, it is likely that many motorists are not seeing the signs, leading to injudicious vehicle manoeuvres, reversing into side roads and three point turns when they reach the barriered off areas. High sided vehicles could potentially clip these signs. The above issues could lead to collisions with pedestrians, cyclists, properties or other motor vehicles, parked or moving.

Photo 2 – Example signing at Penleys Grove Street

It is recommended that the signs warning motorists of the change in conditions be repositioned to the motorist line of vision.

The temporary signs were provided on A frames initially and were placed so that these were clearly visible on approach. However, these were vandalised and/or moved on a regular basis and hence a decision was made to erect the signs on the existing permanent posts. Because of the presence of other signage at these locations, the number of signs were reviewed and superfluous signs removed.

The signs are temporary and will be removed and replaced with more appropriate signage upon if permanent measures were implemented.

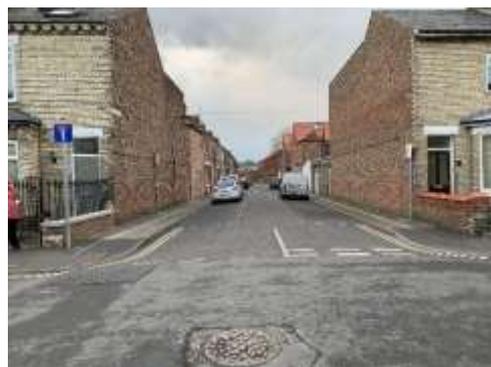
**Summary:** 'No through road' sign only erected on one side of the road, leading to injudicious vehicle manoeuvres due to scheme potentially causing collisions with pedestrians, vehicles and cyclists.

At locations through-out the scheme, single 'No through road' signs have been erected. However they have only been erected as a single sign at the entrance to the street. The audit team feel that due to the urban nature of the scheme and the on-street resident parking that some of these single signs are not being seen by motorists, leading to injudicious vehicle manoeuvres, reversing into side roads and three- point turns when they reach the barriered off areas. This could lead to collisions with pedestrians, cyclists, properties or other motor vehicles, parked or moving.

Photo 3 – Example signing at Earle Street

It is recommended that the 'No Through Road' Signs are erected in pairs and either increased in size or placed on yellow backing boards to aid the visibility of the signs to motorists.

No through road signs are provided on all entrances to the area. In practice it would be beneficial to introduce these as pairs. The size of the signs is appropriate for the speed limit. This will be reviewed as part of the permanent measures if the scheme becomes permanent.

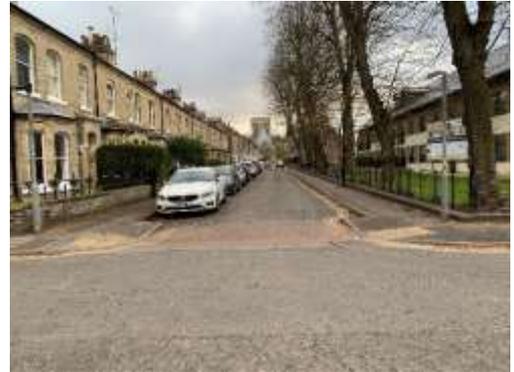
**Summary:** 'No through road sign' not erected at all locations, leading to unpredictable driving potentially causing collisions with pedestrians, vehicles and cyclists.

At some locations throughout the scheme the 'No through road' signs have not been erected. The lack of this signing could be leading to injudicious vehicle manoeuvres, reversing into side roads and three- point turns when they reach the barriered off areas. This could lead to collisions with pedestrian, cyclists, properties or other motor vehicles, parked or moving.

Photo 4 – Example of lack of signing at St Johns Crescent

It is recommended that the 'No Through Road' Signs are repeated within The Groves at all junctions with roads that are subject to a no through road and they are erected in pairs and either increased in size or placed on yellow backing boards to aid the visibility of the signs to motorists

No entry signs are provided on all entrances to the area. In practice it would be beneficial to introduce these as pairs. The size of the signs is appropriate for the speed limit. This will be reviewed as part of the permanent measures.

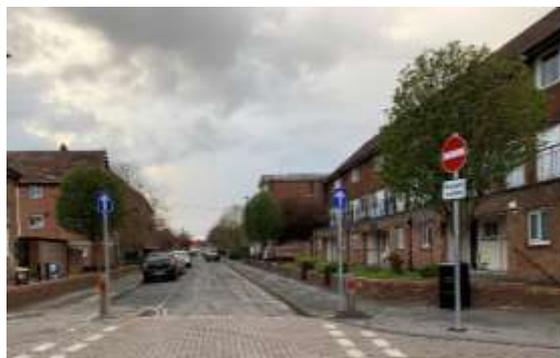
**Summary:** Signing through-out the scheme are located too high for car driver visibility leading to unpredictable driving due to scheme potentially causing collisions with pedestrians, vehicles and cyclists.

New signing located through the scheme extents has been mounted high to avoid cyclists striking them, however, they are not within the motorist's visibility. Therefore, motorist may not see the signs, leading to injudicious vehicle manoeuvres, reversing into side roads and three- point turns when they reach the barriered off areas. This could lead to collisions with pedestrian, cyclists, properties or other motor vehicles, parked or moving.

Photo 5 – Example of height of signs at Townend Street

It is recommended that the signs warning motorists of the change in road conditions be either increased in size or placed on yellow backing boards to aid the visibility of the signs to motorists

Signs should typically be mounted at 2.1m clearance.

Where not done so and where signs are to be retained, the mounting will be amended. However, it should be noted that signs have been erected on a temporary basis on existing posts and will be corrected if they are to remain.

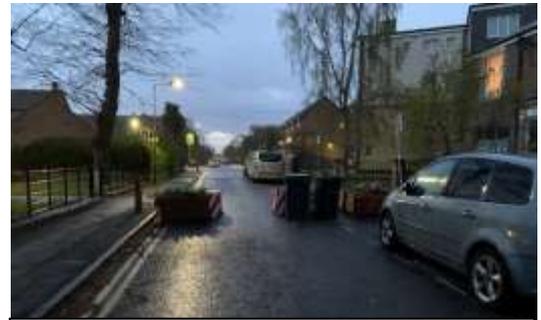
**Summary:** Reflective marking on wooden planters, not visible during the hours of daylight or darkness, which could lead to them being struck by vehicles and/or cyclists.

Where planters have been used to block off the local road networks within 'The Groves' a single reflective strip has been attached to the top of the wooden planter. However, these strips are not highly visible during the hours of daylight or darkness, with some of the strip of reflective material missing, this could lead to them being struck by vehicles and/or cyclists.

Photo 7 – Example of lack of reflective strips

It is recommended that the wooden planters have additional reflectivity strips attached to increase visibility.

A decision is required as to whether the remaining planters are to be retained. If so, they should have appropriate reflective strips.

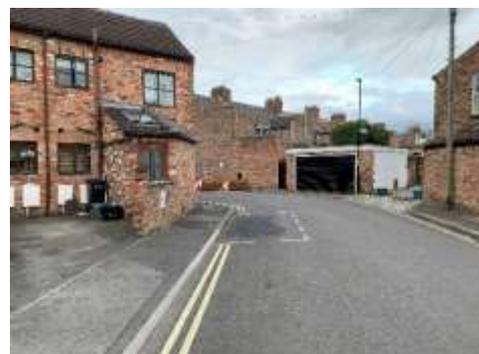
**Summary:** No prior warning of road closure leading to potential collision between vehicles and planters/blockade.

At the end of Amber Street, near number 33, where Amber Street leads into Earle Street there is no prior warning of the road closure which is made up of planters and concrete blocks. Motorists may turn the corner of Amber Street and collide with the stationary objects.

Photo 8 – Example of lack visibility to the planter blockade

It is recommended that warning signs are provided to ensure motorists are aware of the blockade (see also problem 6).

Noted. Warning signs should be provided on both approaches.

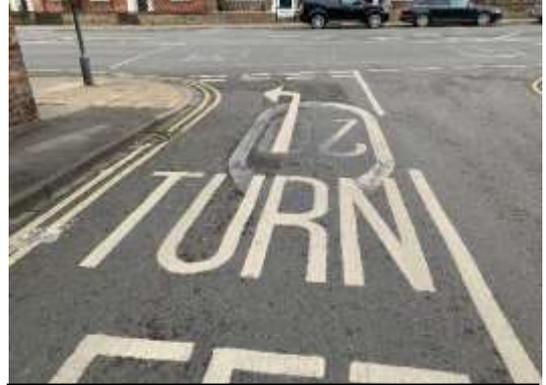
**Summary:** Road marking not removed cleanly before reapplying new ones, leading to driver confusion and possible side-swipe collision

At the end of Penley's Grove Street at the junction with Monkgate, the existing 20 mph roundel has not been cleanly removed before the new road marking has been applied. Not having clear and clean road markings where a particular direction is involved could lead to vehicles misunderstanding the instruction leading to vehicles turning right into the path of other vehicles on Monkgate. This issue was more prevalent at night.

Photo 9 – Road marking still visible

It is recommended that the redundant road markings are completely removed to avoid misperception.

Due to the nature of the temporary trial, redundant road markings were blacked out. As these markings are again showing through, they will either be blacked out again or permanently removed.
