York Walls

Conservation Management Plan
for the City of York Council

November 2021

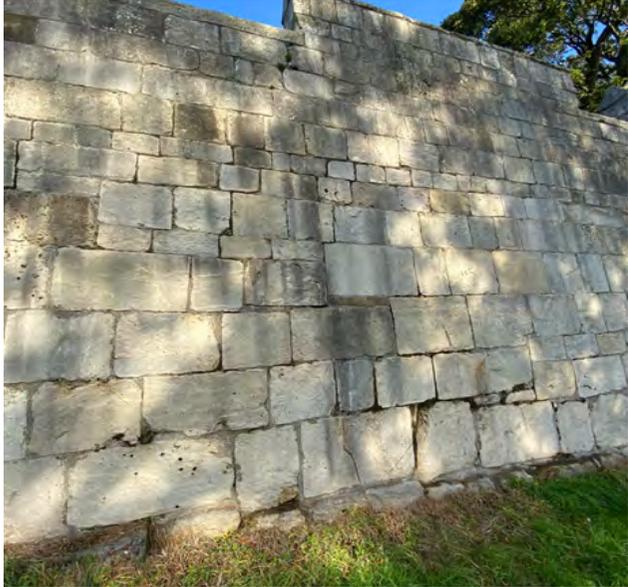
Damp area at 50m chainage

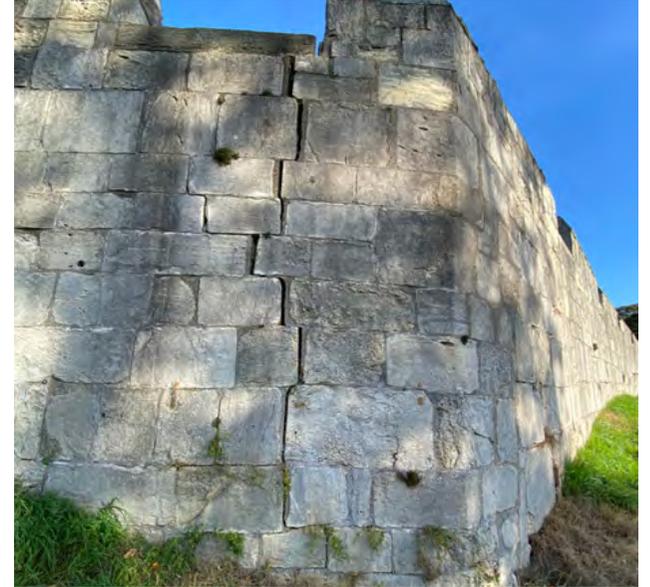
External Crack next to Bitchdaughter Tower

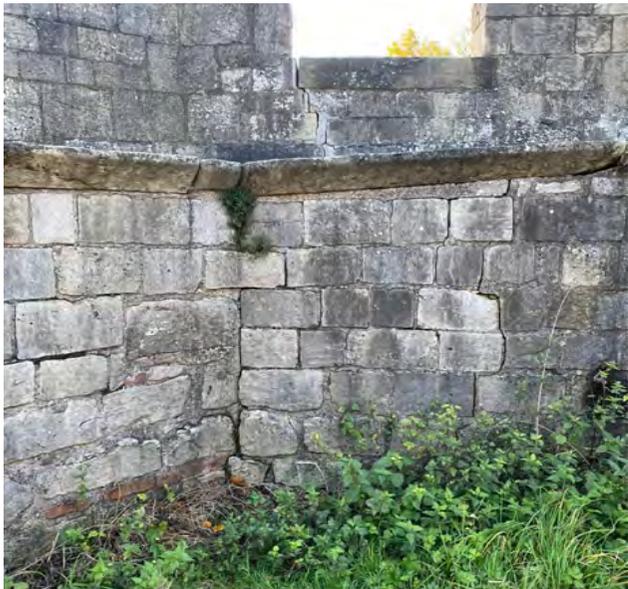
Internal crack next to Bitchdaughter Tower

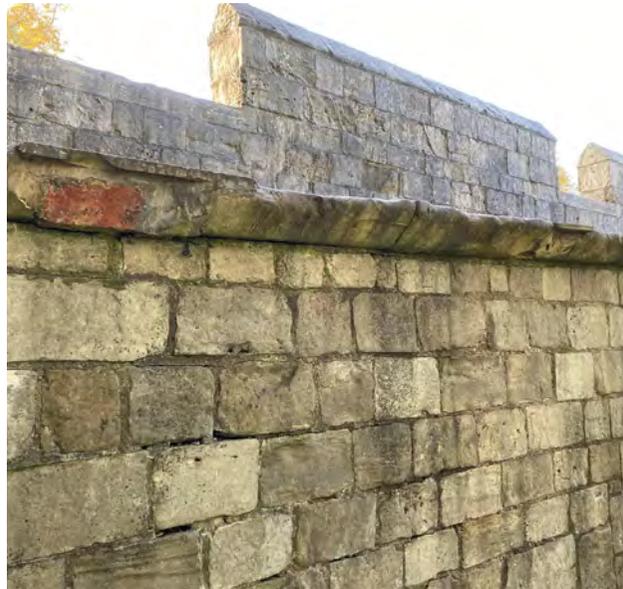
Poor repairs to edge stones of walkway

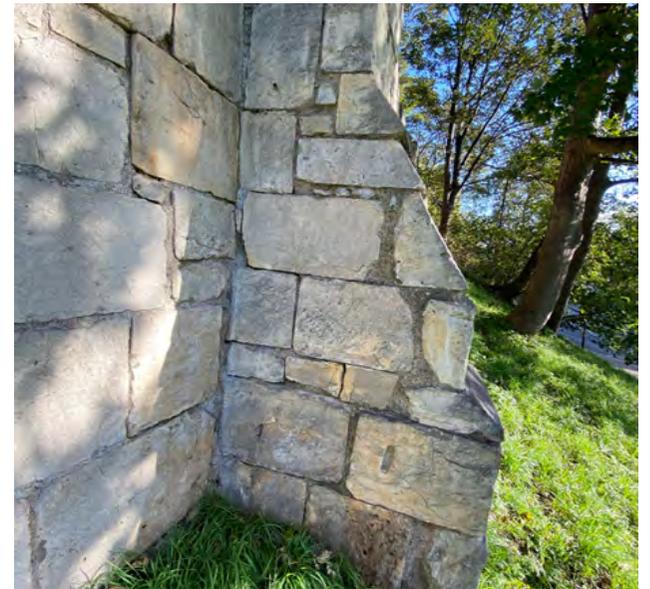
Structural movement to buttress 25m chainage

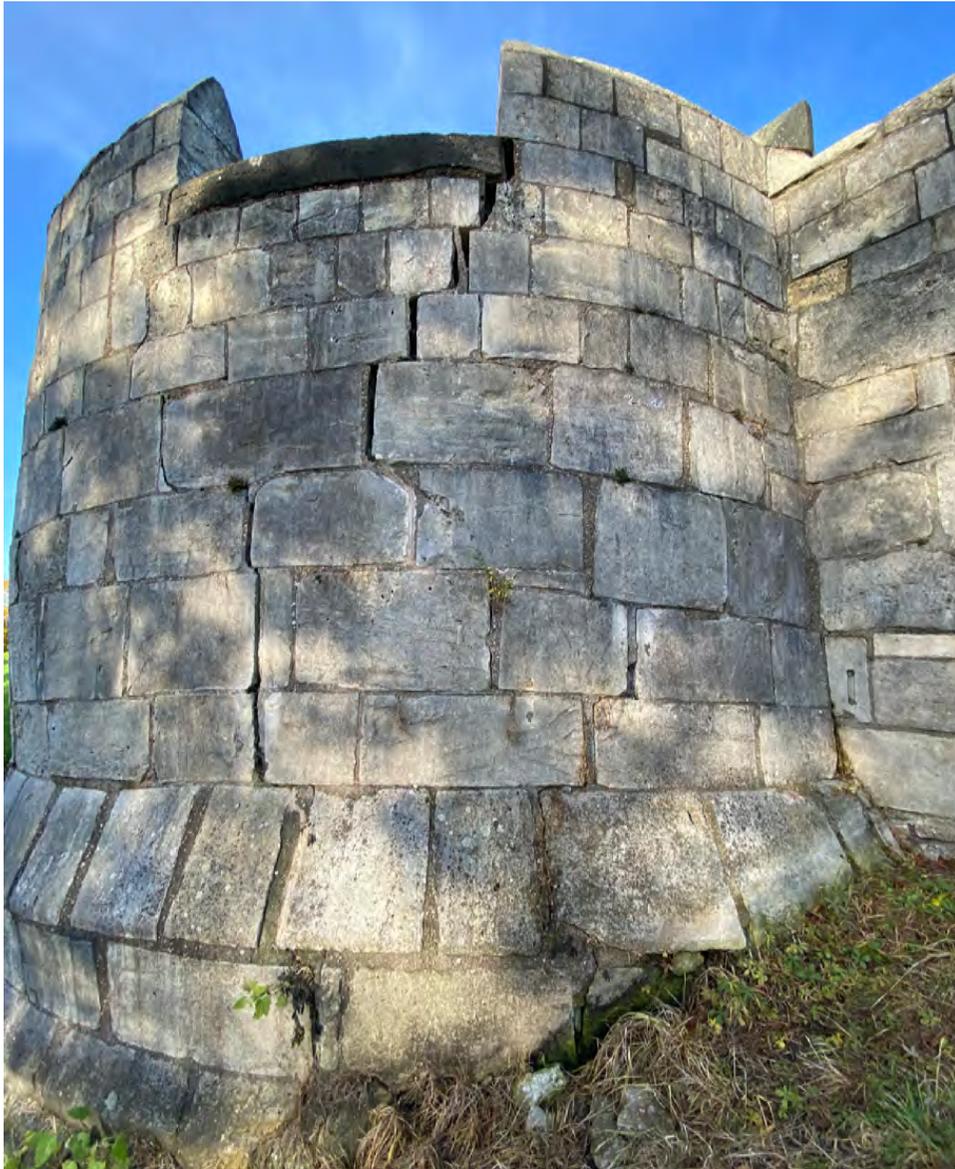
Section 1, Tower 2

South east elevation major crack

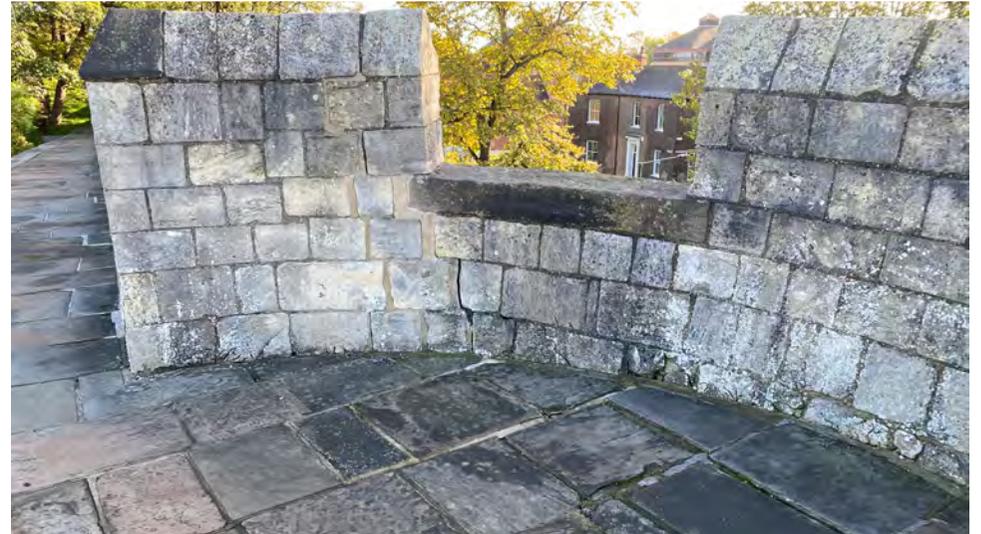
South east major crack under crenel

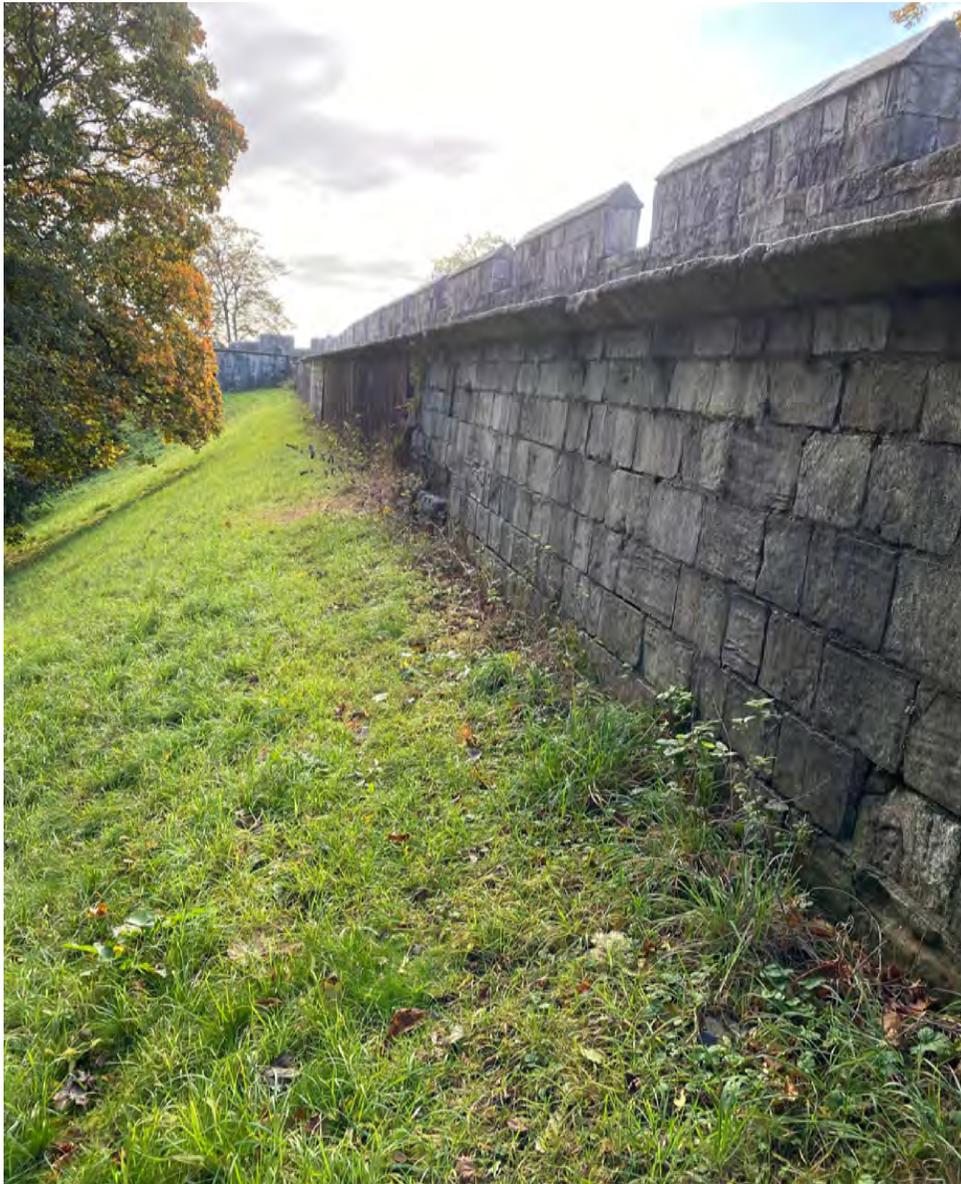
Section 3, Chainage no. 150–650

Intermittent brick infill between stone structures

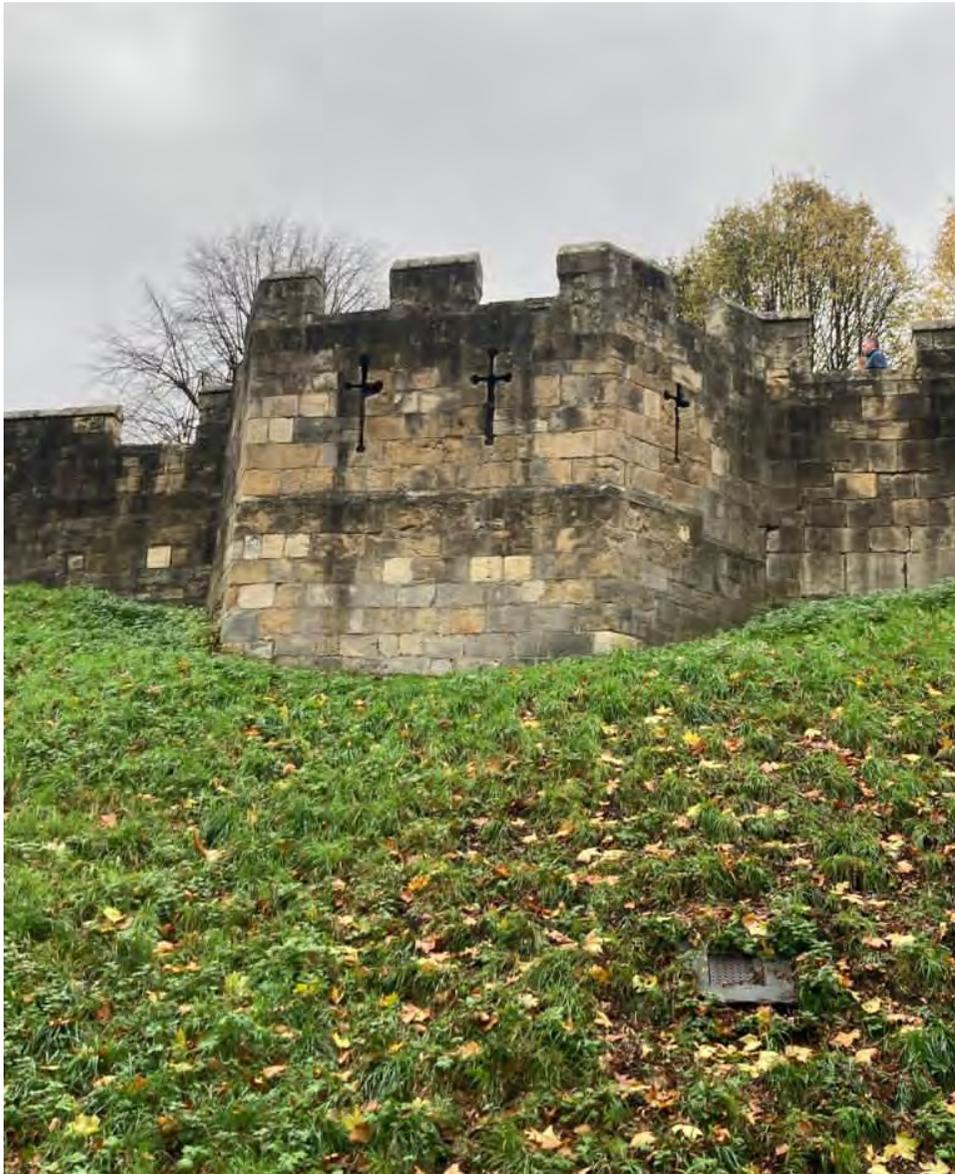
Section 3, Tower 5

External view with cracks to north eastern face

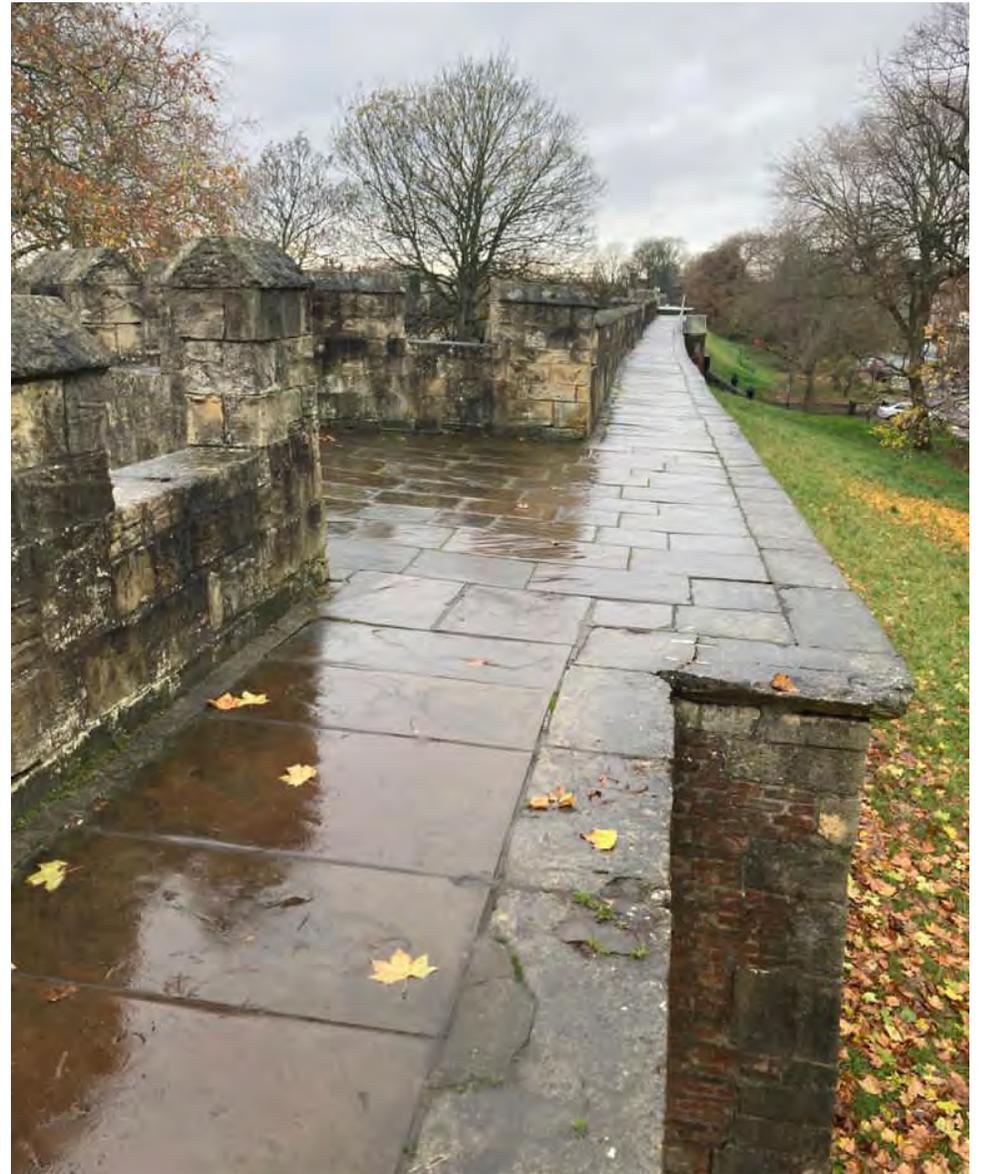
Walkway with movement cracks below

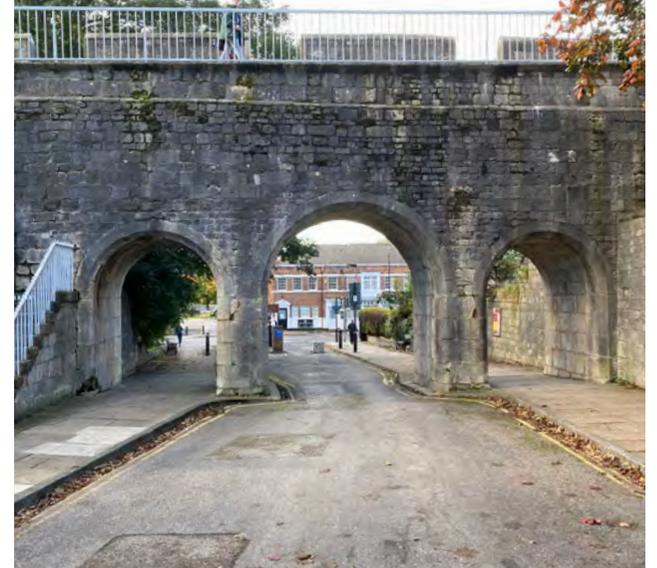
Saturated structure and organic growth

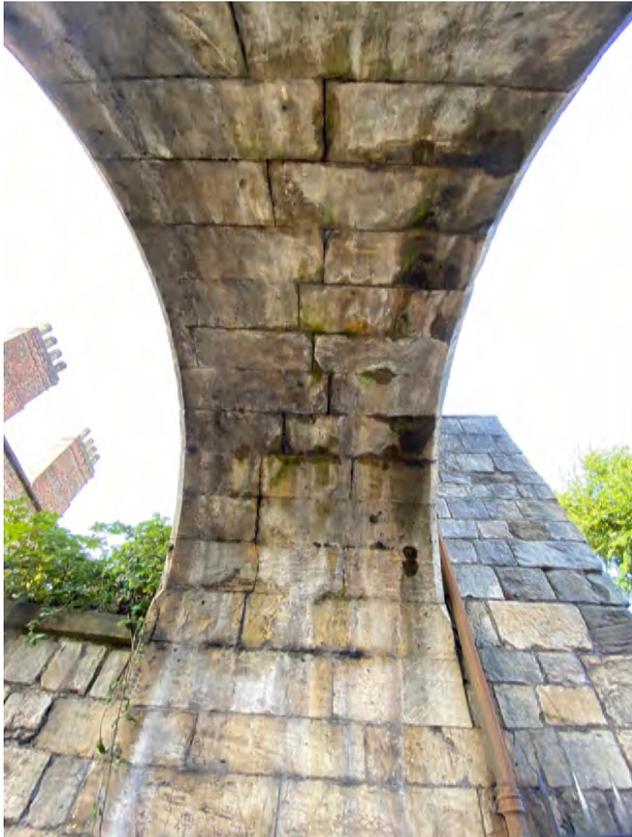
Section 4, Micklegate Bar

Crack along pedestrian archway

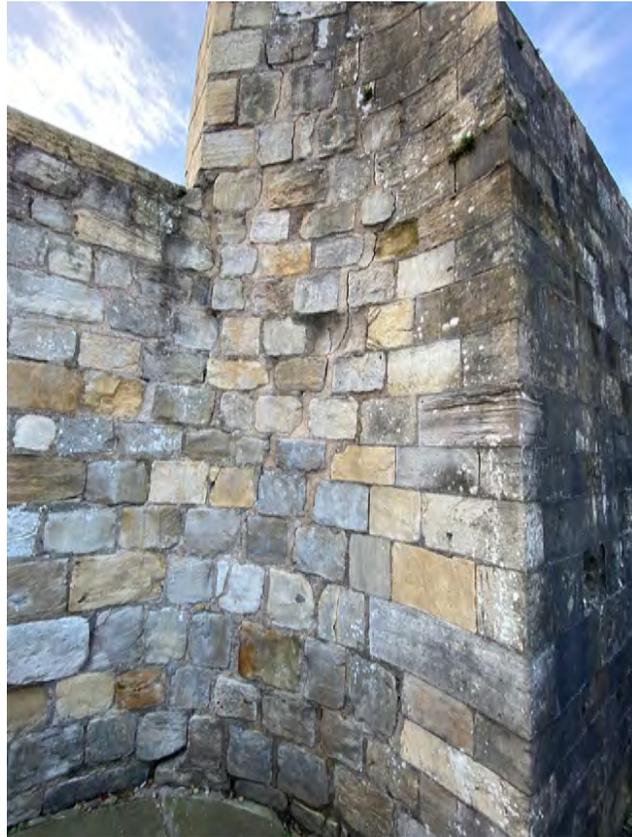
Crack to wall north of Bar

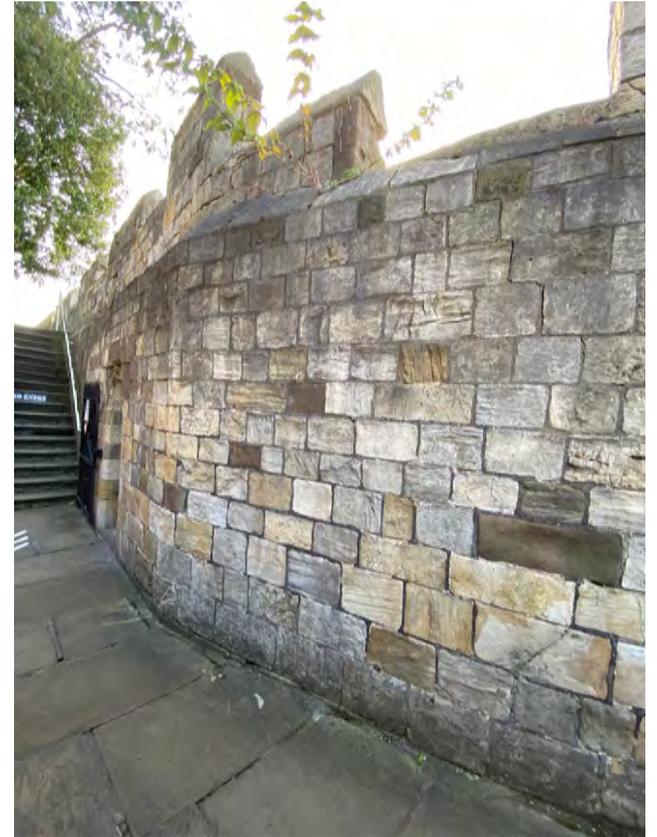
Cracks to wall south of Bar

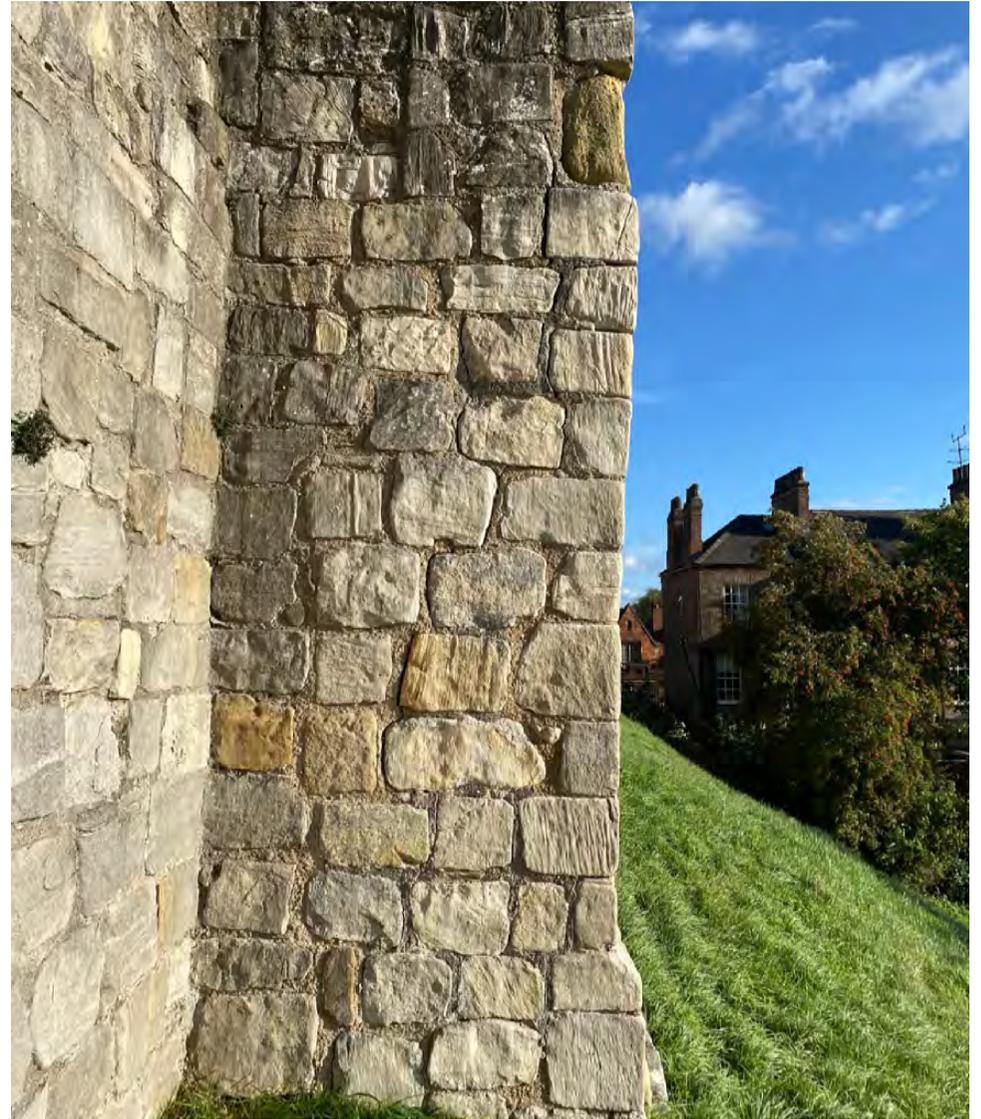
Western elevation vertical crack

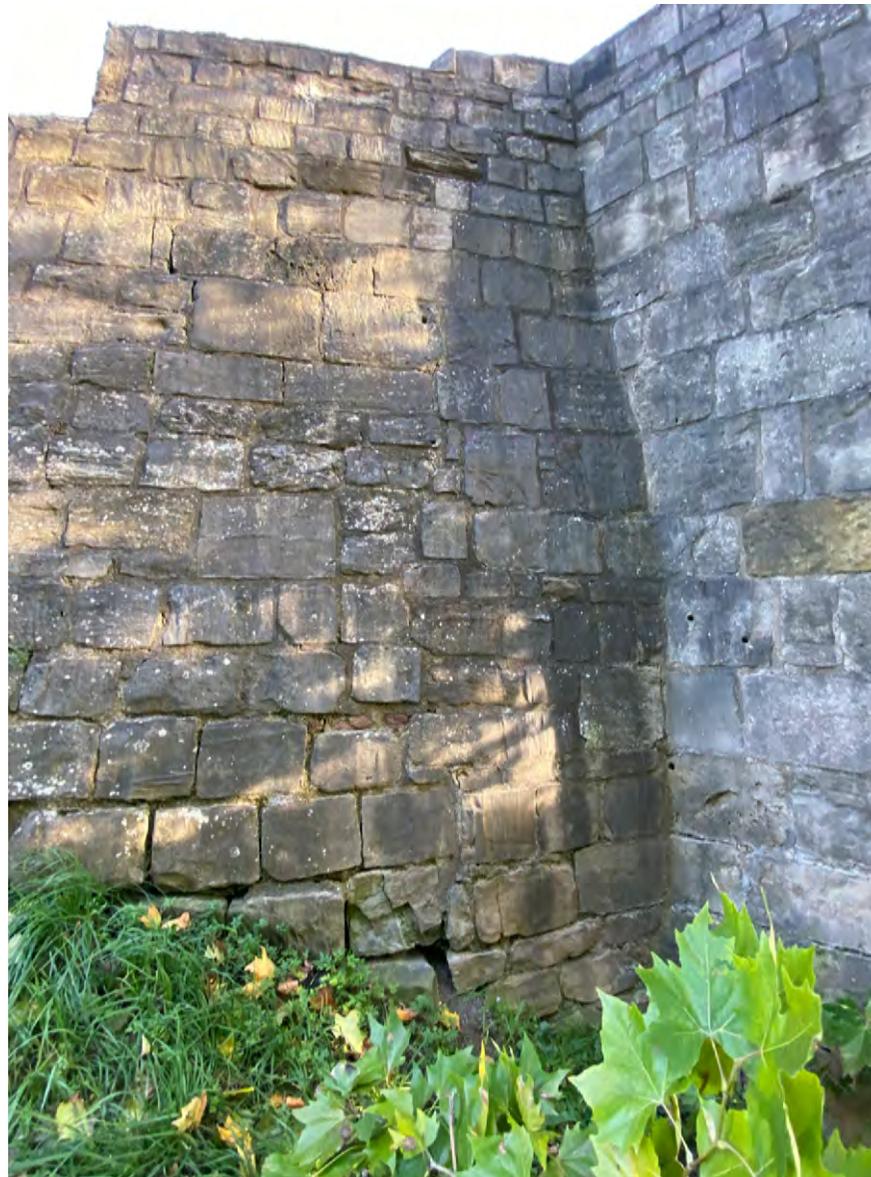
Section 5, Tower 14

North west elevation open joints at low level

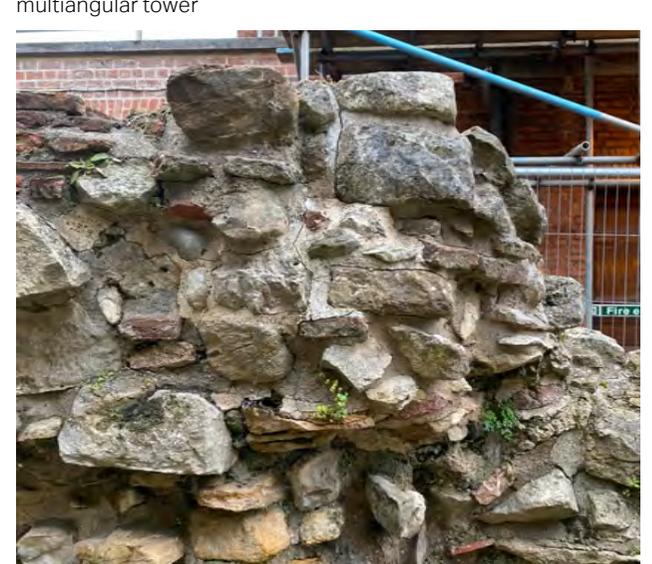
Vegetation growth and failing cementitious mortar to exposed Roman walls

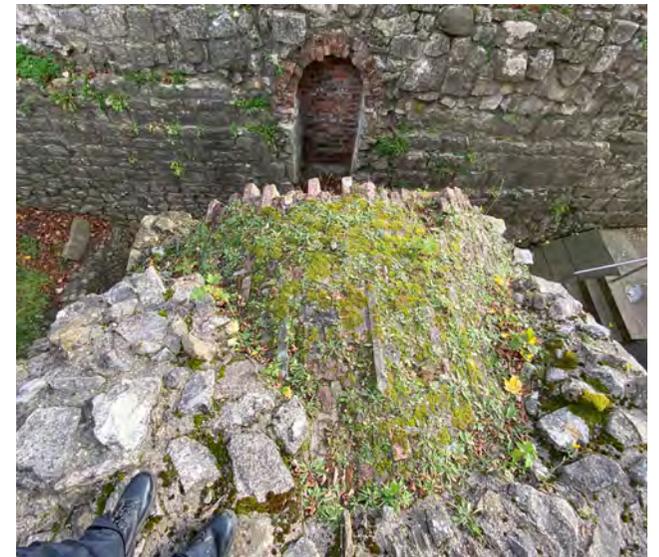
Vegetation and failing mortar and spalling brick to barrel vault

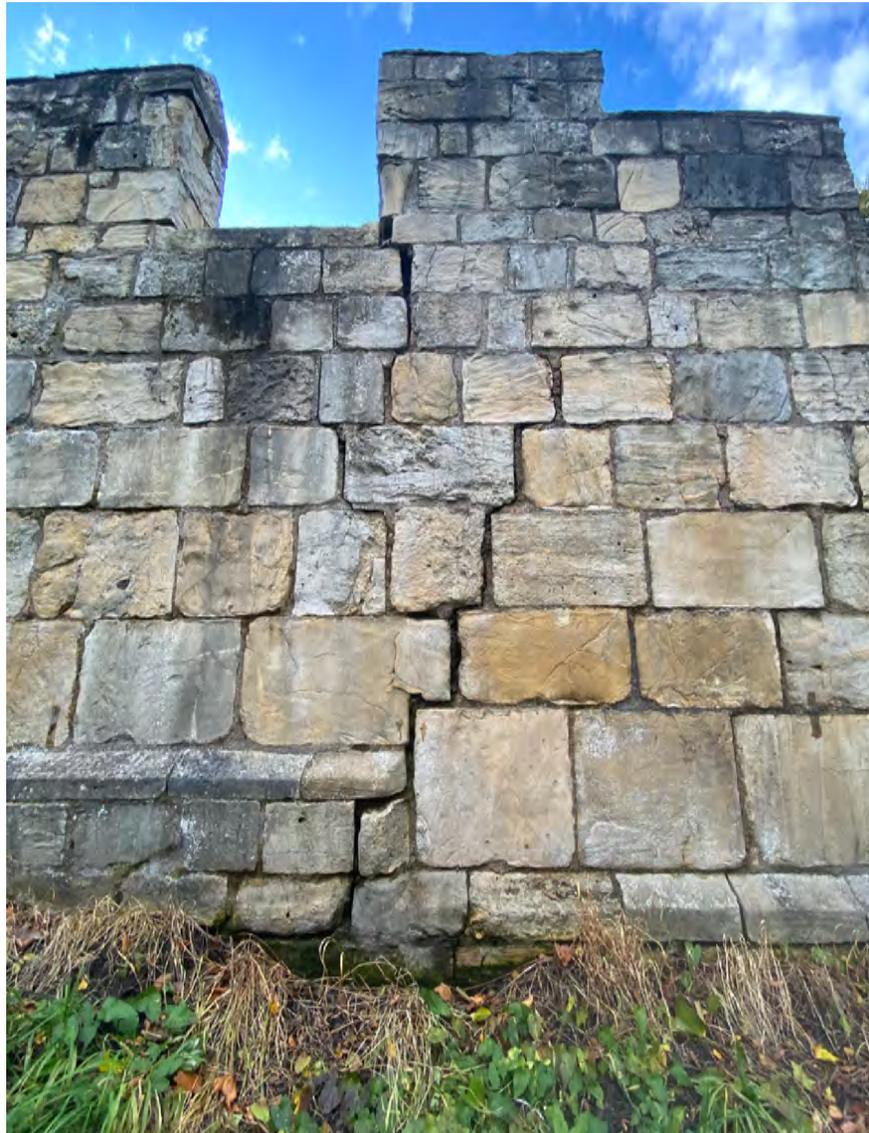
Section 15, Chainage no. 2600-2900

Structural movement at junctions

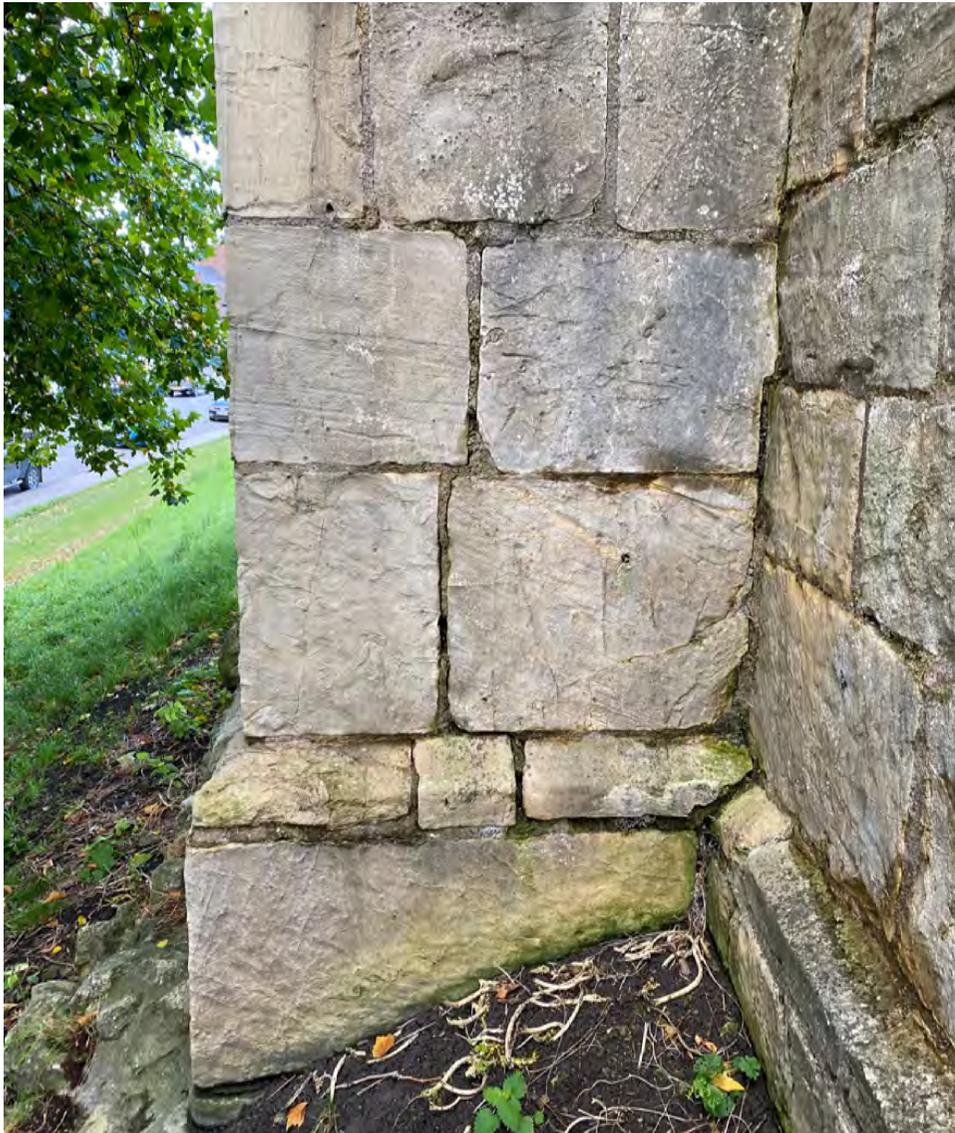
Section 15, Tower 36

Movement crack to north side

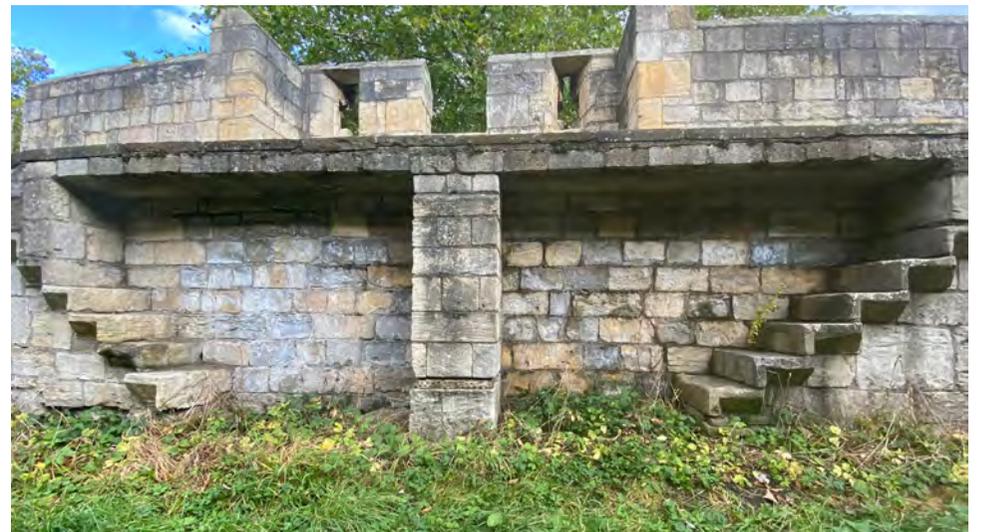
Steps built over with structural movement to central pier

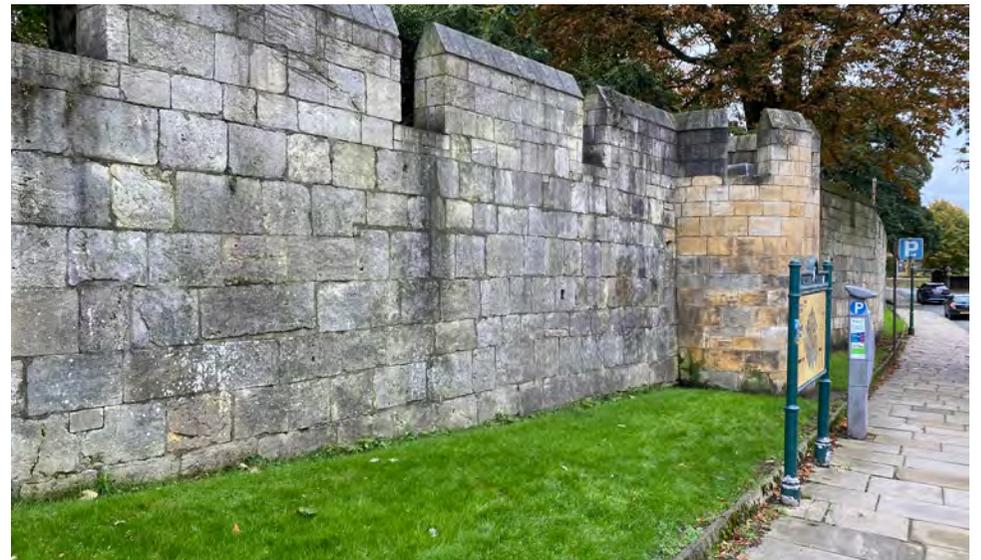
Fine movement cracks to northern side

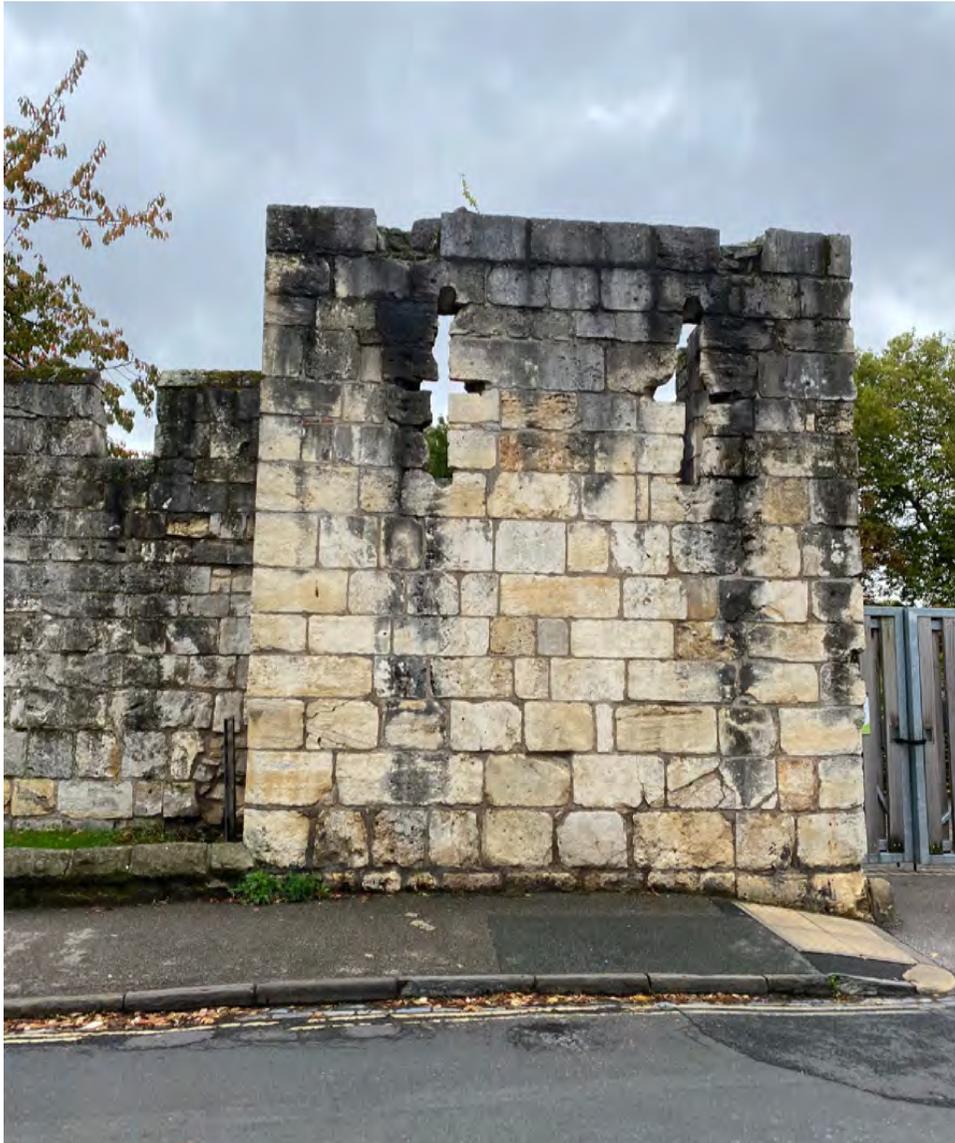
Section 20, St Mary's Abbey Precinct, Intermediate Tower C

Exterior eroding stones from concentrated water movement from fractured stone to top course

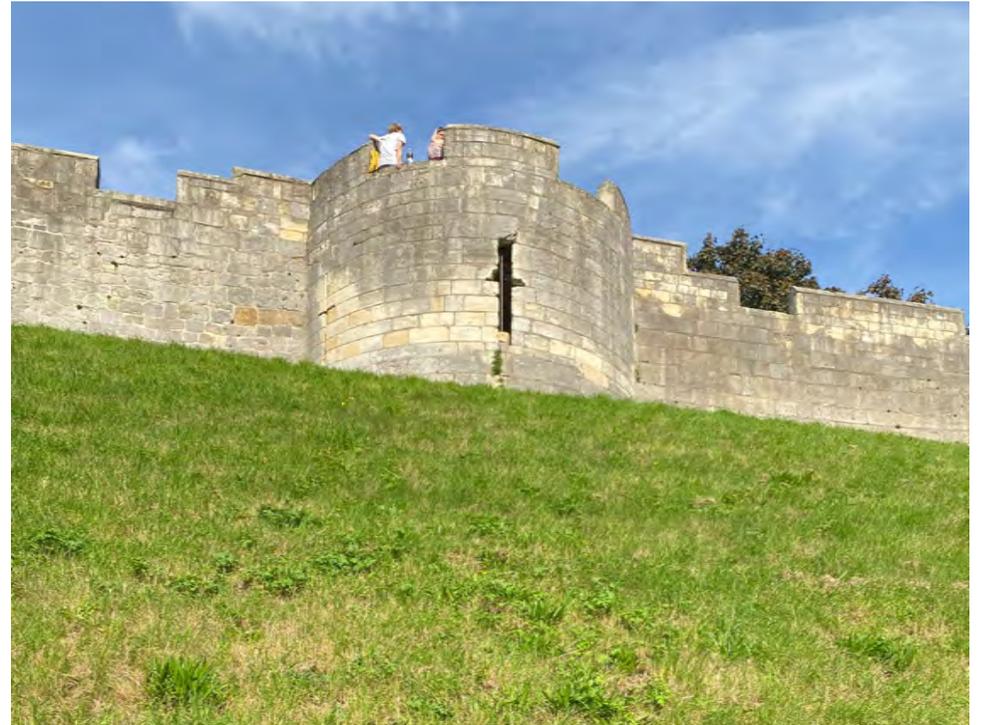
Section 3 Tower 7, with adjacent walls displaying signs of cannon shot damage
