Character area 14: Piccadilly

Historic Core Conservation Area Appraisal

City of York Historic Characterisation Project - 2013, Character area statements

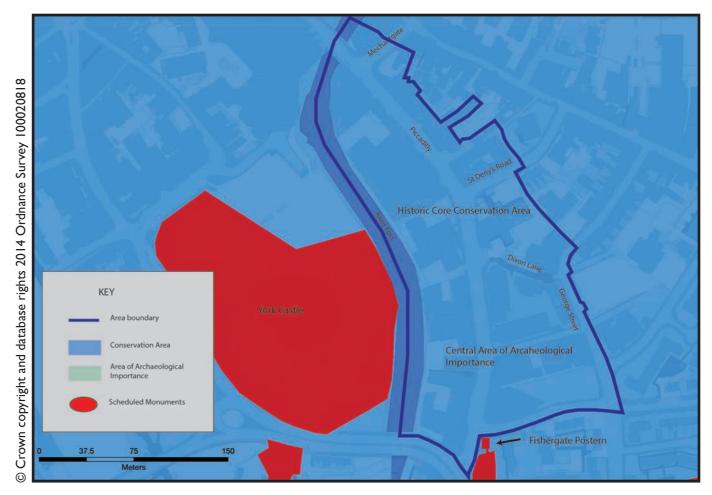
Above: Plan showing designated heritage assets within this character area.

Designations: The site falls within the Central Area of Archaeological Importance and the Historic Core Conservation Area.

The Piccadilly area contains few architecturally or historically significant buildings. There is only one Grade II listed building. Two buildings of merit have been identified in the Historic Core Conservation Area Appraisal, the Banana Warehouse and York Trolleybus Garage (more recently known as Reynard's Garage) as good examples of interwar architecture in the area.
