York city centre Access and Mobility Audit Summary Report

By Brenda Puech
and Ross Atkin

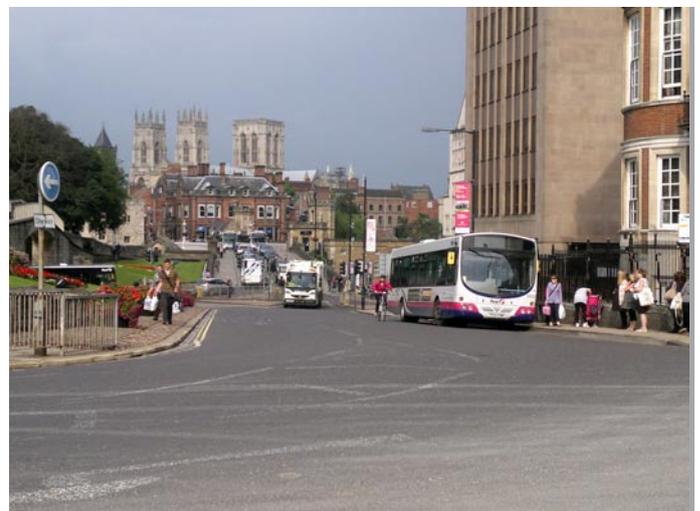
Vehicle dominated route from Station towards the city centre

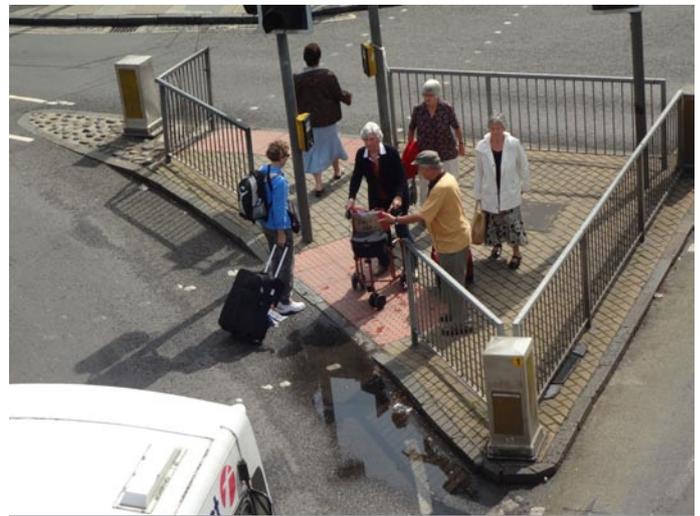
Pedestrian crossing island, Rougier Street

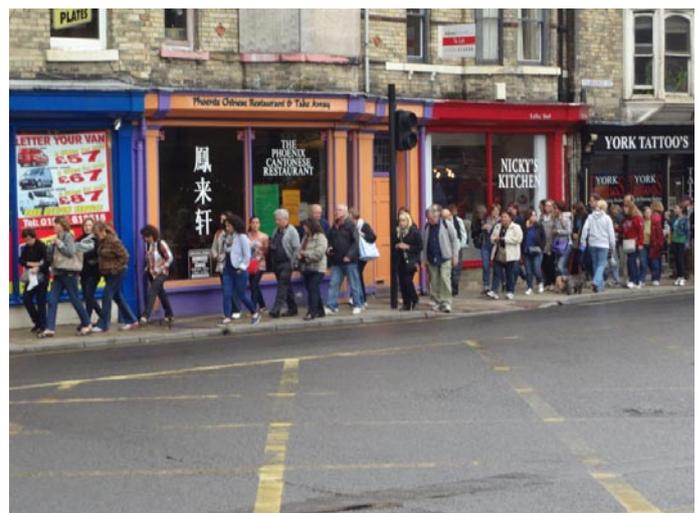
- the coach station has a short and direct route to Bootham Bar and the Minster, but along a narrow footway on one side of heavily trafficked Gillygate that is only 1.3 metres wide in places and has inadequate crossing points to the wider footway on the other side of Gillygate
- the footpath has obstacles including wide side road junction flares, cobbled crossovers, bollards and traffic signposts restricting the available width
- there is a difficult signalled pedestrian crossing at Bootham Bar which is extensively guardrailed and requires some detours from desire lines. Crossings to the city Walls or High Petergate leading to the Minster can involve up three crossing stages across guardrailed pedestrian refuges (which often become overcrowded)

Gillygate with visitors from Union Street coach park

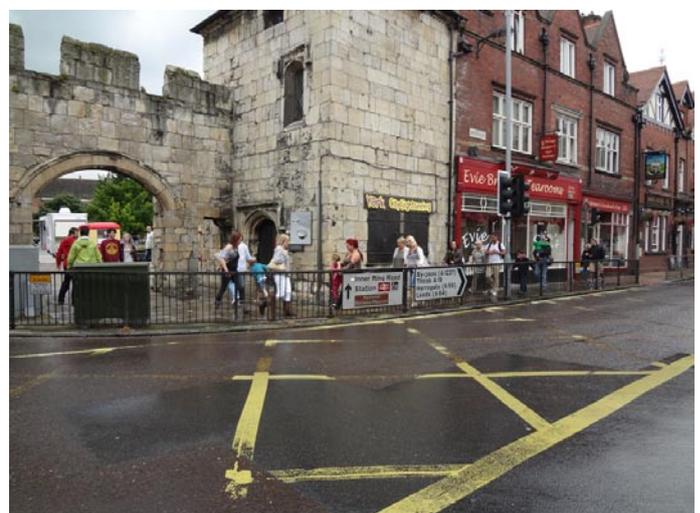
Bootham Bar pedestrian crossing

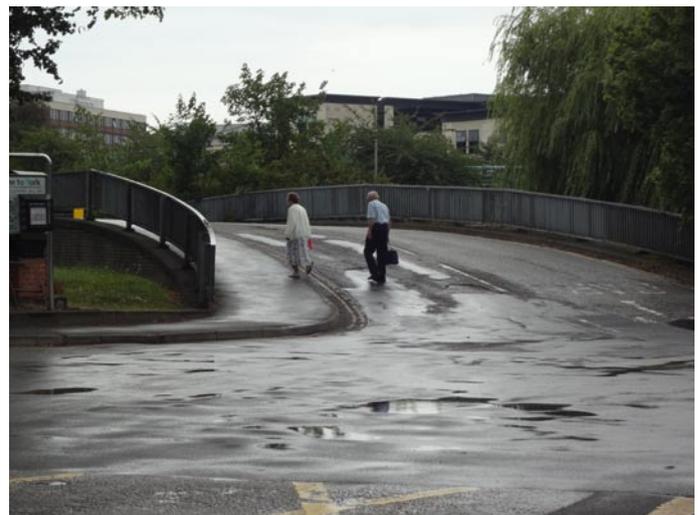
- If you exit right from the street entrance to the coach park, you are led past the wide mouth of the junction onto a guardrailed footway adjoining the dual carriageway that leads over a canal bridge to Fishergate dual carriageway with a raised median strip in the middle. From here you can view Fishergate Tower the entrance to the city Walls across the road, but there is no crossing point here. You need to walk way past the Tower until you get to the crossing of Fishergate with Foss Island Island Road quite a distance further down. There is a two stage signal crossing here that leads to the other side of Fishergate and then a long walk up the other side of the Fishergate to reach Fishergate Tower.

Exit from Foss Islands Coach Park

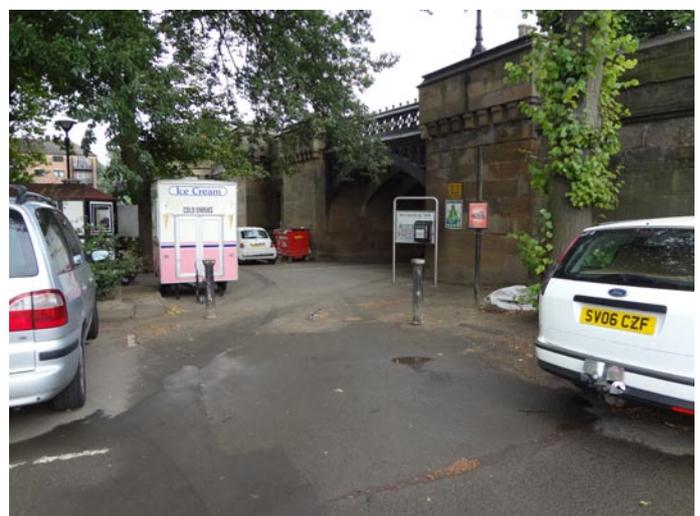
Riverside exit from Foss Islands Coach Park

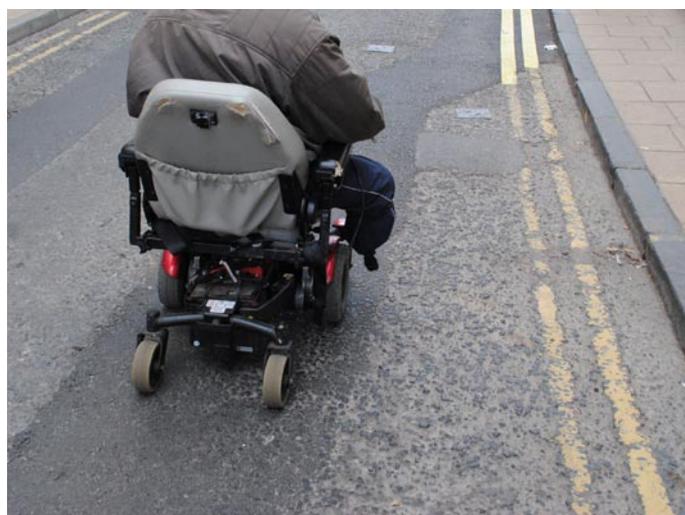
Colin follows a trench to avoid poor road surface

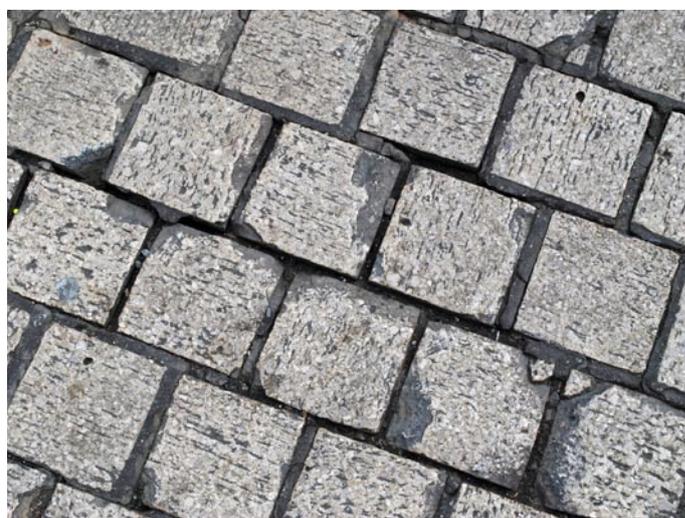
Cracked and missing pointing, Colney Street

The most significant source of problems for participants was the poor standard of paving found throughout the city centre and the steep and unpredictable crossfalls often found on the often narrow and overcrowded footways. Steps should be taken to identify and repair problematic areas of paving whilst ensuring that steep (and especially uneven) gradients are removed on any street receiving significant attention. Efforts should be made to remove unnecessary street furniture as well as deterring other footway obstructions through better enforcement of parking and the elimination of as many 'A' boards as possible.

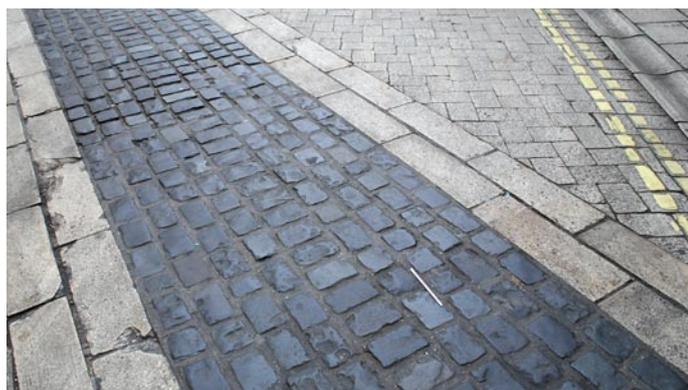
Diagonal patch of cobbles, Peasegate

‘I don’t know why that’s there really. If you’re in a wheelchair that’s a problem’

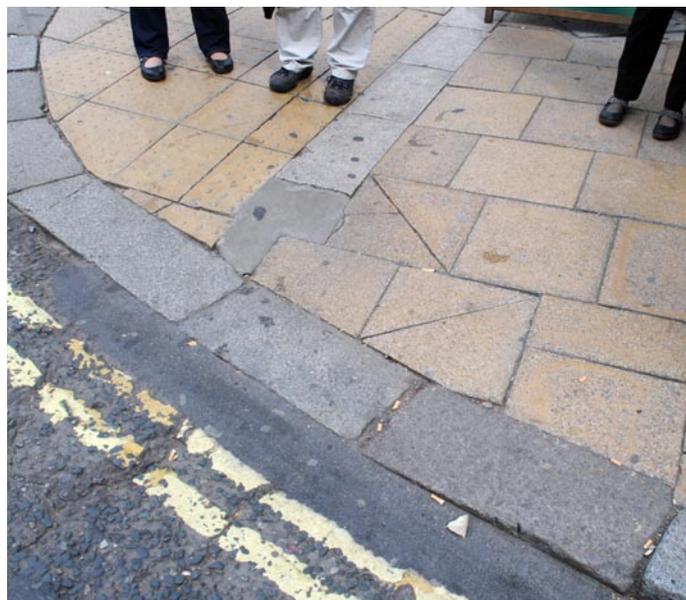
Surface with unpredictable camber where Susan and several others have fallen, Fossgate

Steep, uneven and unpredictable crossfalls were also a problem for those using wheelchairs, stick users or anyone not totally confident on their feet. These were exacerbated at crossings where steep and uneven dropped kerbs were a major barrier to people mounting the footway and a hazard to those encountering the crossing point as they passed along. Wheelchair users were observed to lose control of their chairs as they passed some crossing points due to the steepness and undulation of the surface. Susan pointed out a particular dropped kerb area at the corner of Fossgate and Pavement where several members of her rheumatoid arthritis support group, including herself, had all fallen due to the undulating and unpredictable gradient of the paving.

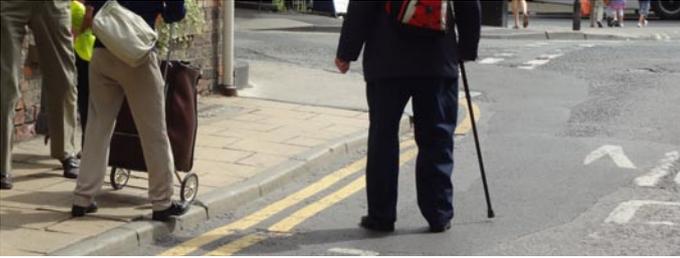
Narrow footway, Fosgate

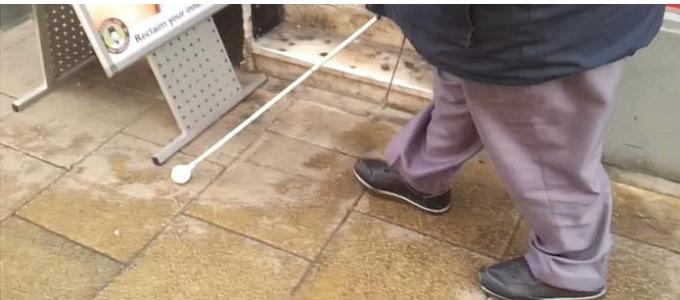
'A' board obstructs David on Spurriergate

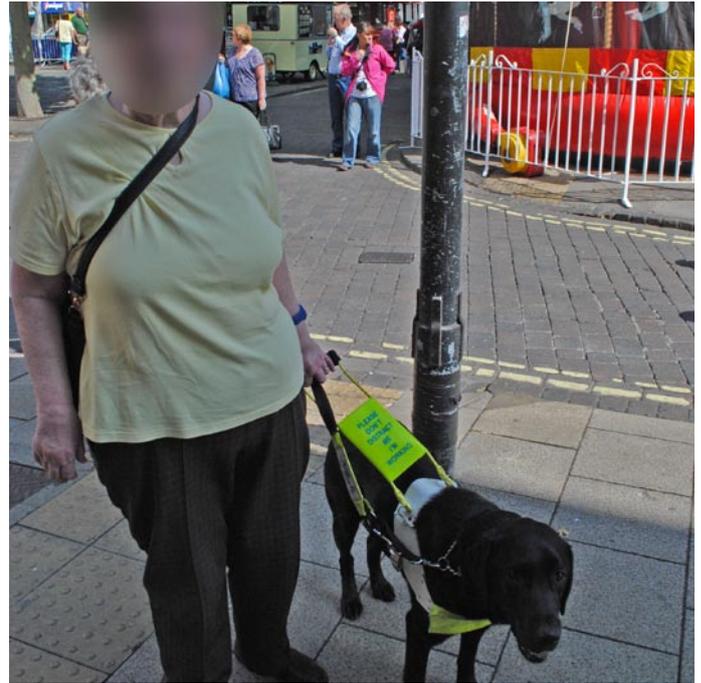
Funfair on top of tactile paving, Parliament Street

'The funfair obstructs the getting across because we work to the tactile bit, that's what we head for and we can't get across because the fun fair's there'

Better control of the siting of temporary erections (such as cafe tables and market stalls) would also be useful so that their positioning works in harmony with other street elements to minimise the disruption they cause. This is particularly true on Parliament Street where any future design work should deal specifically with the positioning of these temporary erections.

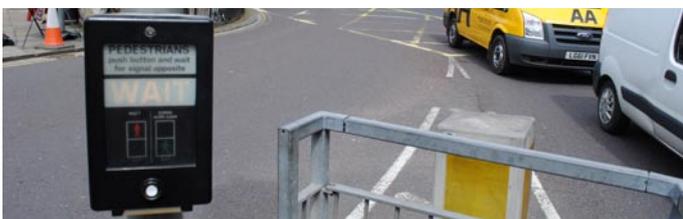
Pedestrian Island, Museum Street

“[it is good] because it’s split in the middle... you’ve only got to go across one stream of traffic”

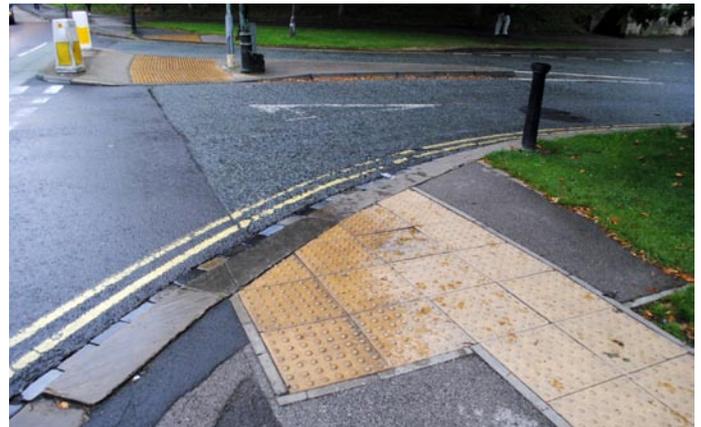
Excessively wide junction splay and incorrect tactile paving installation (tail implies controlled crossing)

“Too much of a lip, I won’t get up it. It’s not down to t’armac is it? it doesn’t meet the tarmac”

It is recommended that pedestrian desire lines should be kept as straight as possible at side-road junctions as advised in Manual for Streets. Small corner radii minimise the need for pedestrians to deviate from their desire line and also help reduce the speed of turning traffic. Manual for Streets also advises raising the carriageway to footway level across the mouths of side roads to allow people to cross on one level.

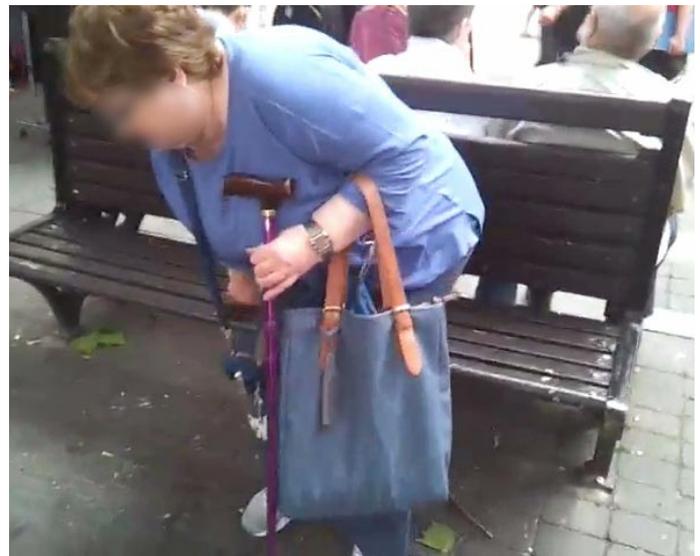
Sandra sits on a seat on Parliament Street

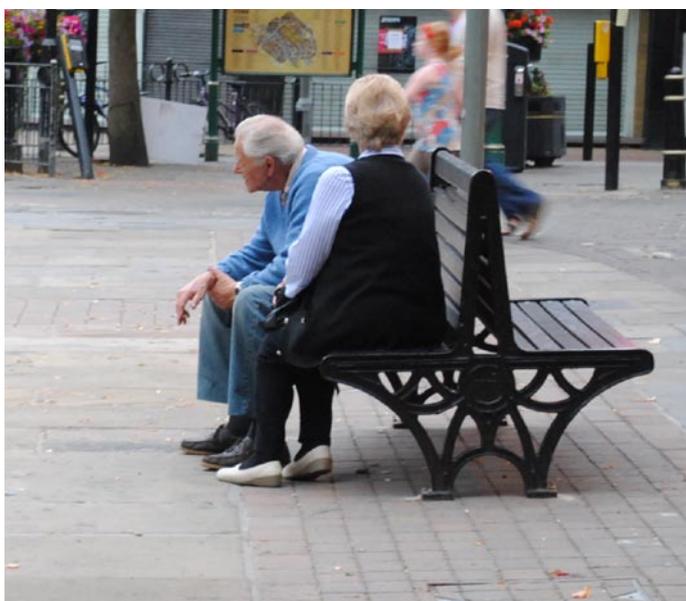
All the seating overhangs its ground level profile significantly meaning that it could cause a long cane user to collide with it, however this occurrence was not observed in the shadowing nor mentioned by the long cane user who participated.

Seat, Parliament Street

The seating itself could be significantly easier to use for older and disabled people, particularly if it was slightly higher and had seating spots with armrests on each side to make standing up easier. There is an opportunity to retrofit cast iron arm rests to existing seating by screwing through into the slats. Such armrests would need to be drawn up to suit the existing seating and procured from a foundry or street furniture manufacturer.

If seating is to be replaced it is recommended that seats are purchased that have a seat height between 450mm and 500mm and have an armrest on either side of each seating space.

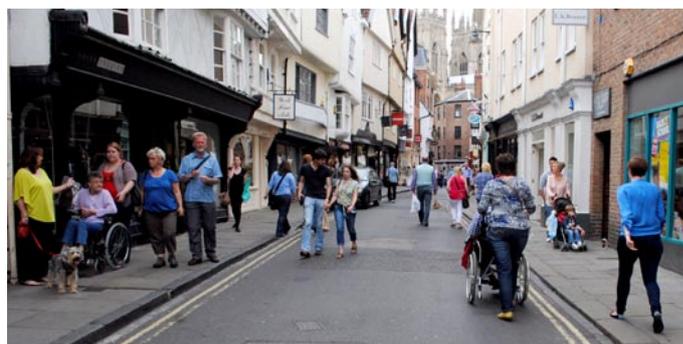
Wheelchair user in the carriageway, Low Petergate

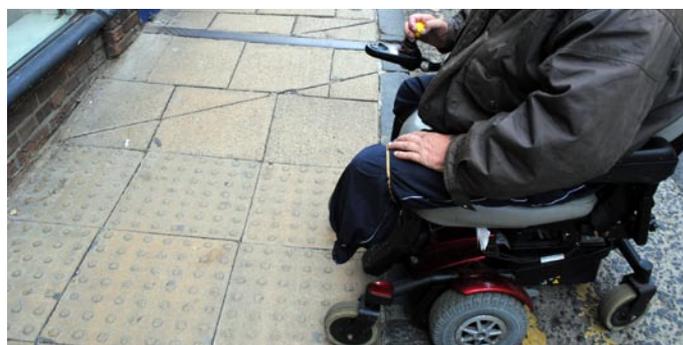
On some streets such as Ogleforth the footways are so narrow that it is virtually impossible for a wheelchair user to mount the footway even where dropped kerbs are provided.

Colin attempts to mount the kerb, Ogleforth

‘Nope, inaccessible, it’s no good at all to me’

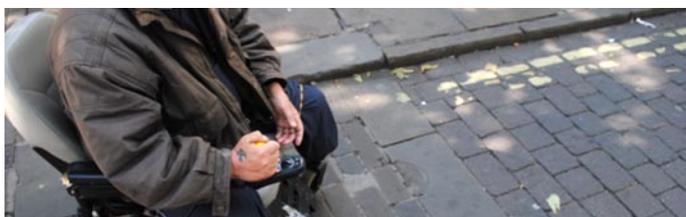
Streets with a combination of kerbs and level surfaces

These streets were easier to use for people using wheelchairs because the frequent level areas (usually where the carriageway is raised to the level of the footway for several metres) provided convenient crossing areas. The situation presented another problem however. For many participants (not just those with visual impairments) it is difficult to predict and judge where level changes will occur, creating a high risk of falling. For some participants with sight loss the lack of demarcation between the carriageway and the footway on the level areas was also a problem.

'This is a classic because it blends with t'road so you could easily go off'

Clive, St Sampson's Square

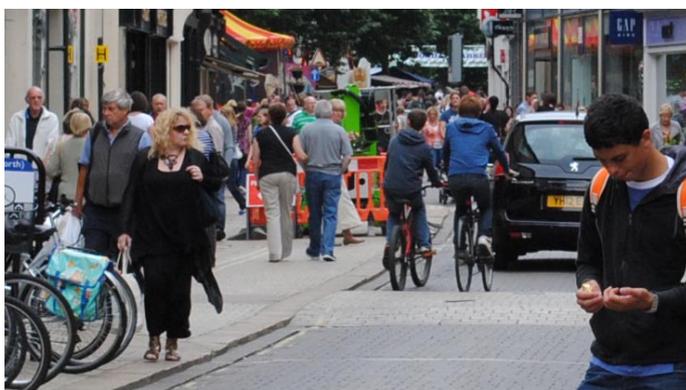
Change from kerbed to level surface, Davygate

'I could get caught on that. You can only see it from here [in carriageway]. You don't see it when you're standing on the pavement.'

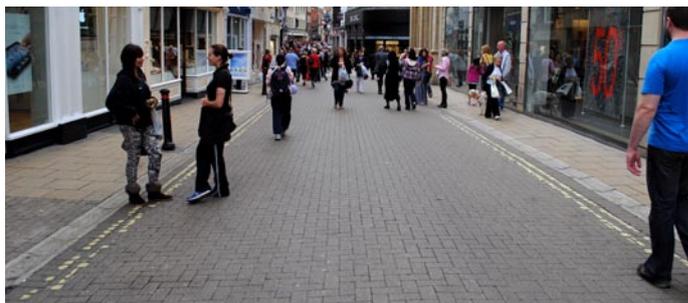
Level surface streets proved popular with many participants because of the relative ease of moving and off the footway. For some participants with visual impairments the shallow drainage gully provided a useful indication of the edge of the footway, however it was also identified as a hazard or obstruction by almost everyone.

'It's a guide... [are you using the gully for orientation?] as much as anything, yes'

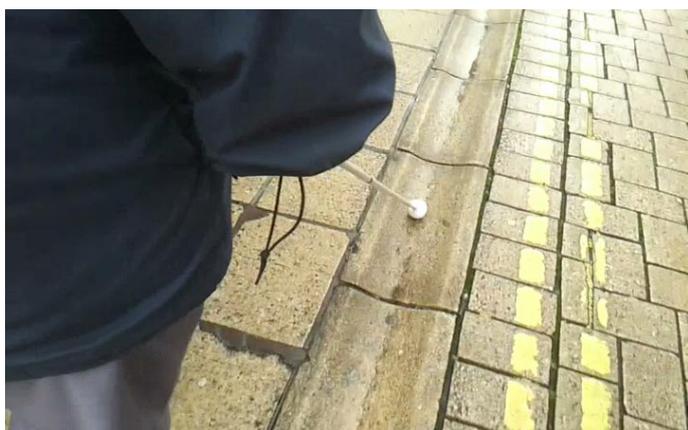
Dovid follows the drainage gully with his cane

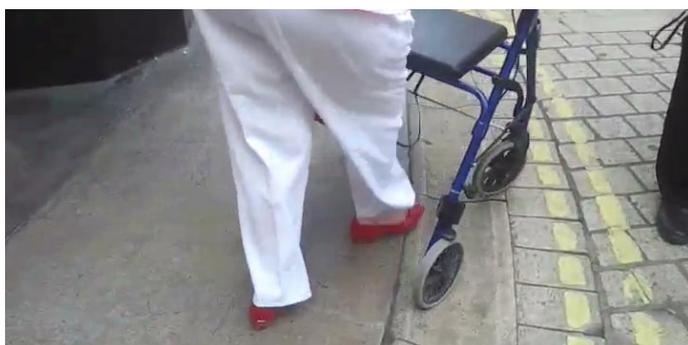
'These things [drainage gully] are a real nuisance if you're in a wheelchair going from one side to the other because you dip down and then have to get up again'

Sandra, Colney Street

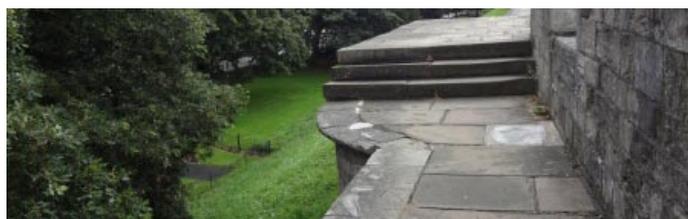
Walkways are in general smooth, level and firm, paved with stone flags and adequately wide at 1.2m average width.

Walkway on city Walls

The frequent level changes along the walkway are overcome by steps rather than ramps, which makes the walkway unsuitable for wheelchair users or those with pushchairs or rollators. It would not be feasible to change this feature of the walkways. However, stick users and other mobility impaired people could be assisted by providing more frequent handrails along the steps at both sides. Step nosings also need to be highlighted, especially useful for visually impaired people.

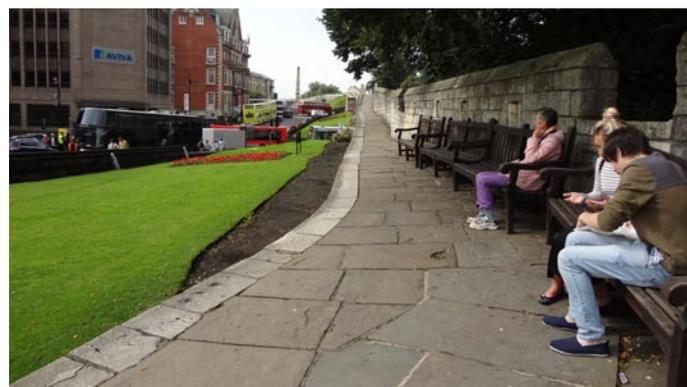
city Walls walkway and seating

There is not always seating provided in these widened sections, or at the top of the steps in these areas which is important for mobility impaired people. It is recommended that more seating is provided particularly at vantage points.

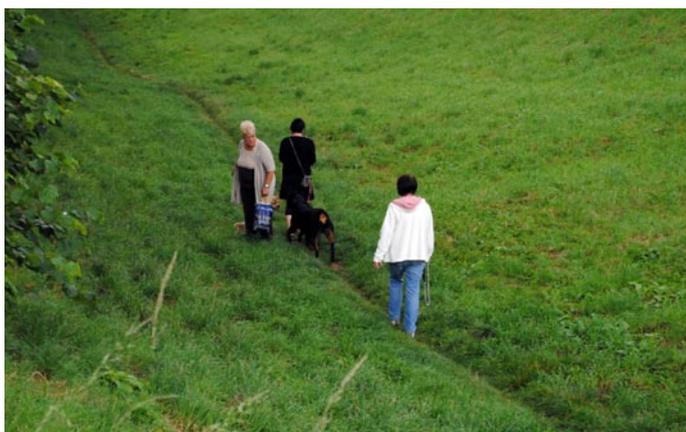
The sides of the Walls are grassy embankments and often extend into an extended level area of green running along the base of the Wall. These areas of green are cut off from the rest of the city by the Ring Road and are difficult to get to. However, where they are used they provide a popular amenity for rest and recreation. People were observed taking a break from work, having a picnic, taking dogs for a walk and children were observed using the steeper embankments as a slope to slide down on makeshift sleds. These areas provide a significant untapped recreational resource for the city and much more could be made of this resource by the provision of suitable crossing points and regular seating at the very least. Further consideration could be given to provision of concessions for food and drink kiosks, interpretation opening out access for parties of tourists or school children.

People using green space between ring road and wall

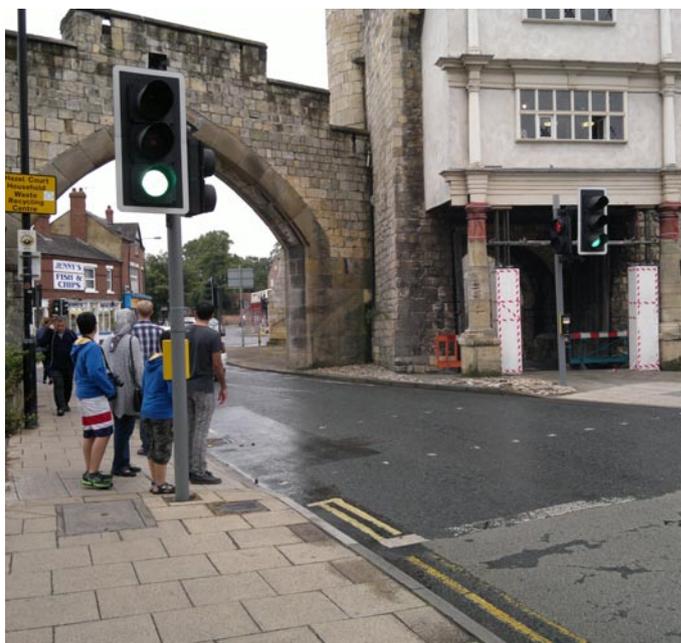
Walmgate Bar crossing

Continuity across Bars of the Walkway route: At Walmgate, Fishergate and Bootham Bars there is a break in the Walkway and visitors need to descend one side of the Bar via set of stairs, cross a vehicular road passing under the Bar and re-enter via a set of steps on the other side. The pedestrian route across the Bar is compromised by vehicular priority through the Bar, which has led to restrictions placed on pedestrian movement via guardrails. At Walmgate the only way of crossing the Bar is to use a signalised pedestrian crossing, controlled by guardrails, which does not provide a pleasant or comfortable crossing.

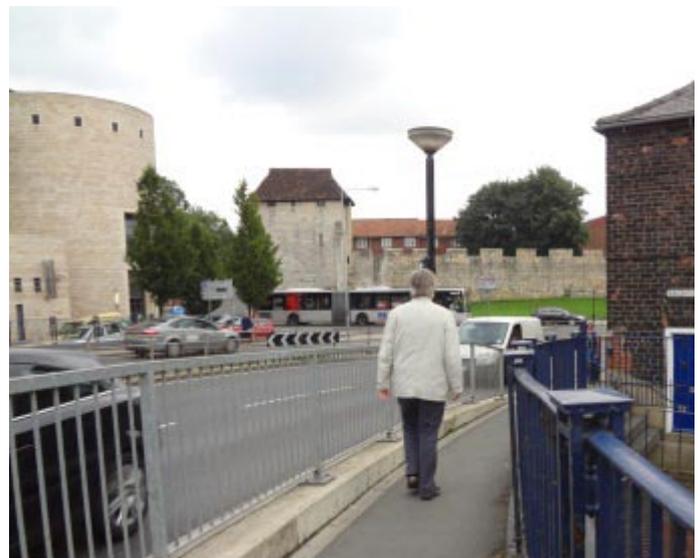
- there are no opportunities to explore other historical sites such as Clifford's Tower in reasonable proximity, but situated across a busy roundabout that provides no crossing facilities as is completely guardrailed all round.
- While Fishergate Tower is in close proximity across Fishergate Road, there is no crossing opportunity to reach it across the dual carriageway. Visitors wanting to make the effort would have to walk around 100ms to the bottom of Fishergate at the junction with Paragon Road and use the two stage crossing there and then walk back up about 100ms on the other side of the road to the Fishergate Tower. This is an unacceptably large detour, making this journey disorienting, difficult and unattractive, particularly to people with mobility impairments.

Trapped in by railings - towards Fishergate Tower

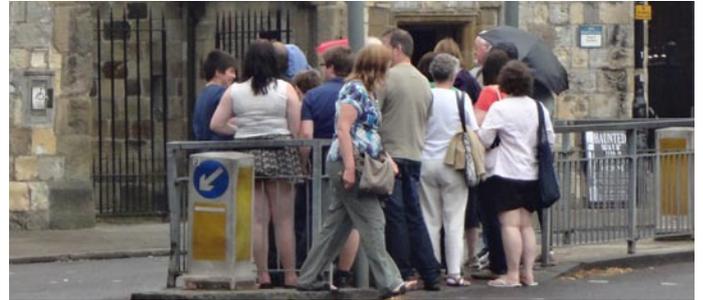
Crowded crossing Exhibition Square

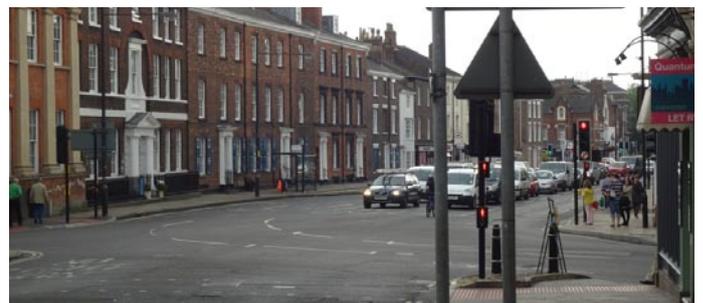
This is a busy four way junction with new style puffin single-stage crossings at each arm of the junction. The waiting time for pedestrians is long at around 90 seconds. The Blossom Street arm has five-and-a-half lanes to cross in a single-stage and is daunting for mobility impaired people. The crossing time was adequate for a slow moving person, but is intimidating nevertheless due to the length of the crossing that requires resting in between. Consultees would prefer to reinstate the pedestrian refuge here that allows crossing in two stages.

Nunnery Lane Blossom Street crossing

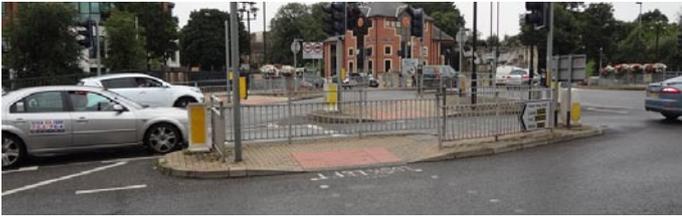
Peasolme Green is a complex junction that is dominated by vehicular traffic with poor pedestrian amenities. Pedestrian crossings are poor with four separate crossing stages and two staggered and guardrailed pedestrian islands to be negotiated to cross each single arm of the junction. Wayfinding and signage is poor.

Layerthorpe Peasolme Green crossing to city Walls

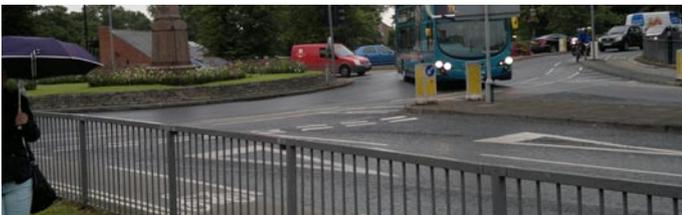
Extensively guardrailed junction, dominated by a roundabout and dual carriageway with few crossing opportunities and necessity to make large detours to reach key tourist destinations such as Clifford's Tower, the city centre and Fishergate Tower. Pedestrians are forced to run across the street to make a crossing where the guard-railing ends on the Bridge, on Tower Street and on Fishergate Street.

Tower Street Skeldergate Bridge junction

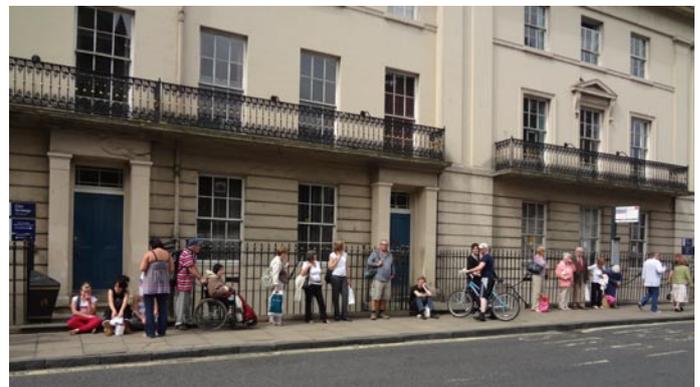
- Narrow and crowded footpaths on St Leonards Place
- Bus stops further encroach on footpath space
- Junctions with wide radii narrow the footpath at crossings
- Footpaths not continuous at Exhibition Square
- Bootham Bar pedestrian barrier

St Leonards Place bus stop

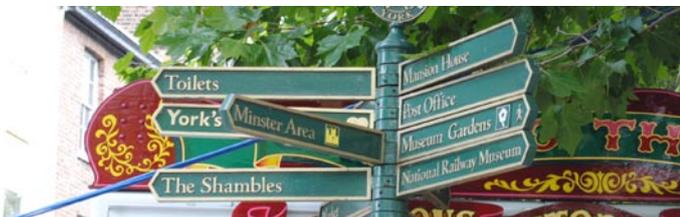
Finger post directing towards Silver St Toilets

People with visual impairments and those looking from a distance had trouble reading the fingerposts because of the low 'x' height of the font and the lack of tonal contrast between the gold text colour and the green of the background. The destinations on the finger posts were also not always the most relevant.

Amongst the people who could read them the finger posts were popular suggesting that if investment were made in improving wayfinding across the city fingerposts may still be appropriate. Improvements could be made to the existing finger posts by painting them in more contrasting colours (such as black and white). New fingers could also be produced with a more legible font (higher 'x' height) and more contrast and fitted to the existing posts.

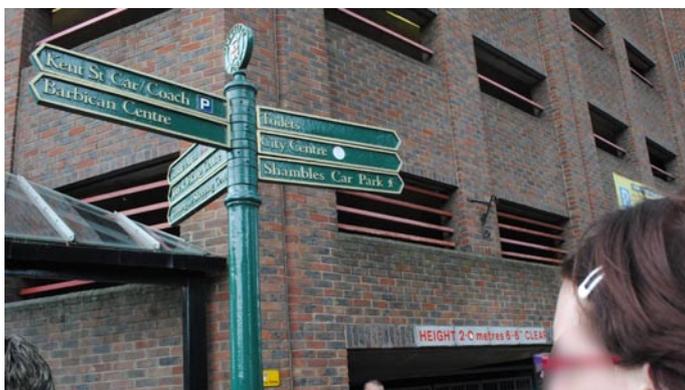
Fingerpost heritage signs

‘It's a bit unclear, the letters are a bit little for me’

Caroline

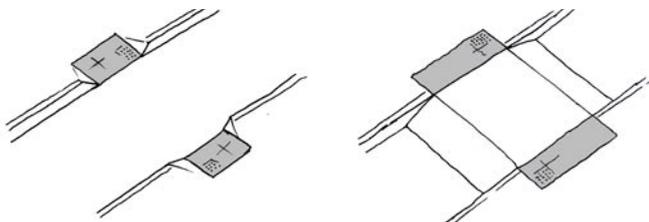
Traditional dropped kerbs have the advantage of being easier to navigate for people with visual impairments however can be harder for people using wheeled mobility aids, especially where geometric constraints necessitate a steeper than desirable slope.

Traditional dropped kerb and traffic table

Traffic tables, where the level of the footway is brought up to the level of the carriageway are easier for people with wheeled mobility aids to navigate however can present problems for people with visual impairments because they can often constitute an undemarcated level surface. It is recommended that where 'traffic tables' are installed tactile paving is provided as a demarcation along the full length of the level section.

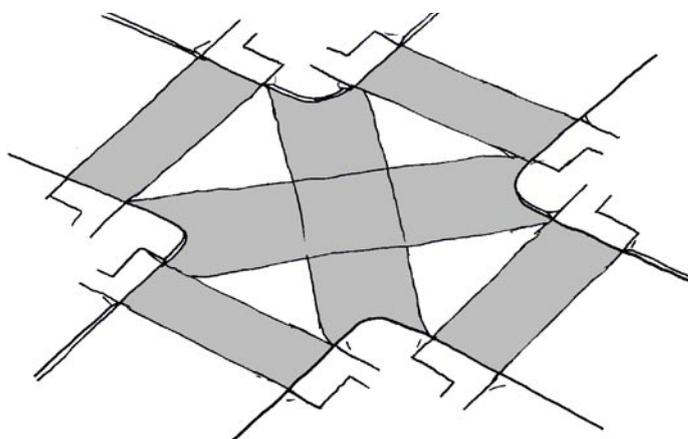
Diagonal crossings can be useful at traffic signal crossings as enable to pedestrians to cross to the opposite arm of a junction in one movement instead of two which is quicker and more convenient. Diagonal crossings should be considered at all signalled crossings where there is a heavy flow of pedestrians including the route from the station to the city centre and along Museum Street to Gillygate and Bootham Bar and the Pavement/ Piccadilly/ Parliament Street junction.

Diagonal crossing

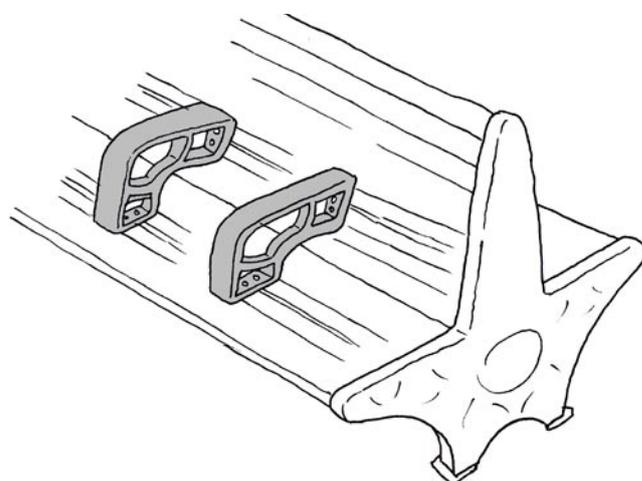
Bolt-on cast iron arm rests

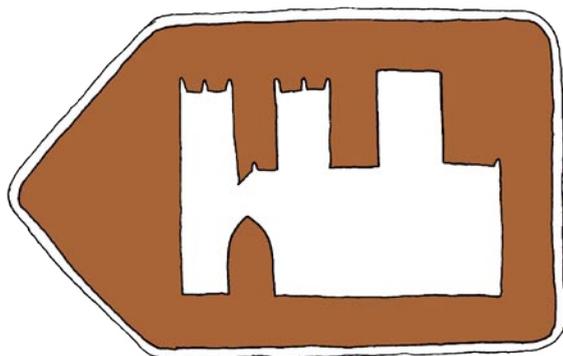
The route to the Minster could be marked by small arrow signs mounted on lamp posts and walls. If these signs featured an iconic depiction of the minster they could be smaller and would also be more accessible to visitors who did not read English.

Minster icon sign
