Foss Barrier, York

York Public Exhibition

How it works: Foss Barrier, York

An investigation into the Foss Barrier

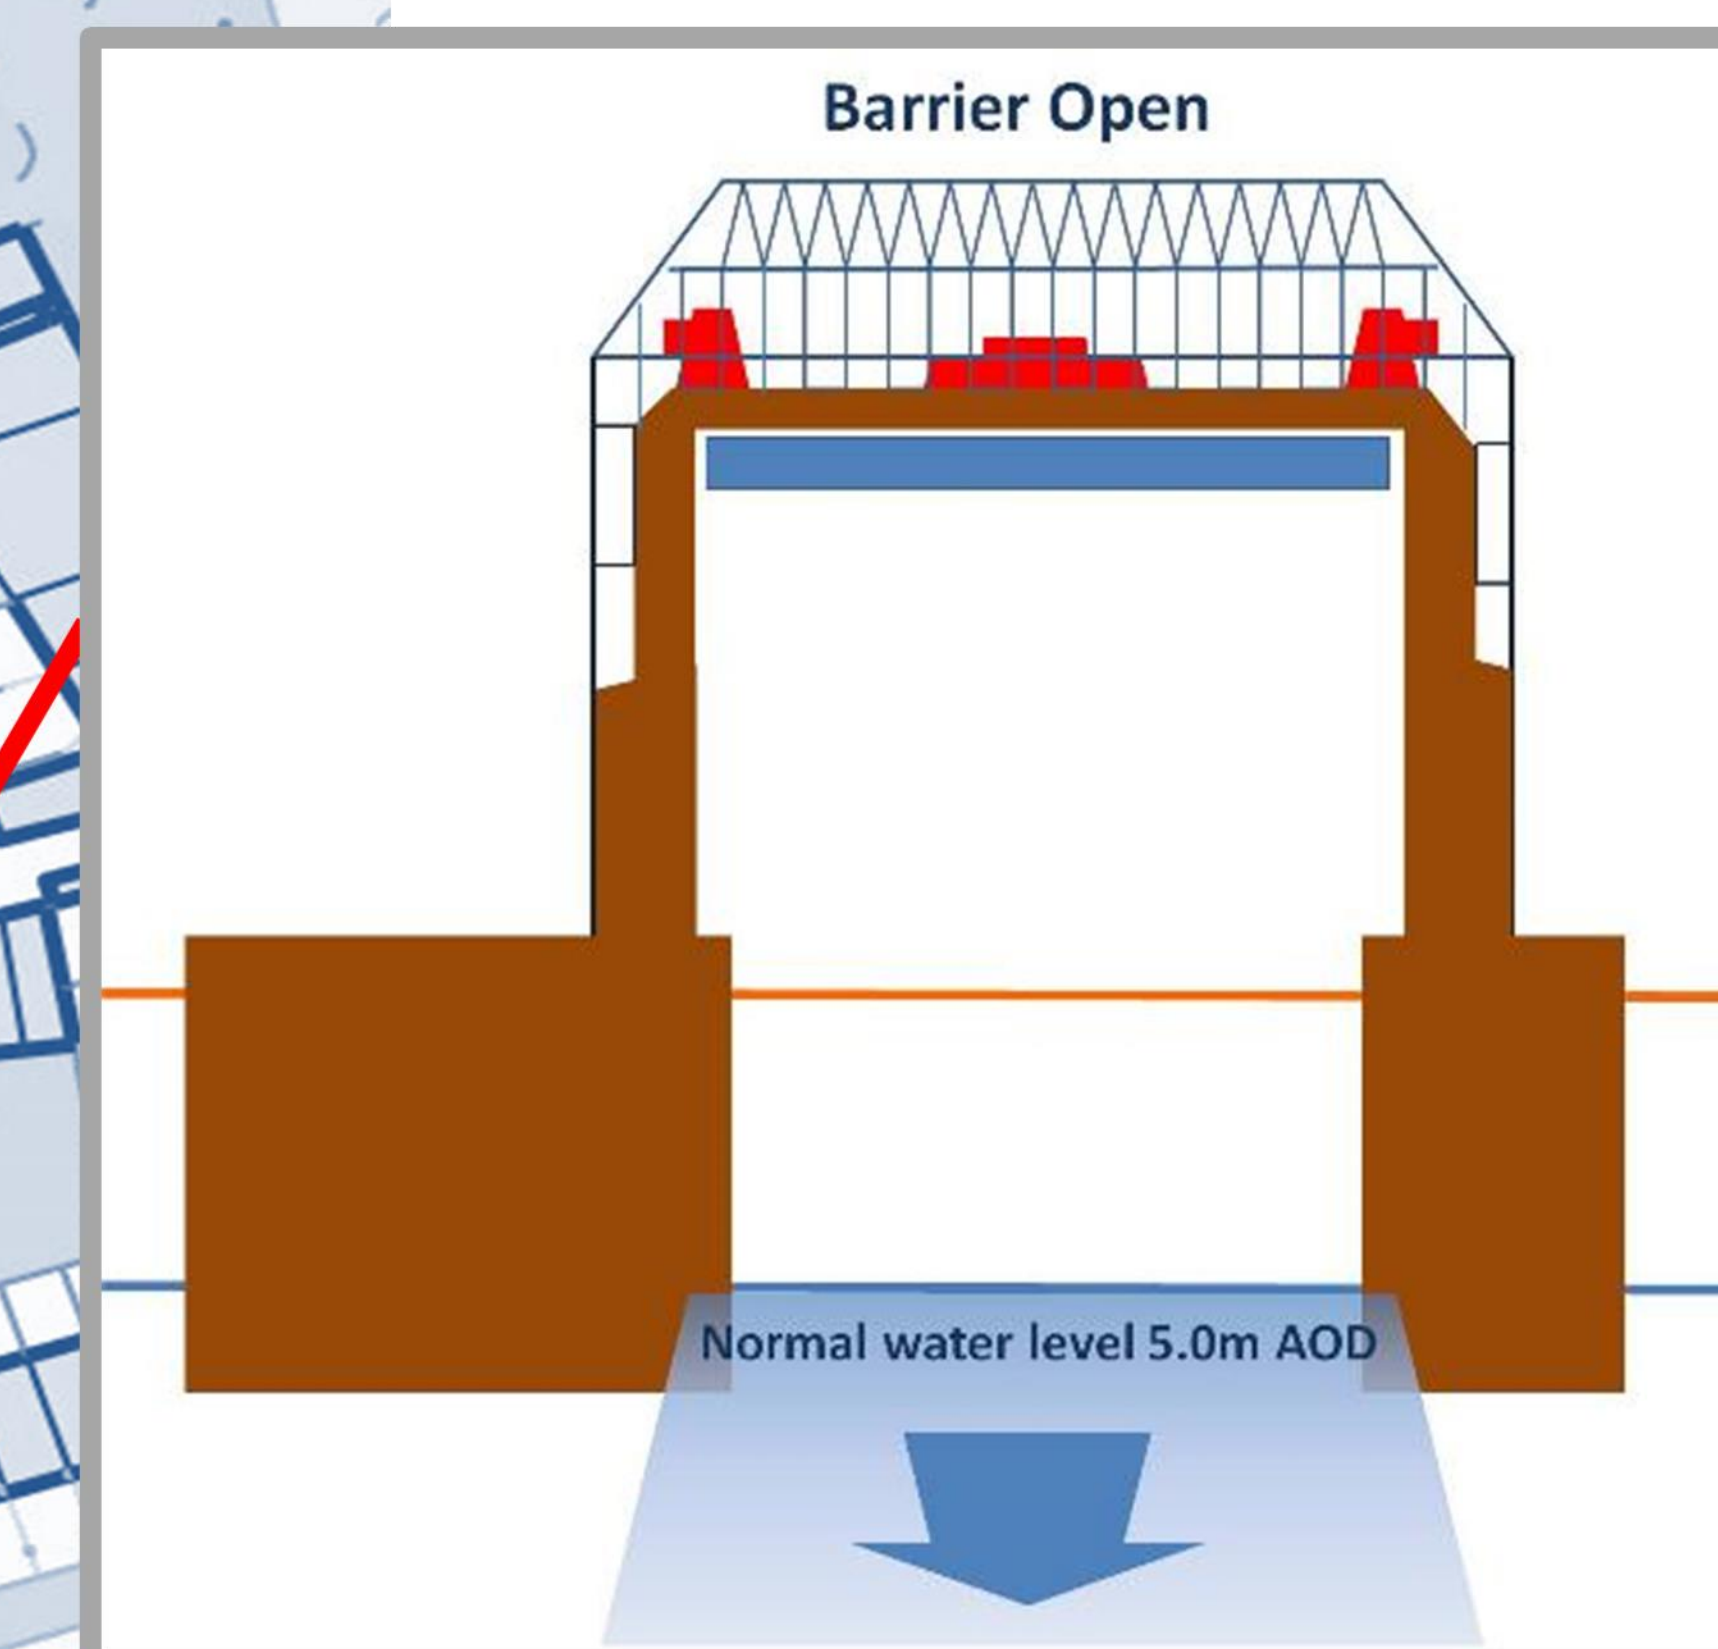
Above: Foss Barrier in open position with gate lifted, allows the water from the Foss to flow normally into the River Ouse

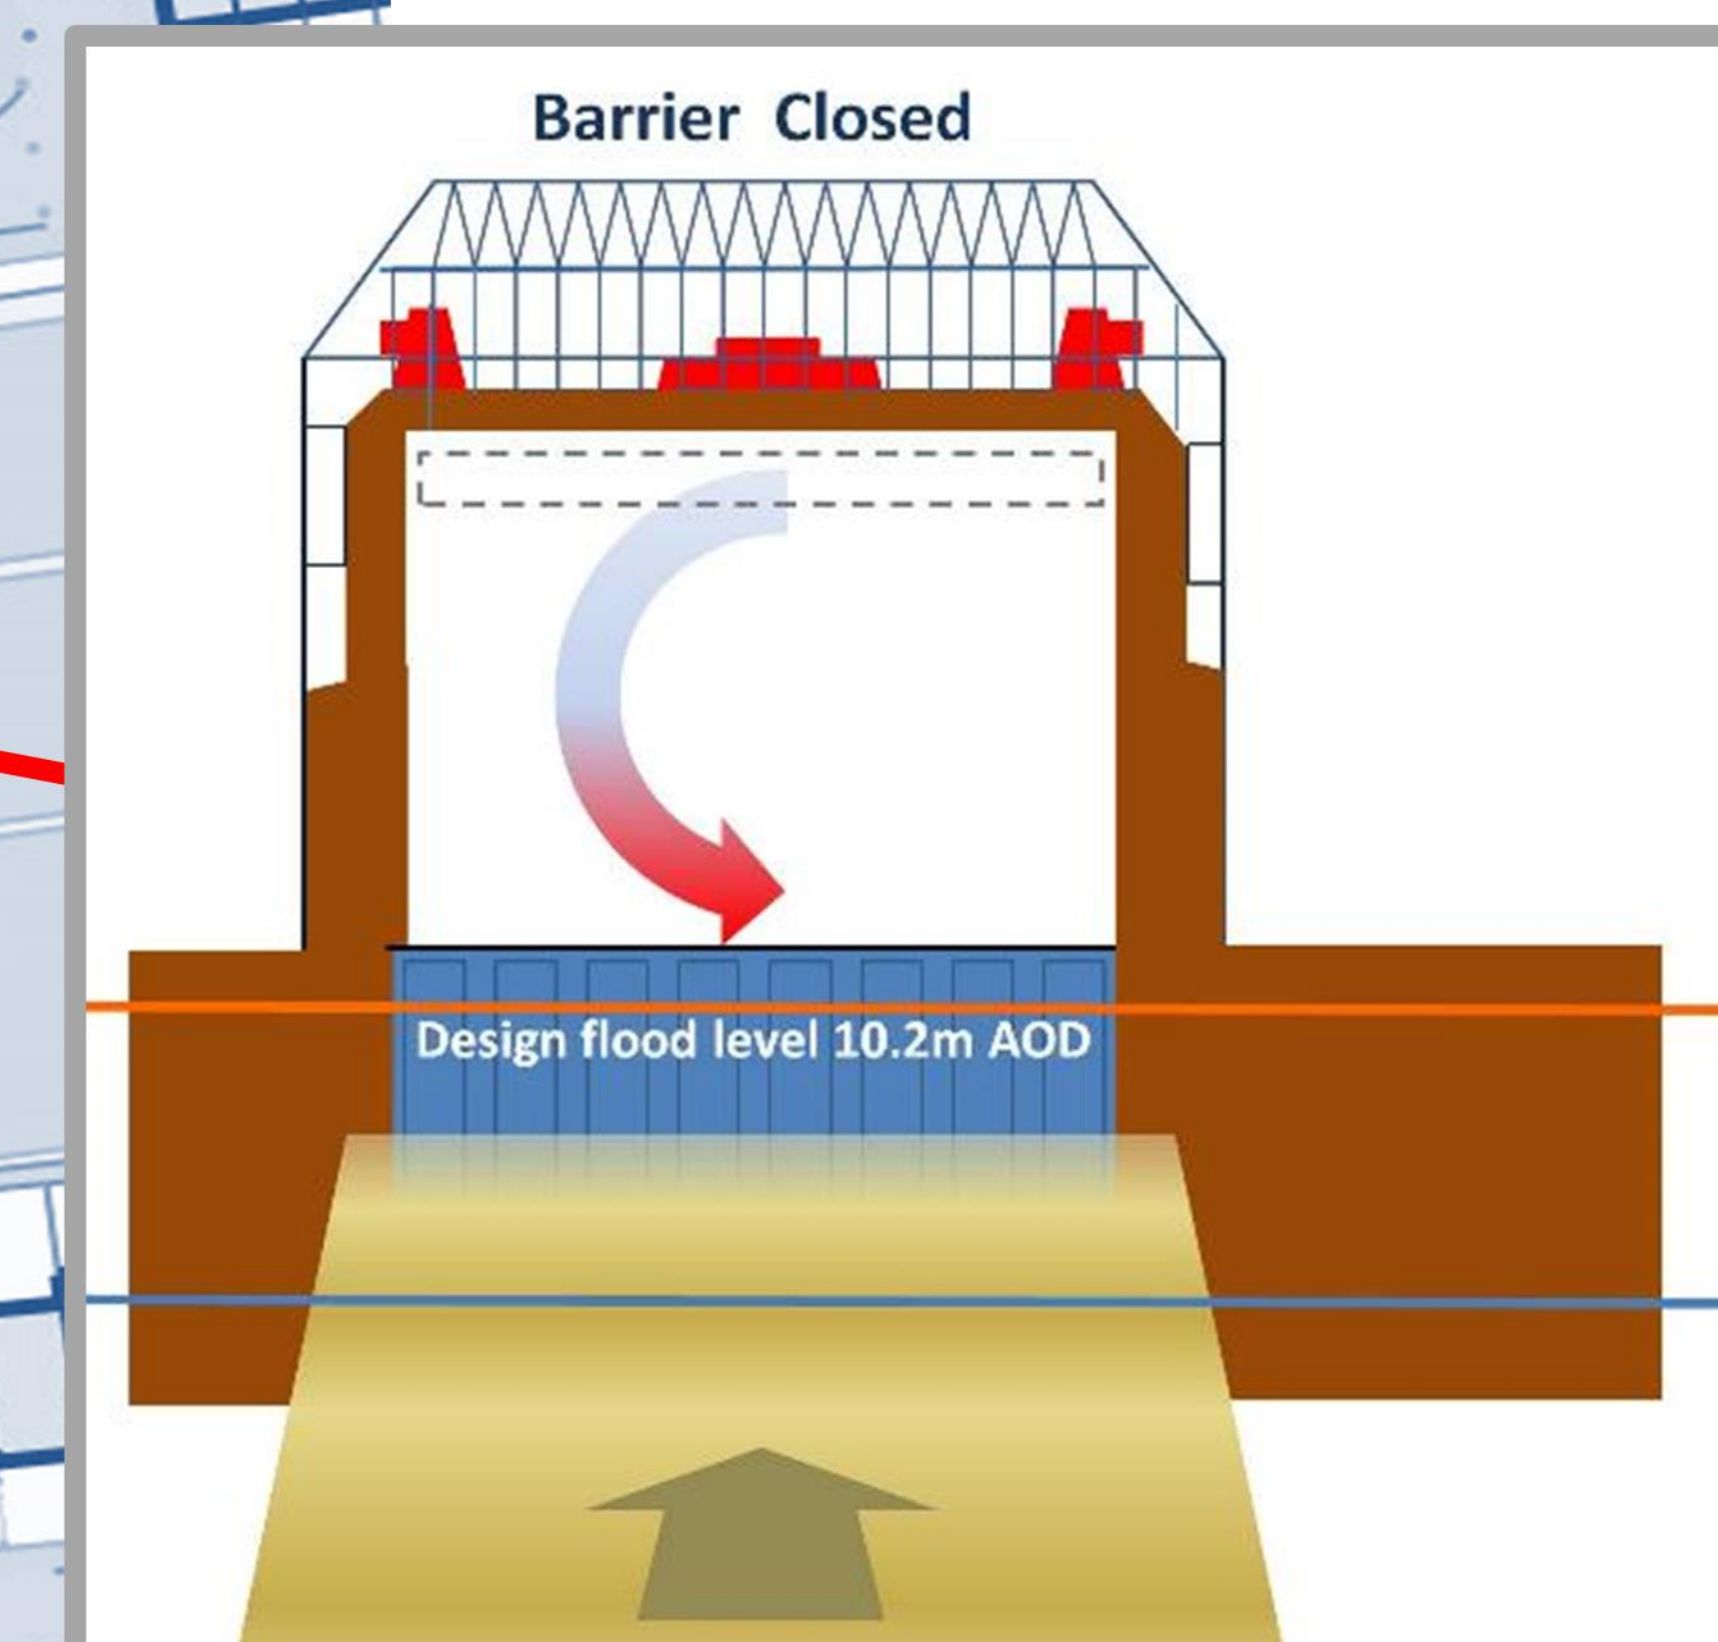
The Foss Barrier in the closed position with gate lowered into position to stop flood water from the Ouse pushing up stream into the Foss River. When the gate is closed the water in the Foss then needs to be pumped around the barrier to keep it flowing.

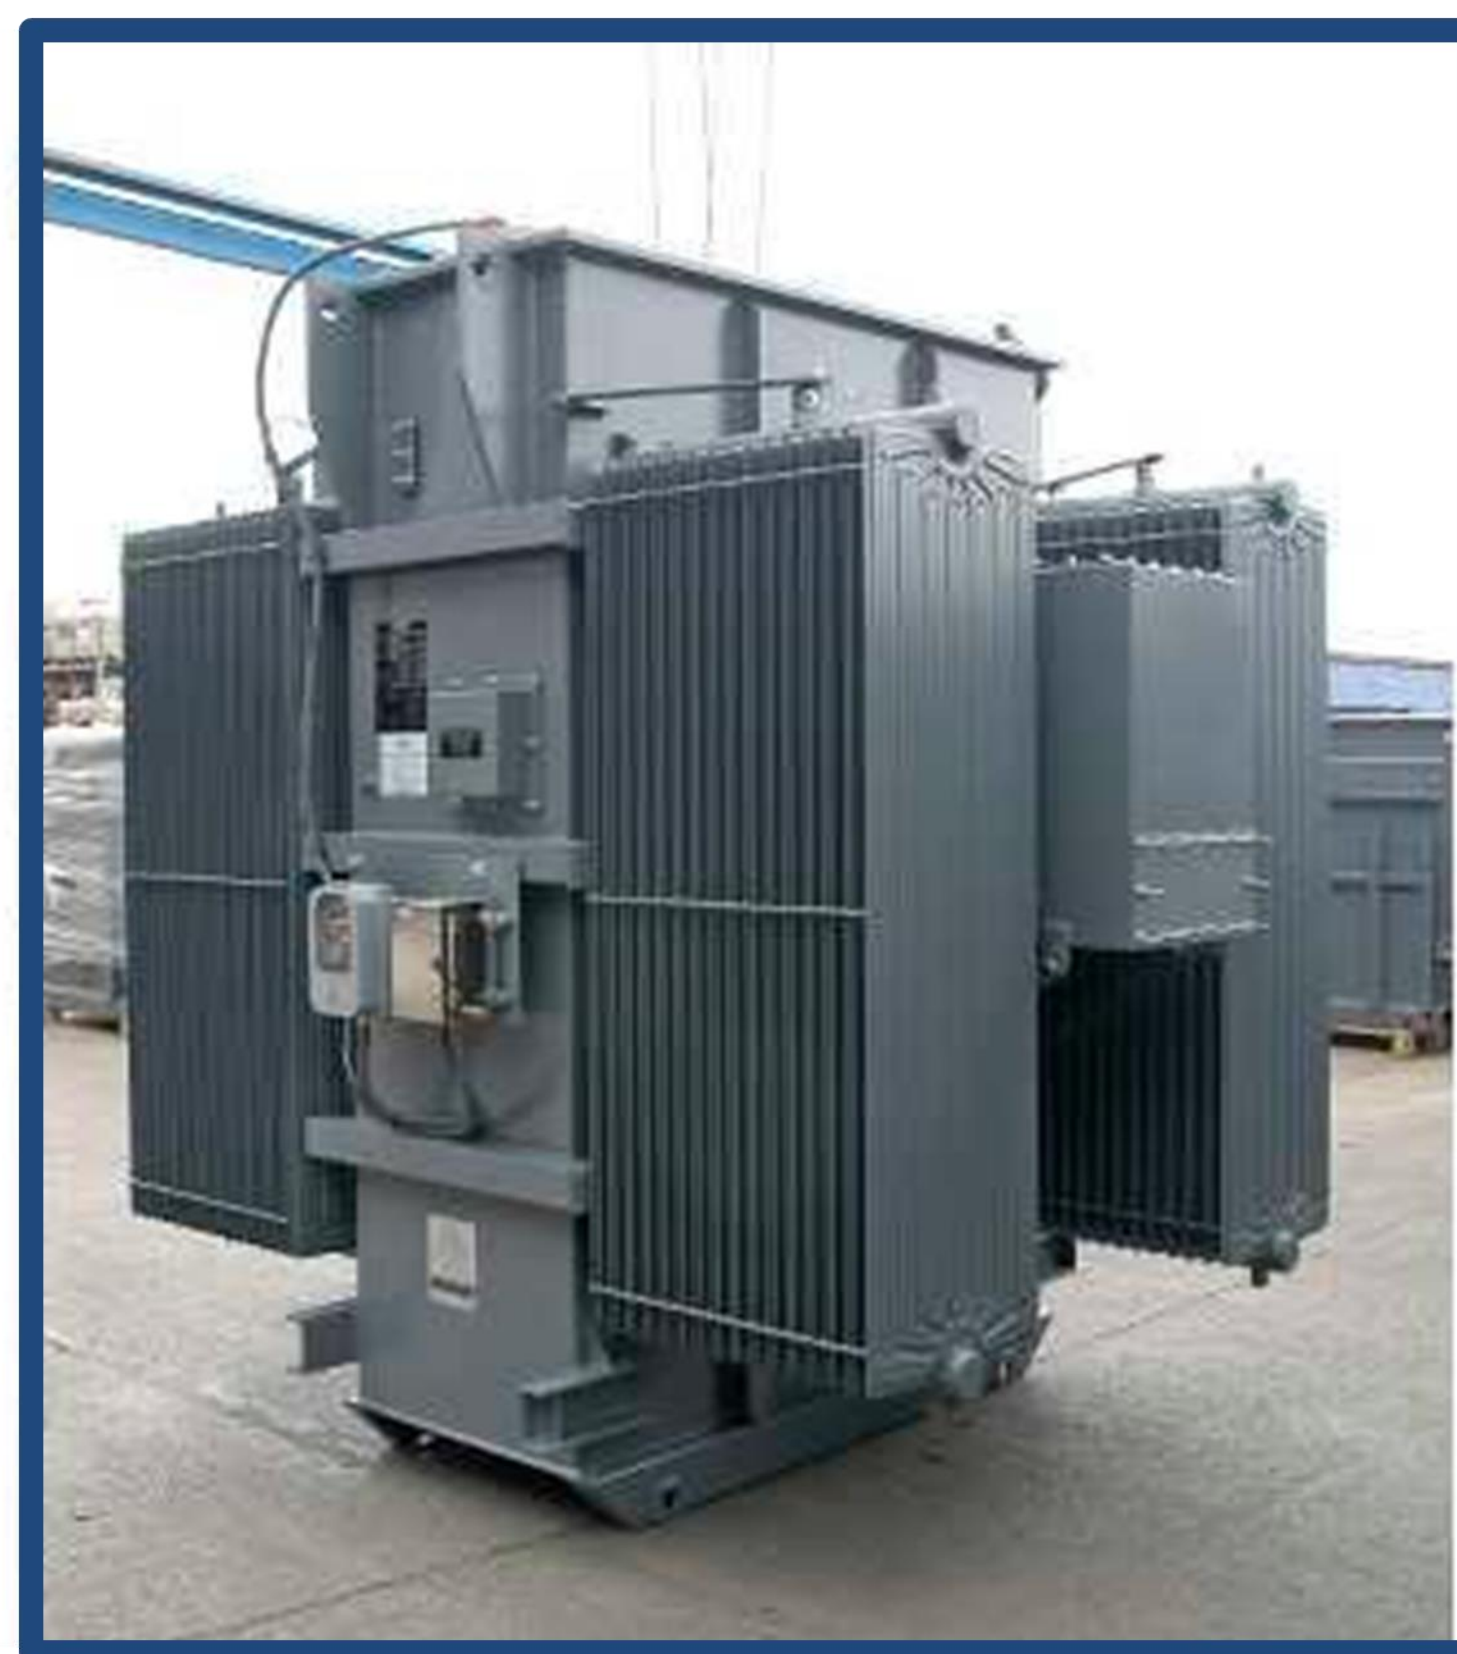
Equipment Location	Equipment Performance	Pump Capacity	Standby Power Generation	Power Supply
Existing	Ground Floor	Original, almost 30 years old	30 m ³ /s would empty Yearsley Pool in 35 seconds	Power delivers 15 m ³ /s	1 live - Foss Islands 1 backup - Skeldergate
Interim	Elevated approximately 1 metre above Boxing Day's water level	Existing & Newer	40 m ³ /s would empty Yearsley Pool in 27 seconds	Power delivers 30 m ³ /s	2 live - Foss Islands & Skeldergate
Permanent	Elevated approximately 1 metre above Boxing Day's water level	New	40 – 50 m ³ /s would empty Yearsley Pool in 27 to 21 seconds	Power delivers 37 m ³ /s	2 live – Melrosegate & Foss Islands 1 backup – Skeldergate

Power supplies – We will have two main power supplies and one backup.

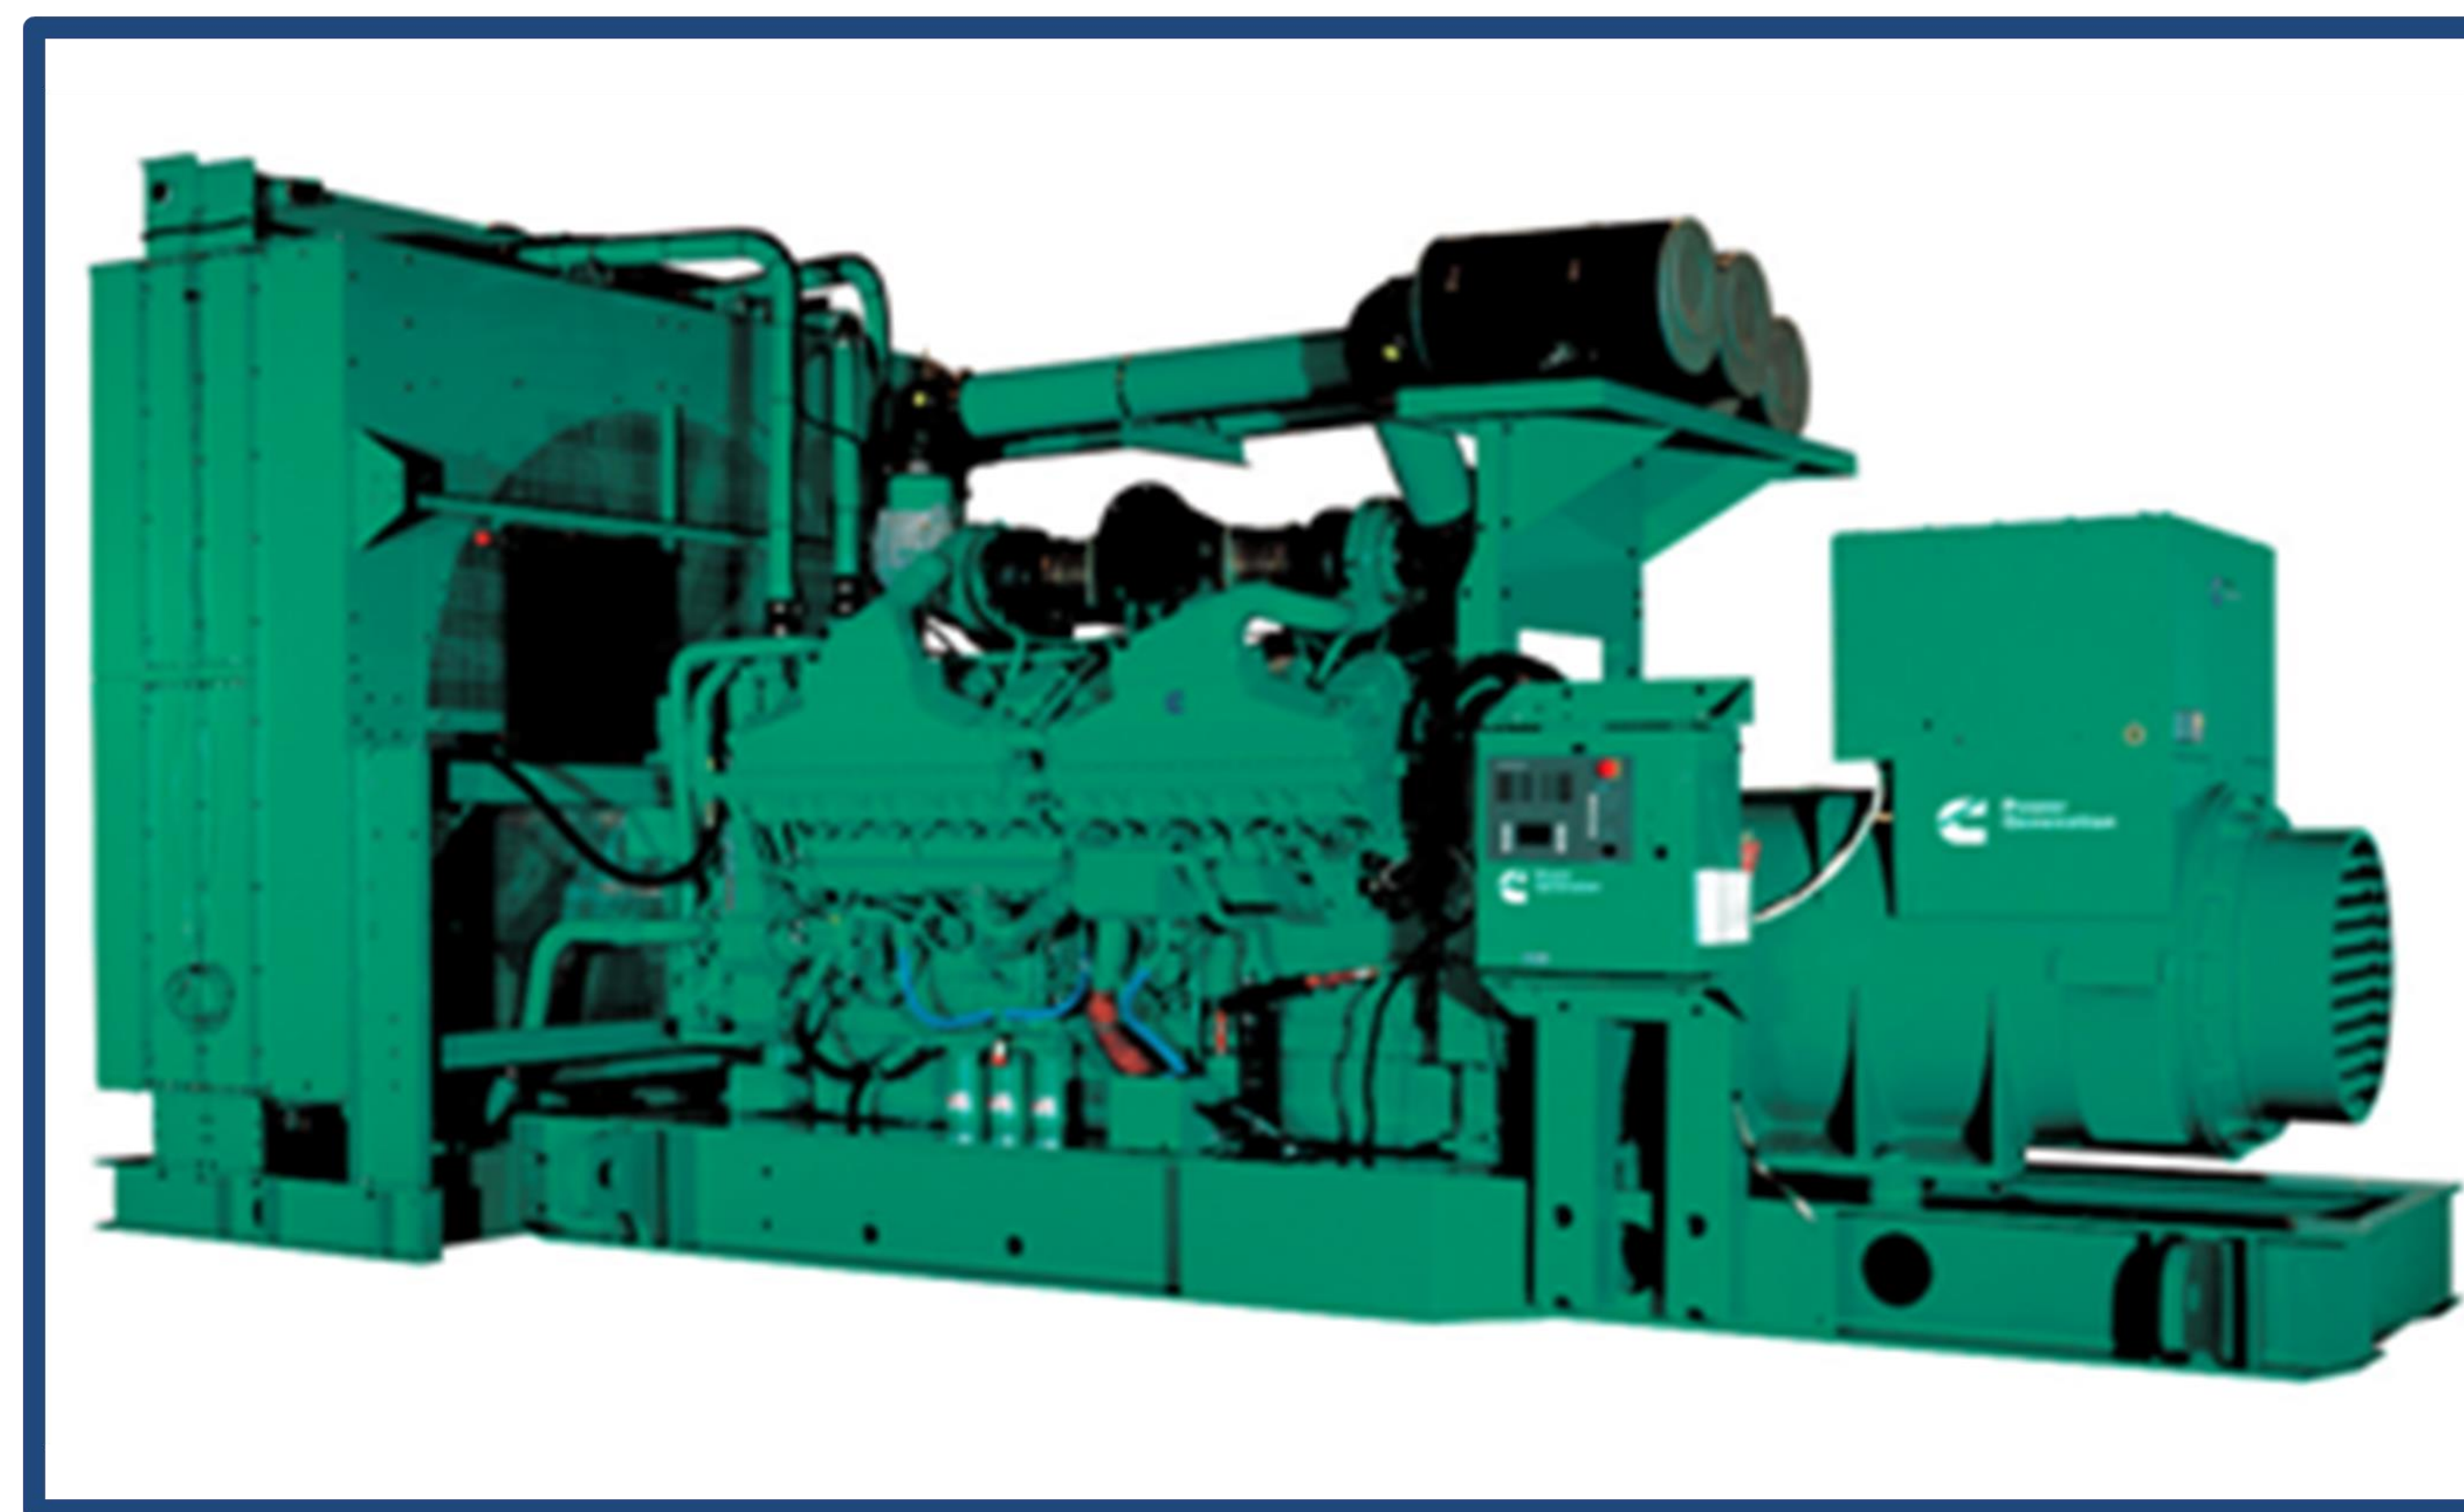
Three new generators provide backup in case of mains power failure.

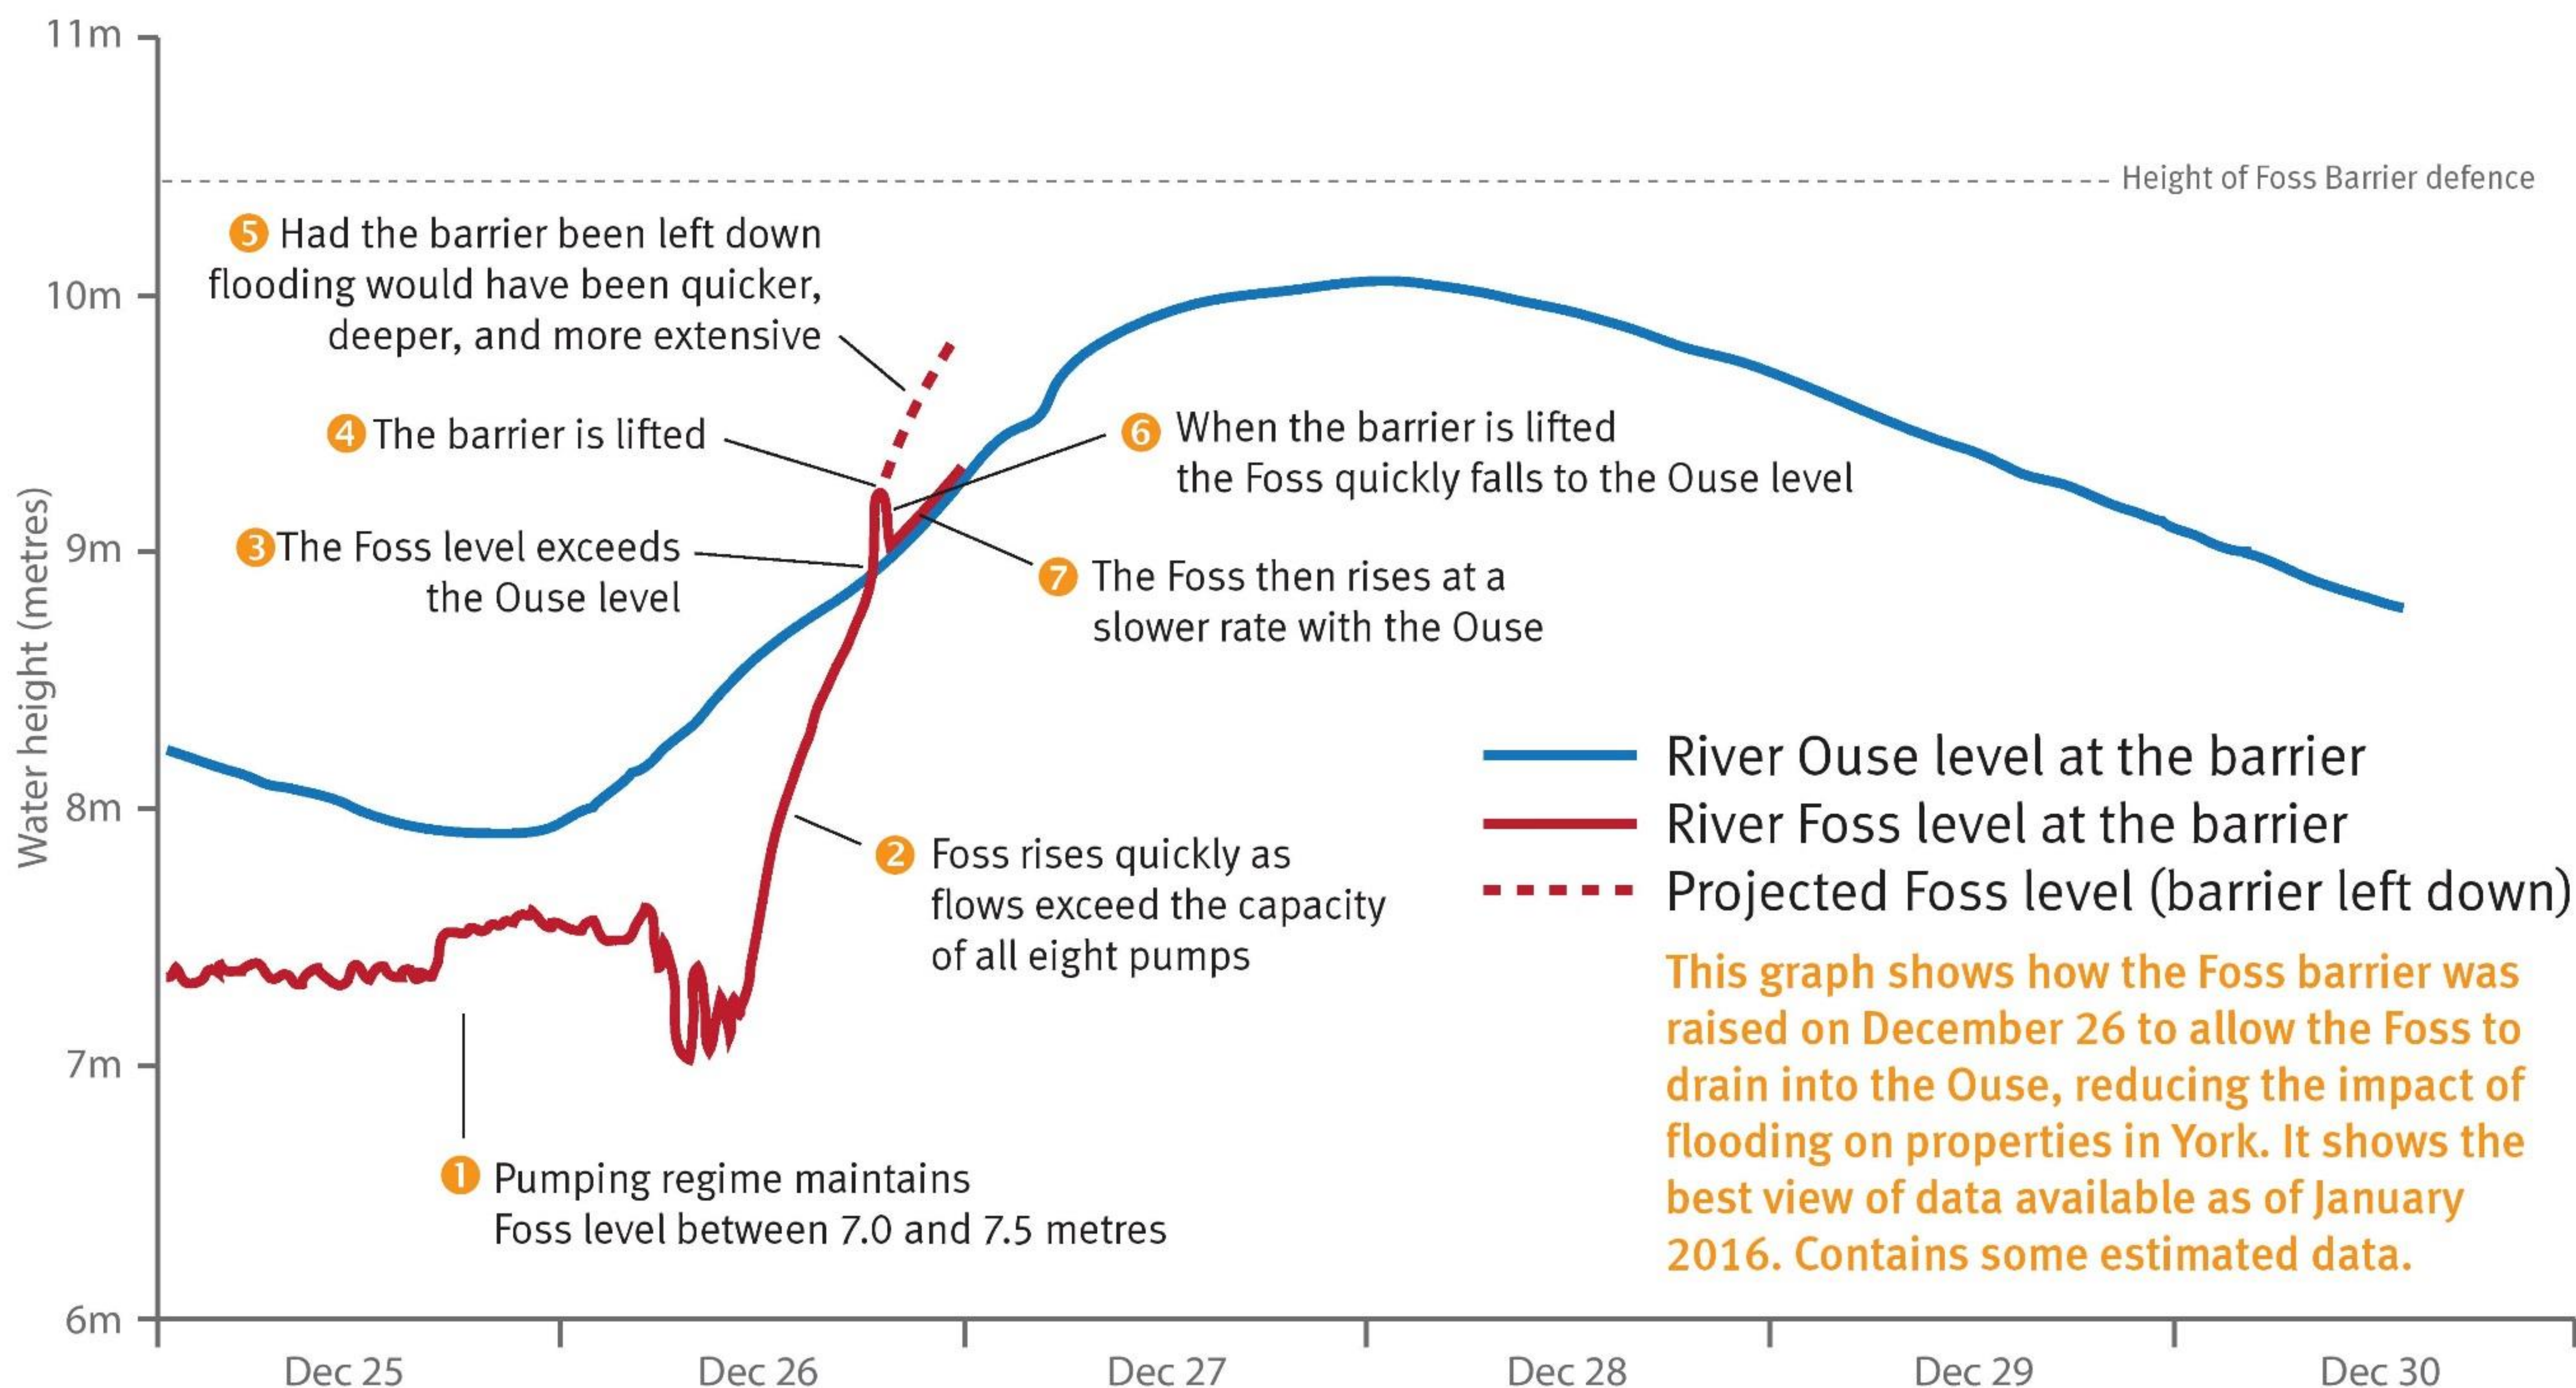
Environment Agency Hydrograph of River Foss Rainfall and River Level 25 to 31 Dec 2015

The continuous red line (Foss Barrier Downstream Ouse level) is the measurement of the river level at the Foss Barrier on the River Ouse side. Up until 19:00 GMT, the time when the green line stops, this measurement is taken from the sensor at the Foss Barrier. After this, the red line is derived from the Ouse at York Viking; which is about 400-500 yards upstream on the Ouse.

The green line (Foss Barrier Upstream Foss level) is the measurement of the river level at the Foss barrier on the River Foss side – it is a measure of the level in the Foss Basin.

The blue line (Huntington River Foss level) is the measurement of the river level of the River Foss at Huntington, 2km further upstream of the Barrier. This is the only site that records the level of the River Foss independently of the barrier. It shows what is happening to the river level in response to rainfall rather than in response to the barrier.

The red dashed line (Foss Barrier defence level) shows the top level of the barrier gate when it is the closed (in the down position). Should the Foss level exceed this height it would overtop the barrier gate and flow into the River Ouse.

The purple and grey bars at the top axis show the total rainfall per hour in mm at two raingauges. This is measure of the rain north of York around Easingwold and surrounding area and shows very heavy rainfall.

The horizontal grey dotted lines show the indicative level of the named streets (the road level in these streets does vary along their length). These streets flood from the River Foss when the level exceeds the height of the grey dotted line. For the purposes of this graph the key relationship is between the level in the Foss upstream of the barrier (the green line) and these street levels (dotted grey lines).

The blue line shows the level of the River Foss upstream of the barrier at Huntingdon. The line rising shows that there is an increasing flow of water. Levels in the River Foss are rising rapidly in response to the overnight and morning rainfall (where rainfall totals per hour in mm at the two gauges are shown by the grey and purple bars at the top axis), through from the afternoon of 25 December. The increase eases off half way up the blue line where there is a kink, as the river is responding to the first period rainfall having stopped.

On 25 December through the early morning of 26 December, the inflow to the River Foss behind the barrier is matched by the ability of the pumps to discharge it into the River Ouse. The Foss river level at the barrier (shown in the green line) is holding more or less constant.

The very heavy rainfall in the upper part of the catchment is easing. Levels in the River Ouse (red line) are rising. From mid-morning on 26 December the blue line becomes steeper again showing that the River Foss upstream is now rising more rapidly in response to the early morning rainfall.

However, the Green line shows how levels behind the barrier are rising as the inflow from the Foss upstream (the blue line) is exceeding the capacity of the pumps to hold the basin (the green line) at a constant level.

The level on the River Foss behind the barrier (the green line) is still lower than the River Ouse level (the red line) at the other side of the barrier. This shows that the barrier is defending the Foss from inflow from the Ouse.

The rainfall in the upper part of the catchment has stopped. The River Foss upstream (blue line) is continuing to rise in response to the morning rainfall. Sections of Huntington Road are under water because of the volume of water coming down the Foss.

The green line shows a steep increase in the River Foss level near the barrier, from around midday on 26 December. The Foss barrier is down and the pumps are on. The steep increase shows that although all eight pumps were operating, they were not keeping up with the inflow from the Foss and the river level behind the barrier was rising quickly. Levels in front of and behind the Foss Barrier are very close.

The level of the Foss River behind the barrier (green line) has now risen far enough that it has exceeded the road levels (dotted grey line) at both Foss Bank and Lower Huntington Road. At 16:30 there are reports of houses flooding in Huntington Road area as a result of these levels in the Foss.

The red line shows the level of the River Ouse rising through 26 December, whilst the Foss Barrier is down and the pumps are on. But it is rising less quickly than the River Foss at Huntingdon and significantly less quickly than the Foss at the barrier.

The Foss Barrier pumps were turned off at 18:45 on 26 December and we then started to open the barrier. The barrier takes 10 to 15 minutes to open fully. At this time the Ouse level in front of the barrier was approximately 0.06m higher than the level in the Foss immediately upstream of the barrier. At around the time of these actions, there is a jump or spike in the green line. This is due to a combination of both shutting down the pumps and the time it takes to raise the barrier enough to allow the Foss to flow out into the Ouse.

After the spike, the green line then follows a curve which is less steep, meaning that the water level is rising less quickly in the Foss than it was when the barrier was down and all eight pumps were running. The green line then follows approximately the same line as the red line, meaning that the river levels at the barrier on both sides are the same. The Green line stops at this point because the sensors at the barriers were no longer working.

The River Foss (blue line) reaches peak levels in late morning on 27 December. It then declines as the levels are reducing.
