Gold Standard Car Parks

Car Park Accessibility Review and Inclusive Design Framework

MIMA recommendations

YAF – 19 September 2023

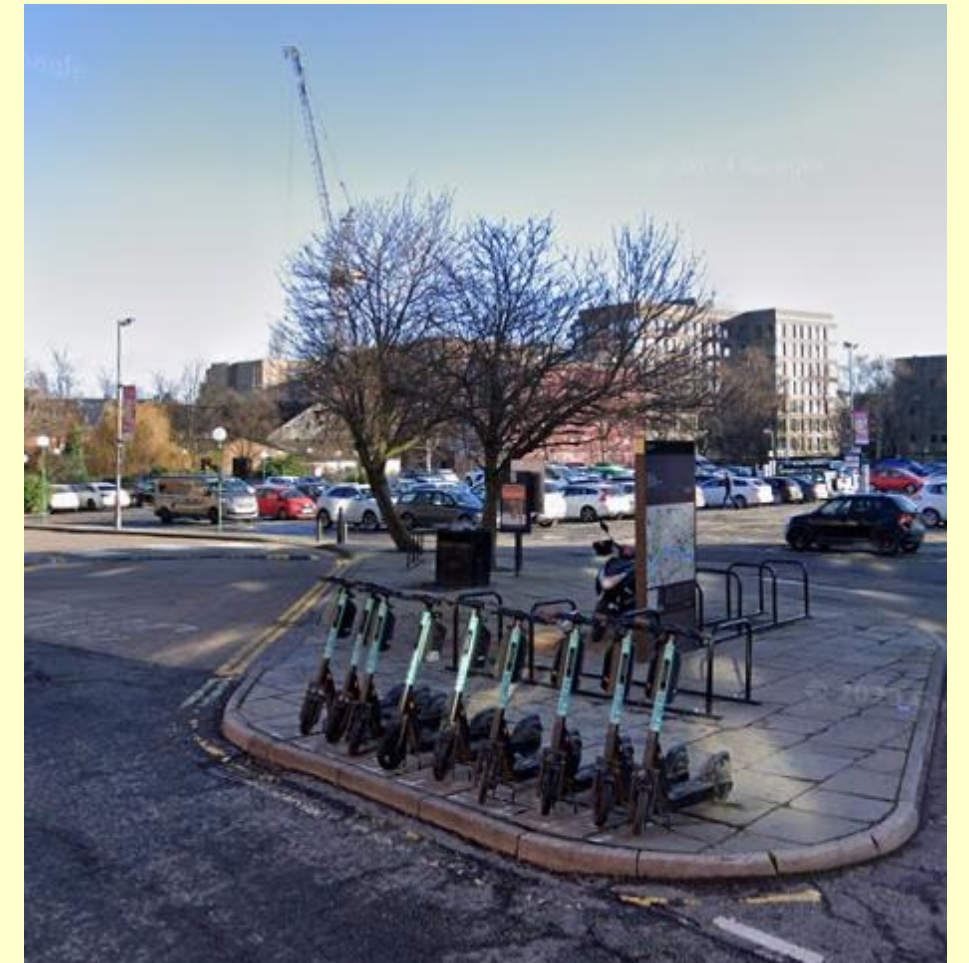
Issue – General

- Plans for Castle Gateway regeneration may result in the closure of Castle car park

Recommended action:

- It is recommended that all of the accessible parking bays are retained within Castle car park, should the rest of the provision be closed.
