YORK ARCHAEOLOGICAL TRUST REPORT

SITE ADDRESS	The Black Swan Inn, 23 Peasholme Green, York		
CLIENT NAME	The Black Swan Inn		
YAT PROJECT #	5672	YAT REPORT #	2012/60
MUSEUM ACCESSION #	n/a	GRID REFERENCE	SE 6075 5194
PLANNING REFERENCE #	11/00824/FUL	AAI OPS NOTICE #	n/a

INTRODUCTION

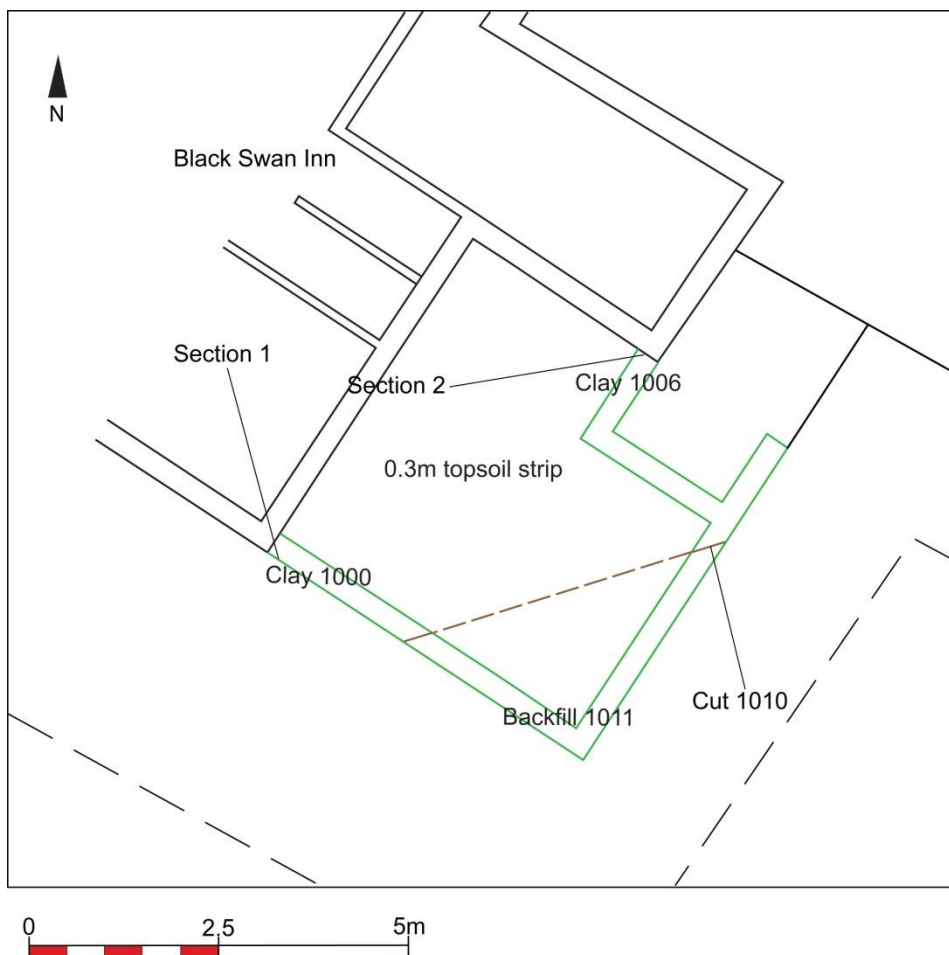
Figure 3 Location of recorded sections, new foundation trenches (green) and cut 1010 (solid brown observed - dashed brown conjectured)

In this section, in one of the foundation trenches and located towards the western corner of the extension footprint, the earliest deposit noted, between 0.9m below ground level and the base of the new foundation trench at 1m below ground level, was a firm, mid brown clay (1000). Overlying it was a 0.2m deep layer of dark greyish-brown very slightly clayey silt with occasional flecks of white mortar (1001) and above this was a 0.2m deep mixture of brick rubble and white / mid brown mortar (1002). This was sealed by a 0.15m deep layer of dark brown silt (1003). Overlying this was a thin, 0.05m deep, deposit of mid brown sand (1004) above which was the modern ground surface of dark brown silt with roots (1005).

This section was located approximately half way along the south-west facing side of the new building footprint. Here, the earliest deposit, between 0.5m and at least the base of the new foundation trench, was a firm, light to mid orange-brown clay (1006). Sealing this was a 0.3m deep layer of mid brown very slightly clayey silt with occasional charcoal and brick / tile (1007). Above this was a 0.1m deep deposit of very dark brown silt with occasional brick (1008). The uppermost context, forming the modern ground surface, was a concrete slab (1009).

The clay seen in Section 1 could be traced for c.2.5m before being truncated across the full width of the foundation trench. The clay in Section 2 could be traced to the south-west, then south-east and then again the south-west before also being truncated. If these truncations are part of part of the same feature then it would appear to be a substantial linear cut (1010). An unknown amount of it lay beyond the foundation trenches but it must have been at least c.1.75m across. Its profile is also uncertain but observations within the trenches suggested that the sides were moderately to steeply sloping. Only the uppermost backfill was seen and this was a dark greyish-brown very slightly clayey silt with occasional flecks of white mortar (1011).

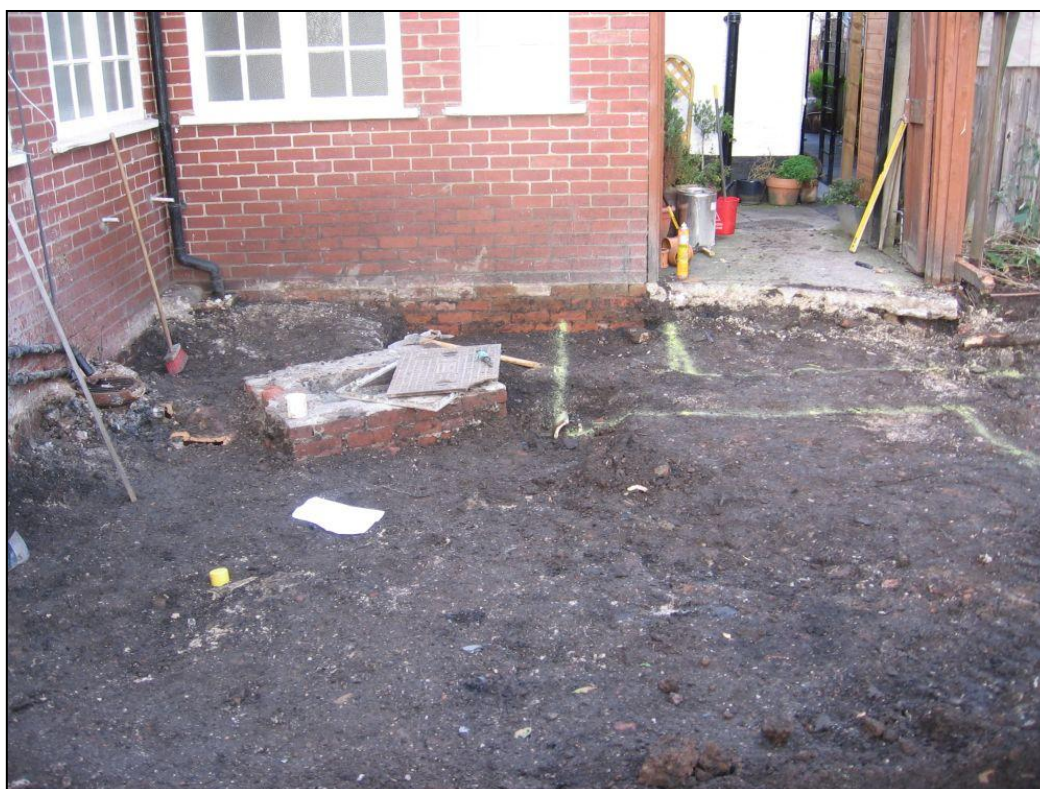
Plate 1 General view of site, looking north-east

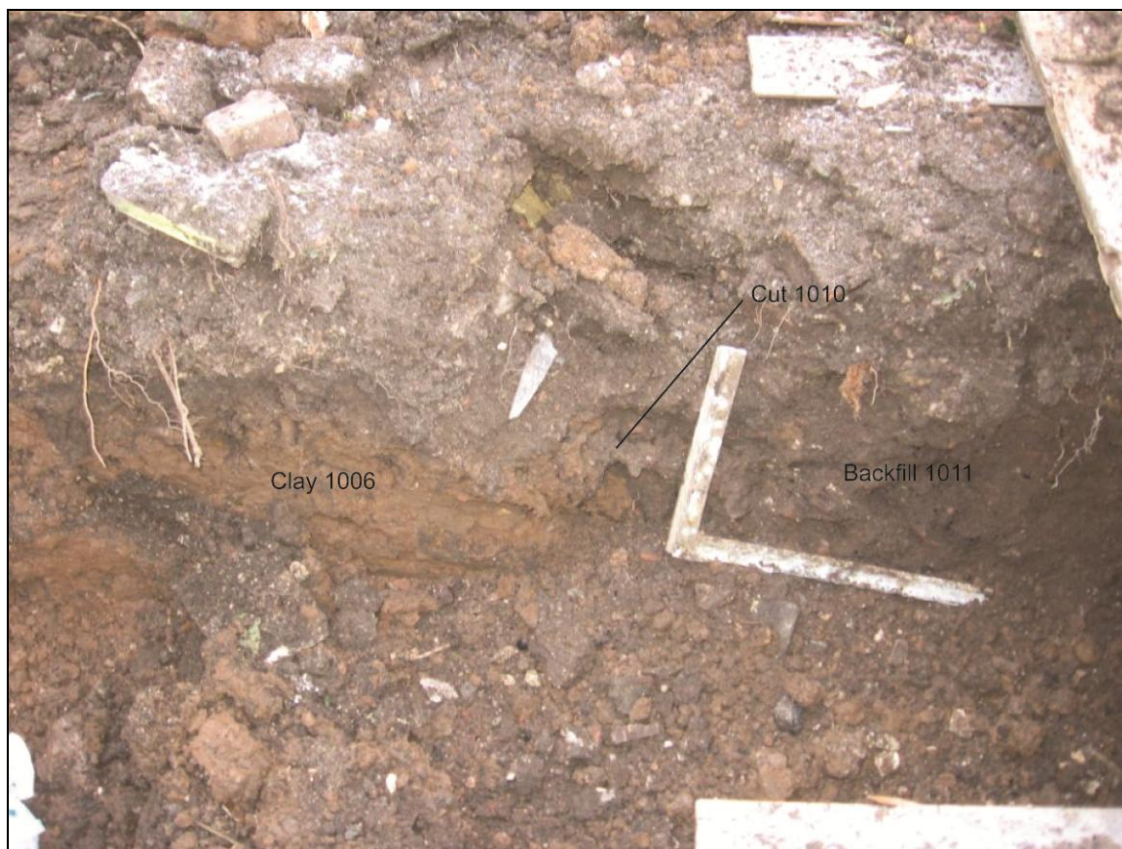
Plate 2 Detail of south-east foundation trench showing cut 1010, looking south-east

The clay seen in both sections (1000 and 1006) was unexpectedly shallow and although very clean may not be in-situ. It is possible that it was brought into the site as a levelling deposit to create a terrace on the slope down towards the River Foss. Such terracing has been attested in the vicinity previously and is thought to be of Roman date. So little of feature 1010 was seen it is impossible to be sure of its function. It could be a clay quarry pit or perhaps a large ditch. No finds were recovered from it so it was not possible to date it. All other contexts recorded were definitely or probably modern and since the groundworks only penetrated c.0.2m into parts of the upper backfill it is considered that little damage was done to the archaeological deposits of the immediate area.
