Impthal Barracks, Fulford Road, York.

Heritage Assessment

April 2014

Defence Infrastructure Organisation

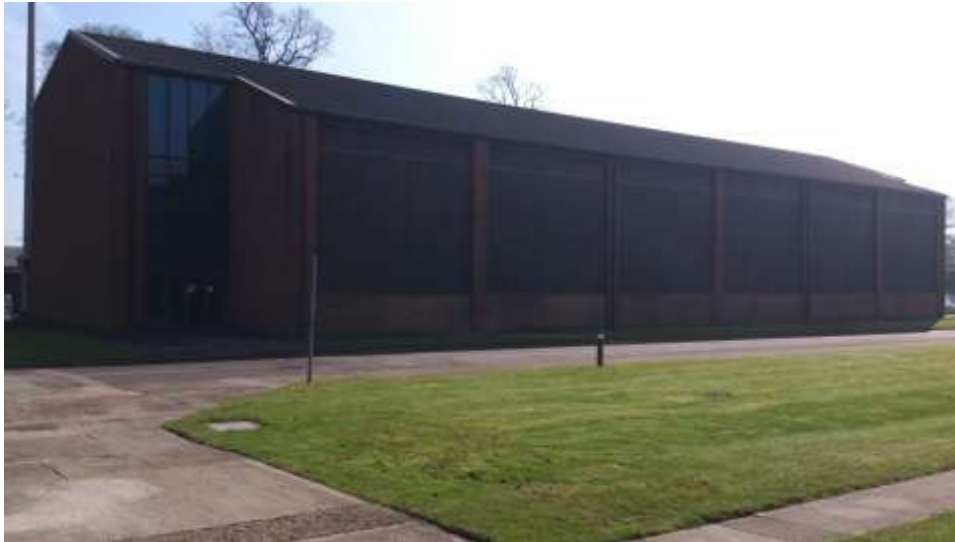
Photograph 1: West facing photograph of extant structure within development area.

The site visit was undertaken on Monday 24th March 2014, all of the proposed development area was observed. There is a mixture of uses across the area with a large concrete structure (Building 140) present at the western extent (Photograph 1). This structure was set within green space (Photograph 2), which will be removed under the current development proposals. A large telecoms mast was also observed, which will require relocation.

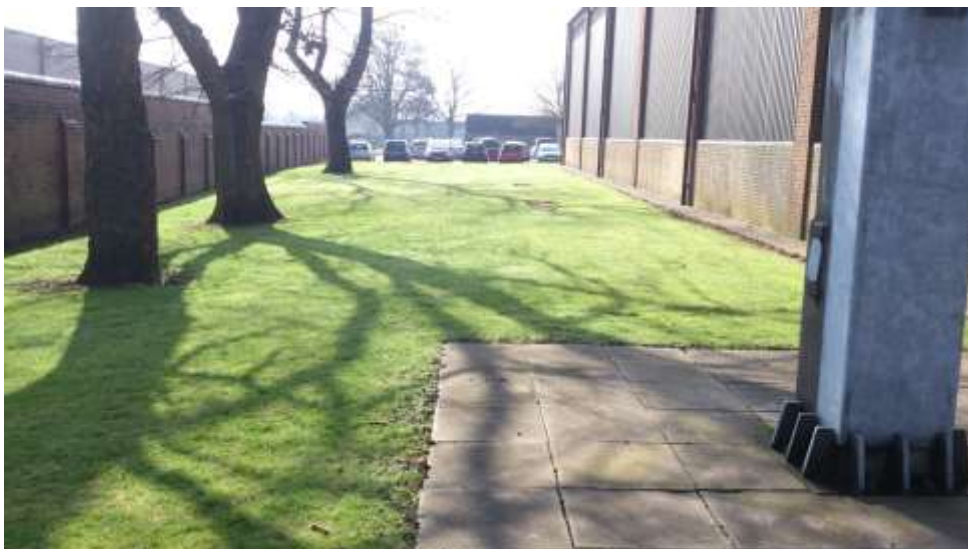
Photograph 2: south facing photograph of green space within development area.

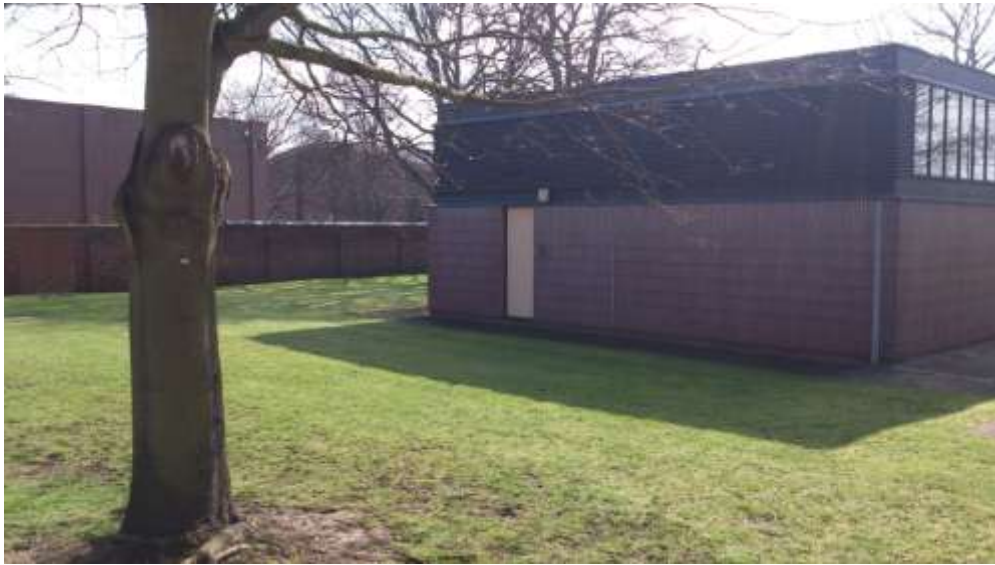
Photograph 3: southeast facing photograph, showing building 101 and surrounding green space.

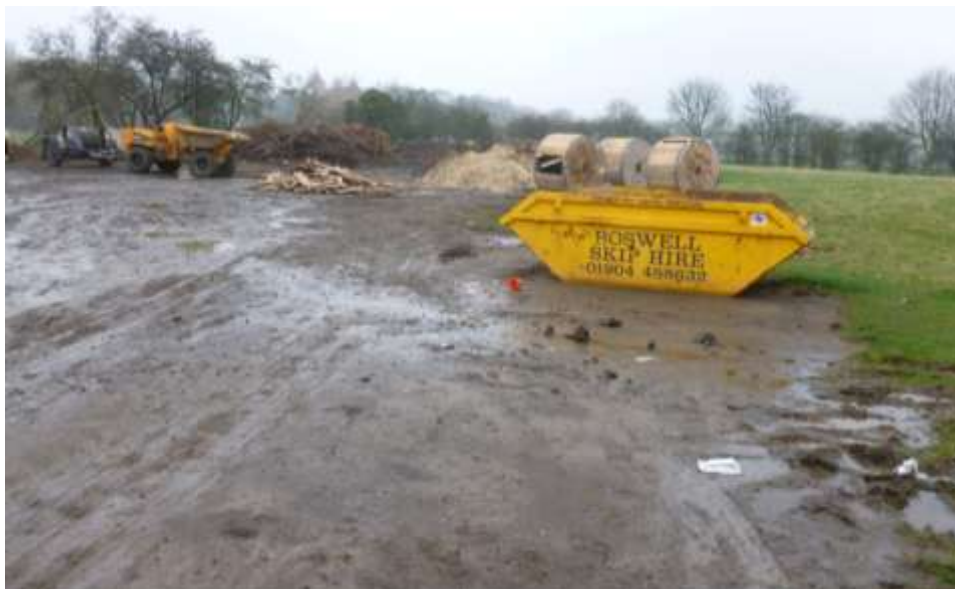
Photograph 4: East facing photograph across area 2 car park.

Within the middle of the development area is the Merlin hardstanding car park was observed, which under the current proposals will be removed and reallocated within the Area 2 car park (which will need re-surfacing). At the southern extent of the development area is a square structure (Building 110, Photograph 3). This structure will be removed and the green space within this area used for the construction of the new accommodation blocks.
