York Castle is strategically situated at the confluence of two rivers, the Ouse and Foss. Founded in the 11th century, it was a seat of power and administration throughout the Middle Ages. From the 17th century, a series of court and prison buildings were built at the Castle to deploy justice and punishment for the county. Since the early 20th century when its prison function ended, the site has been attracting tourists who come to see the iconic Clifford's Tower and Castle Museum, housed in former prison buildings.

Historic Core Conservation Area Appraisal

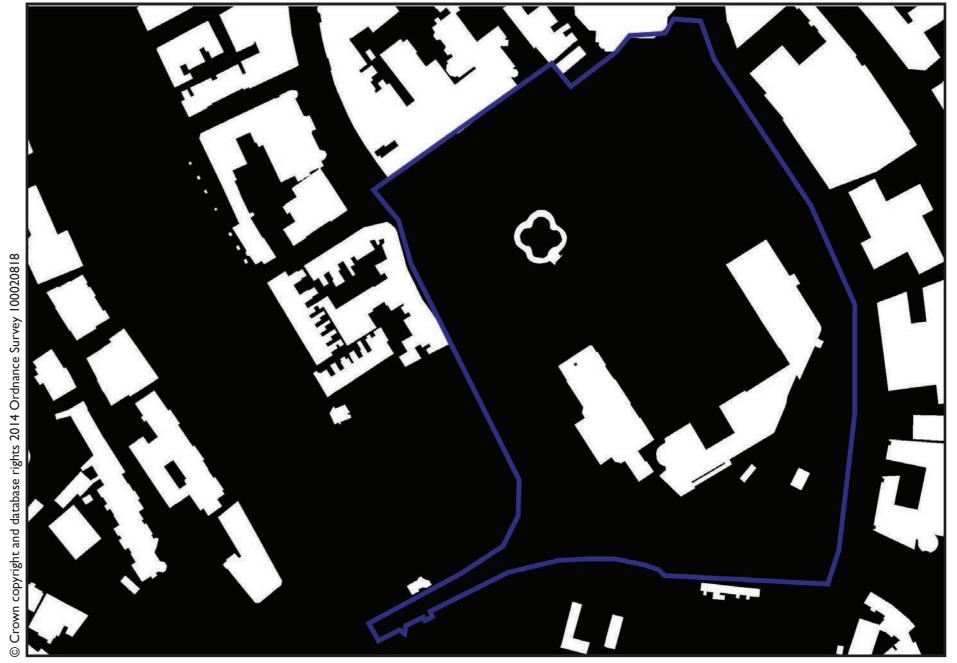
Figure ground map with built environment shown as white on black.

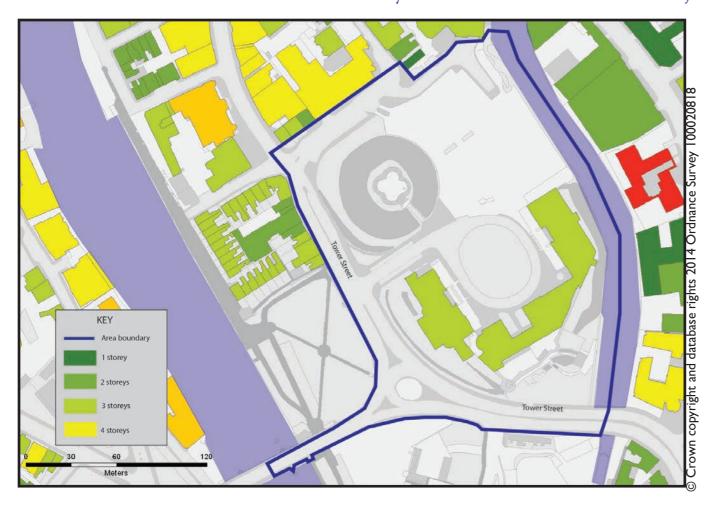
Above: Plan showing the heights of the buildings within this character area.

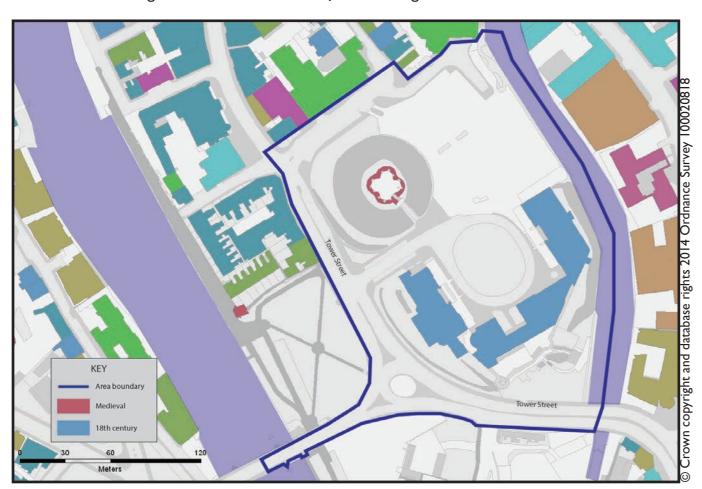
Below: Plan showing the construction dates of the buildings within the area.

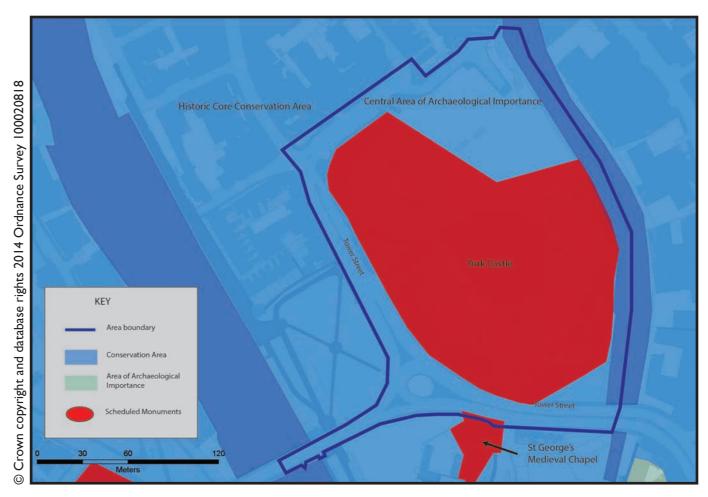
Above: Plan showing designated heritage assets within this character area.

Designations: The site falls within the Central Area of Archaeological Importance and the Historic Core Conservation Area.

All the structures within the Castle area are Grade I listed. The site is also largely a Scheduled Ancient Monument (SAM 13275).

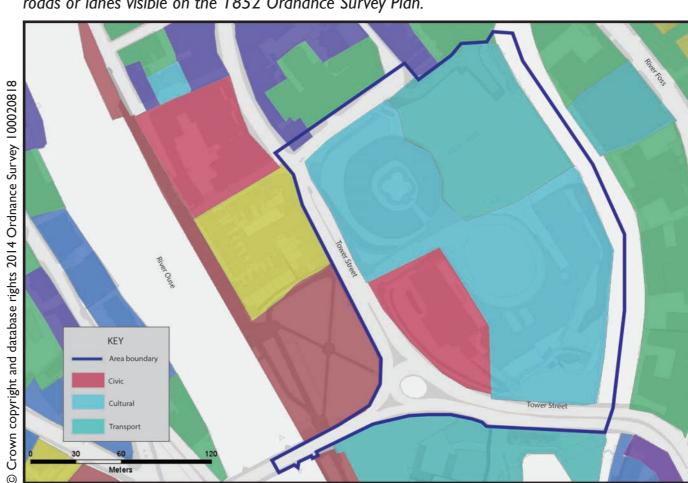
Below: Plan showing the Broad Type characterisation of the area. White roadways indicate roads or lanes visible on the 1852 Ordnance Survey Plan.

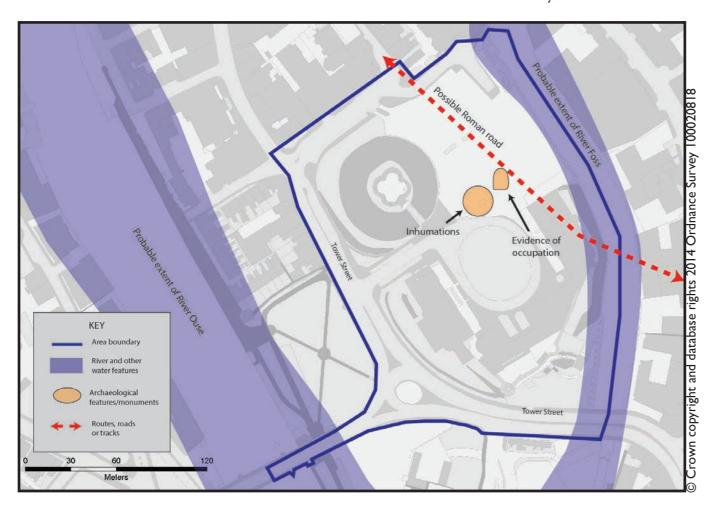
Above: The Roman landscape.

Construction of the castle and latterly, York Prison has impacted significantly on buried archaeology to the extent that very little is known about earlier periods. Within the Castle Yard itself, part of a Roman inhumation cemetery was located in 1835 and again in 1956. In the modern car park area, the site of former prison buildings, Roman deposits indicative of occupation were noted at relatively shallow depths c.2.5m below ground level (EYO57). The extent of the cemetery is unknown and the extent of any settlement activity is also unknown. The road, identified through investigations on Spurriergate and High Ousegate is presumed to continue through the area leading from the present Castlegate.

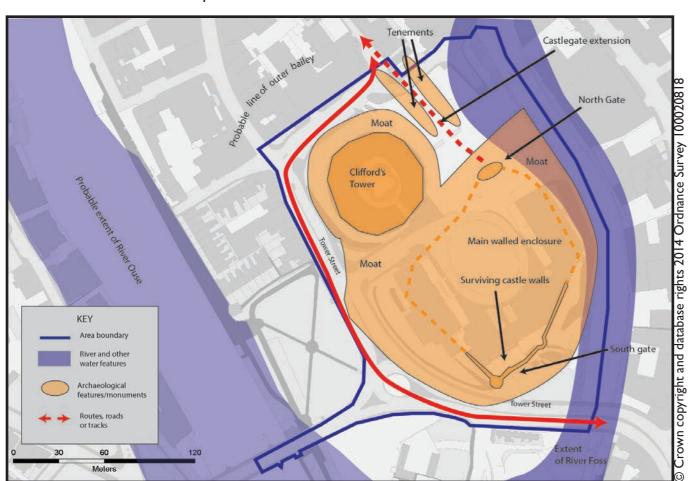
Below:The medieval landscape.

The castle was founded in 1086 and by 1070 probably consisted of a simple timber and earth motte with two baileys. The castle was comprehensively re-built in the 1240's and was certainly mostly a masonry construction at this time. There are indications that Clifford's Tower (MYO1748) was built of stone by the 12th century but many buildings were timber. The castle was substantially destroyed by fire in a siege resulting from an anti-lewish riot in 1190.

The Foss was dammed in the 11th century to create a moat for the castle and the King's Fishpool. A medieval ground surface adjacent to the drawbridge out for the South Gate and floor level of the south angle tower were encountered during an excavation at the southern tip of this area (EYO2864-5).

Other medieval deposits found south of Clifford's Tower include a pit and 1.3m thick rubble and clay dumps containing pottery (EYO3068 & 2887). The possible remains of the gatehouse were uncovered in the castle car park during investigations in the mid 1990s (EYO57). These remains and the earlier deposits located during the same excavation, were truncated by the foundations of council offices dug in the 1930s but abandoned at the outbreak of the Second World War.

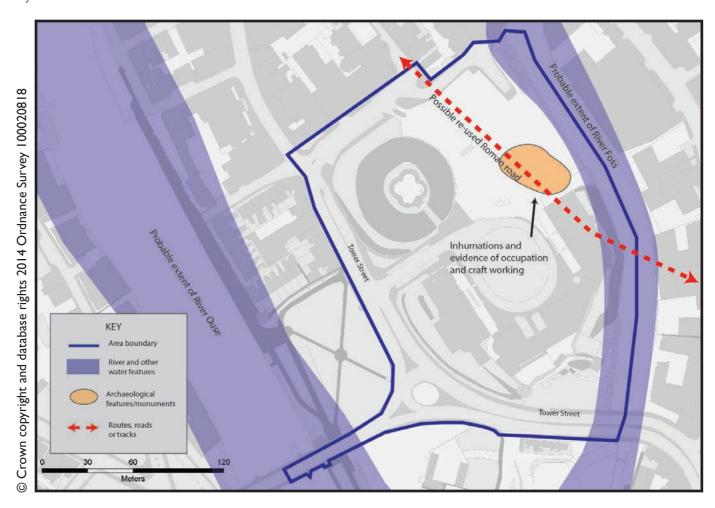
Above: The Anglo-Scandinavian landscape.

The evidence from the Coppergate excavations and contemporary accounts of the building of York Castle in the 11th century strongly suggest that settlement continued throughout this area although later development (castle and prison) has significantly impacted on sub-surface survival. Anglo-Scandinavian activity in the area is also attested by chance finds, the excavation of pits and craft working evidence at the Castle Car Park (EYO57 and EYO29) and intriguingly, inhumation burials close to the former Female Prison, Castle Yard (EYO132). The top of these burials survived at shallow depths of c.0.7m. Although not fully investigated, they may suggest the site of a pre-Conquest church destroyed during the construction of the castle. Evidence of bone and antler working as well as textile manufacturing was uncovered during the excavation of six trenches in 1992 at the Castle car park (EYO29).

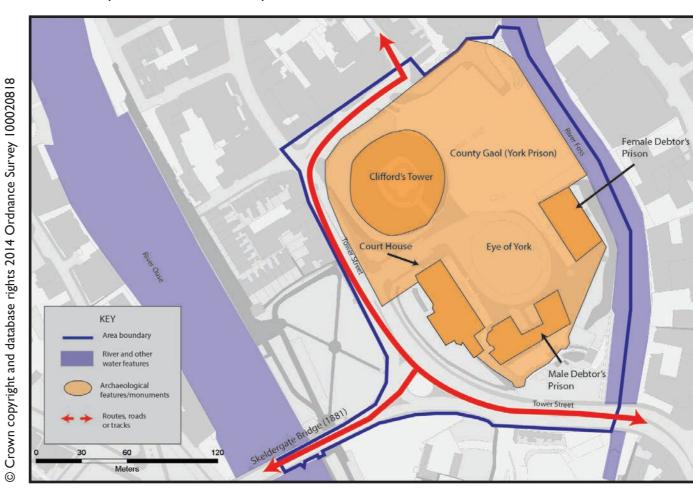
Below:The post-medieval landscape.

During the 18th and 19th centuries large scale changes were made to the castle's buildings, landscape and function including the construction of the court buildings (MYO1749) and prisons. The construction of the female, debtors and felons prison buildings have partially removed the majority of medieval and post-medieval deposits in this area. Further burials dating to the 19th century were recovered associated with the prison itself. The Tyburn (gallows) originally sited on the knavesmire off Tadcaster Road was moved to the Castle after 1801. Until 1896, murderers and others were executed from a specially constructed platform, known as The Drop, at the end of the Female Prison. The Prison is associated historically with many of the significant social and political events of the 18th and 19th century. Chartist and Luddites were all incarcerated here and some, executed.

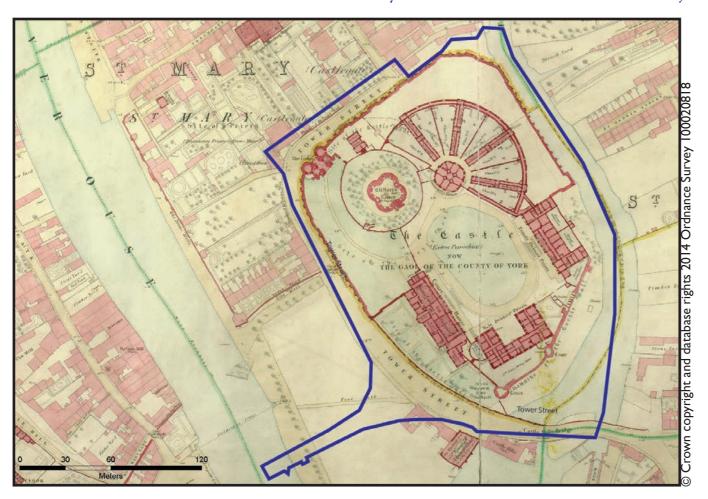
Above: The 1852 landscape.

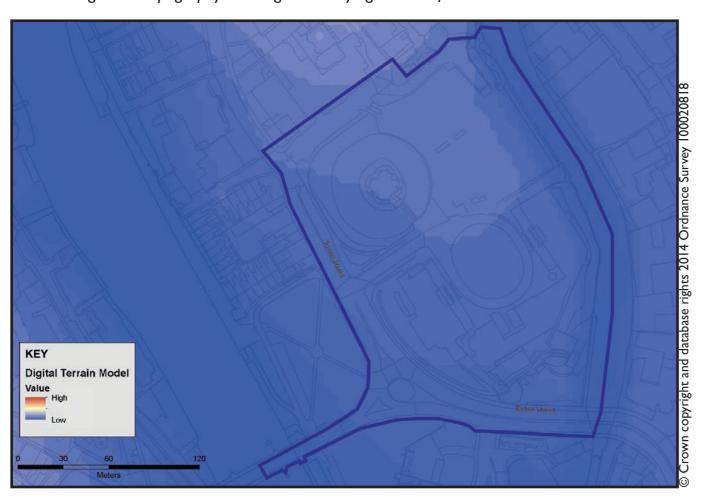
Below: The general topography showing the low lying nature of the castle site.

Overview: This area is situated on generally low lying land within the Foss Waterfront (West Bank, south) and the Confluence zone as identified by Ove Arup. The Confluence is the area containing the Anglo-Scandinavian settlement of York. Average depths range between 3.0m and 5.0m. The Study suggests that on the waterfront, deposits of a high quality dating to all periods are known to exist at an average depth of c.6.0m with likely Roman-medieval deposits preserved anaerobically. Other areas of deep, organic deposits have been identified on Piccadilly and in some castle ditch area. The Study also suggests natural ground levels at anywhere between 2.0m and 8.0m below ground level in the Castle Car Park area. However, in this area dry, generally disturbed deposits are usually located.

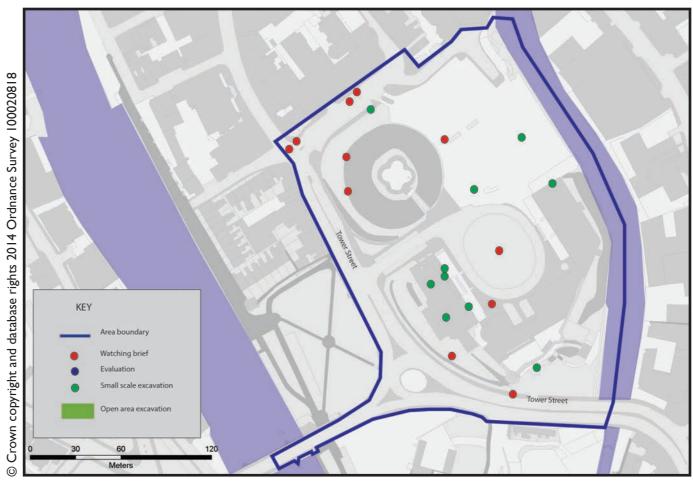
Above: The location of archaeological interventions recorded on the City of York Historic Environment Record.

Interventions (recorded on HER April 2013): There are approximately 17 interventions recorded on the City of York Historic Environment Record (HER). Few of the interventions are recorded in any detail and a brief examination of some grey literature suggests several interventions are yet to be recorded in the HER. See Appendix 1 for a brief summary.

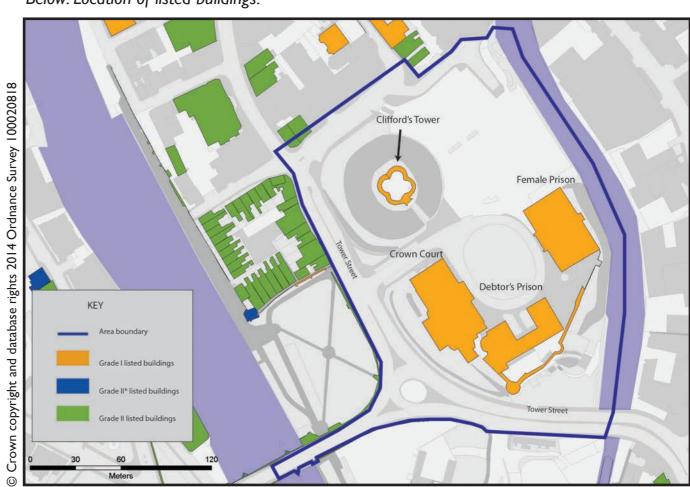
Below: Location of listed buildings.
