## Character area 17: Walmgate Bar

### Description

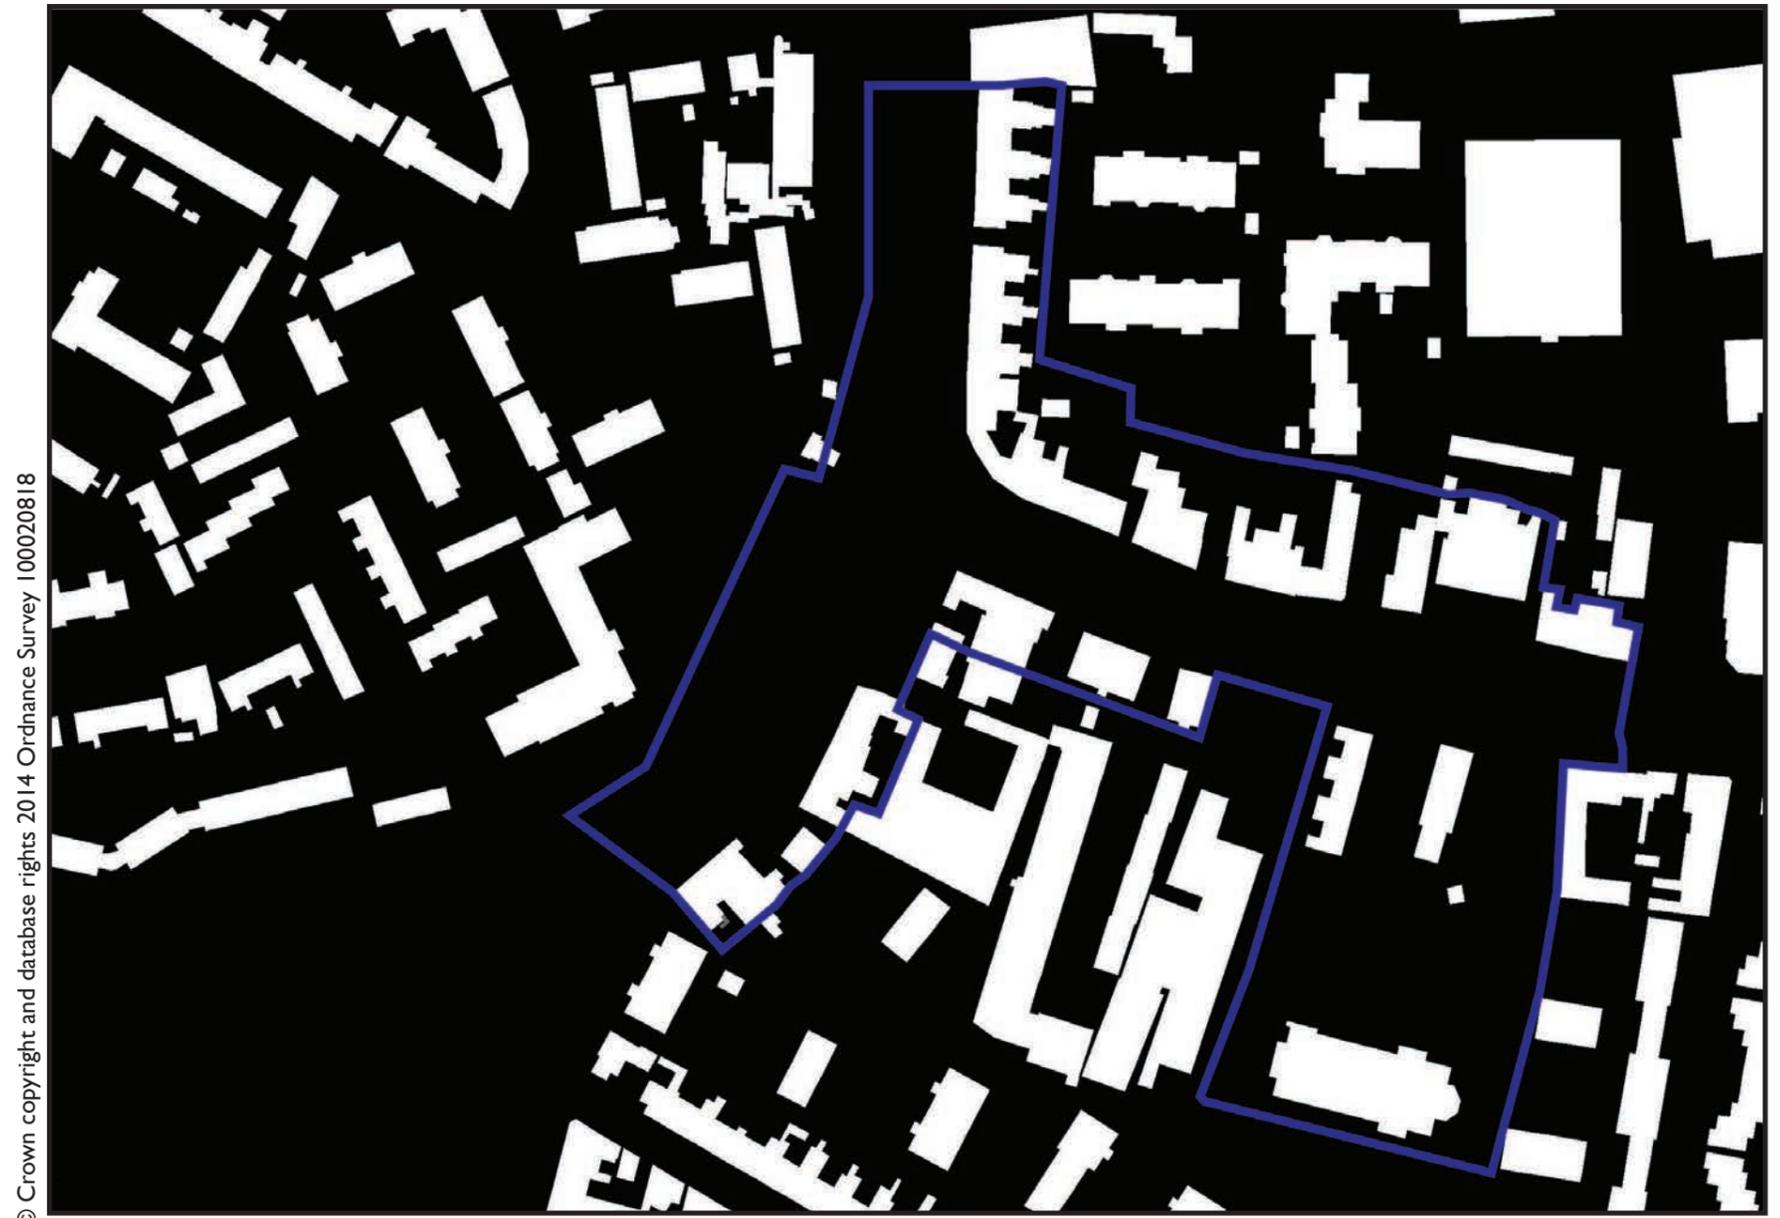
Figure ground map with built environment shown as white on black.

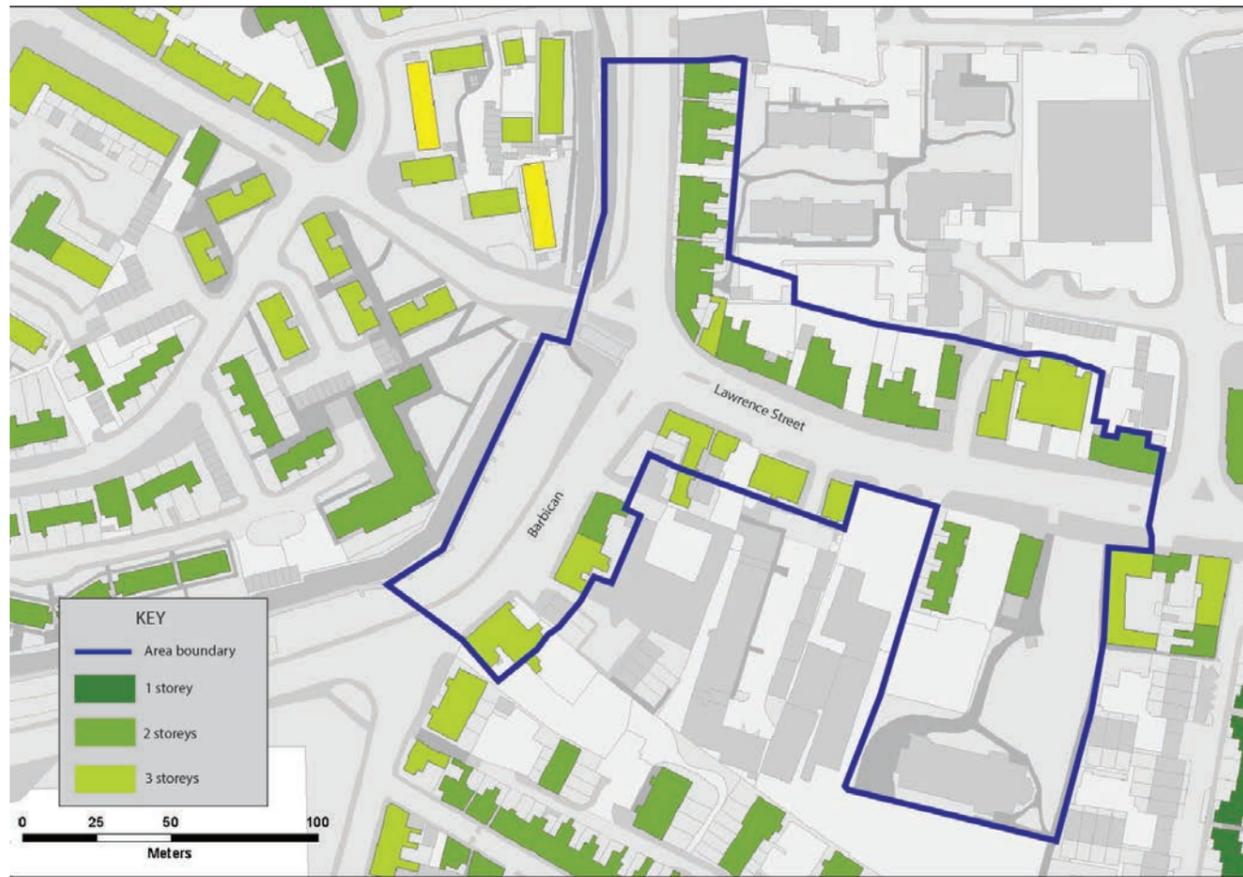
Above: Plan showing the heights of the buildings within this character area.

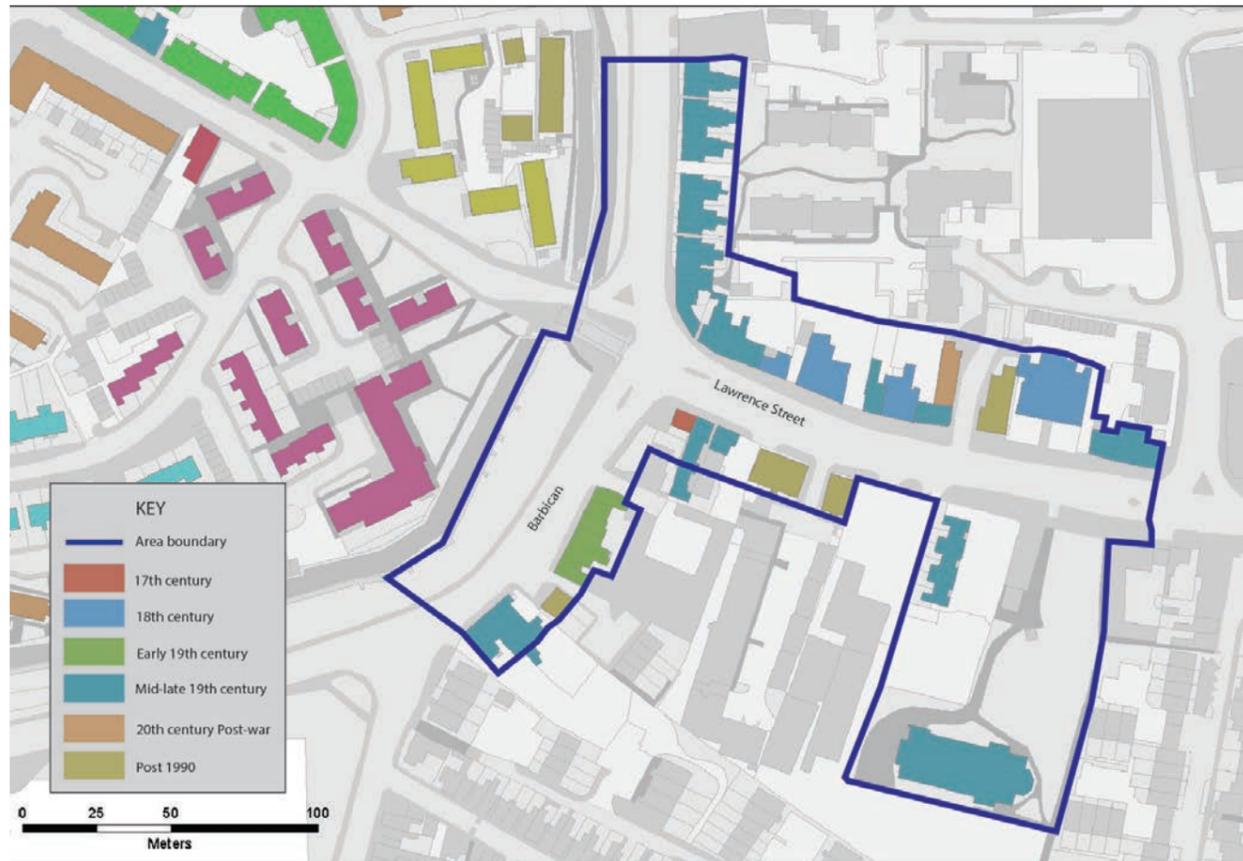
Below: Plan showing the construction dates of the buildings within the area.

Predominantly mid-late 19th century, two-storey buildings

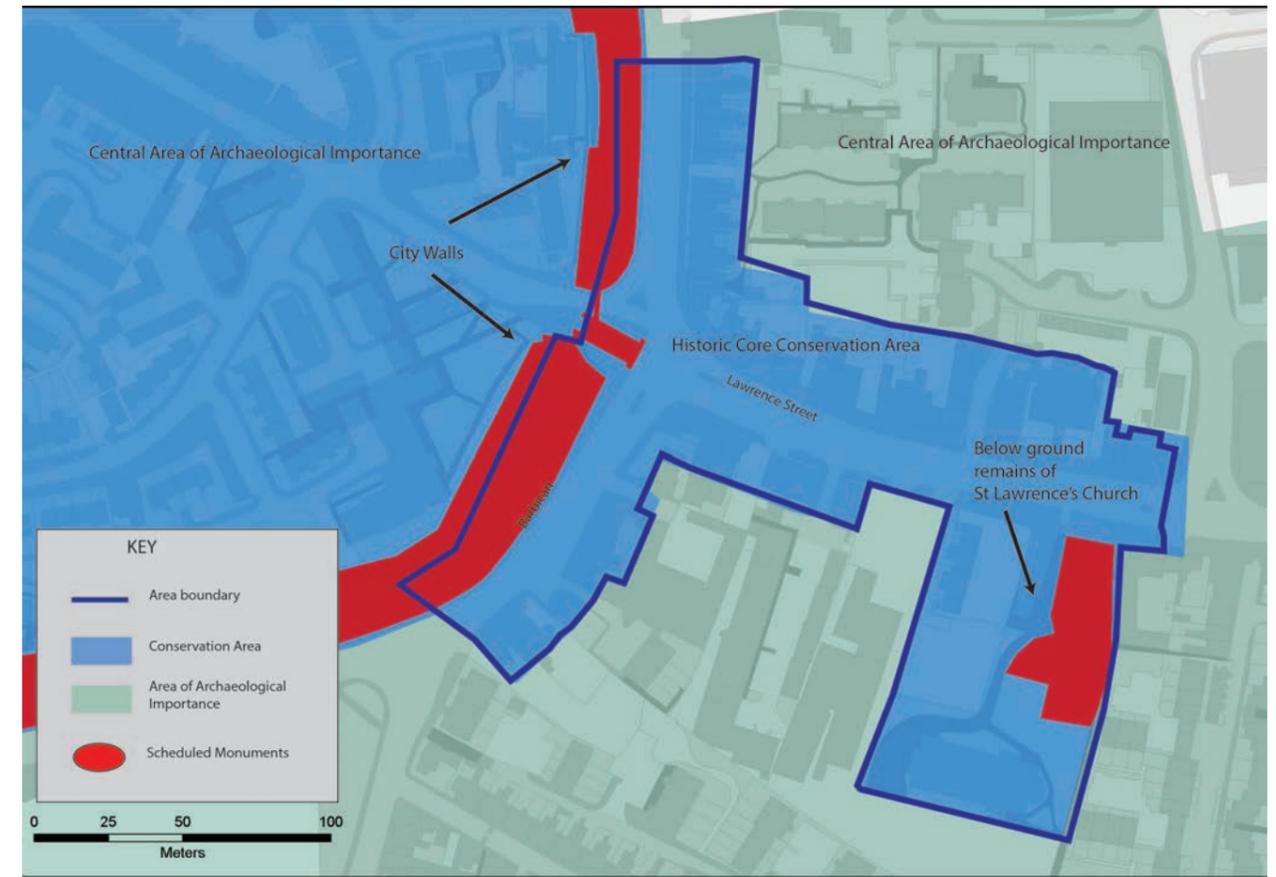
Above: Plan showing designated heritage assets within this character area.

The Lawrence Street area contains some architecturally and historically significant buildings. There are 11 Grade II listed buildings dating between the 18th and 19th centuries. The City Walls (Fishergate Postern to Red Tower) (MYO1734) and medieval tower (MYO1327) and the sub-surface remains of St. Lawrence's Church are Grade I listed and Scheduled Ancient Monuments (SAM30 & 34838). Several Buildings of Merit have been identified in the Historic Core Conservation Area Appraisal such as the Tam O'Shanter Public House and St. Lawrence's Parish Hall.

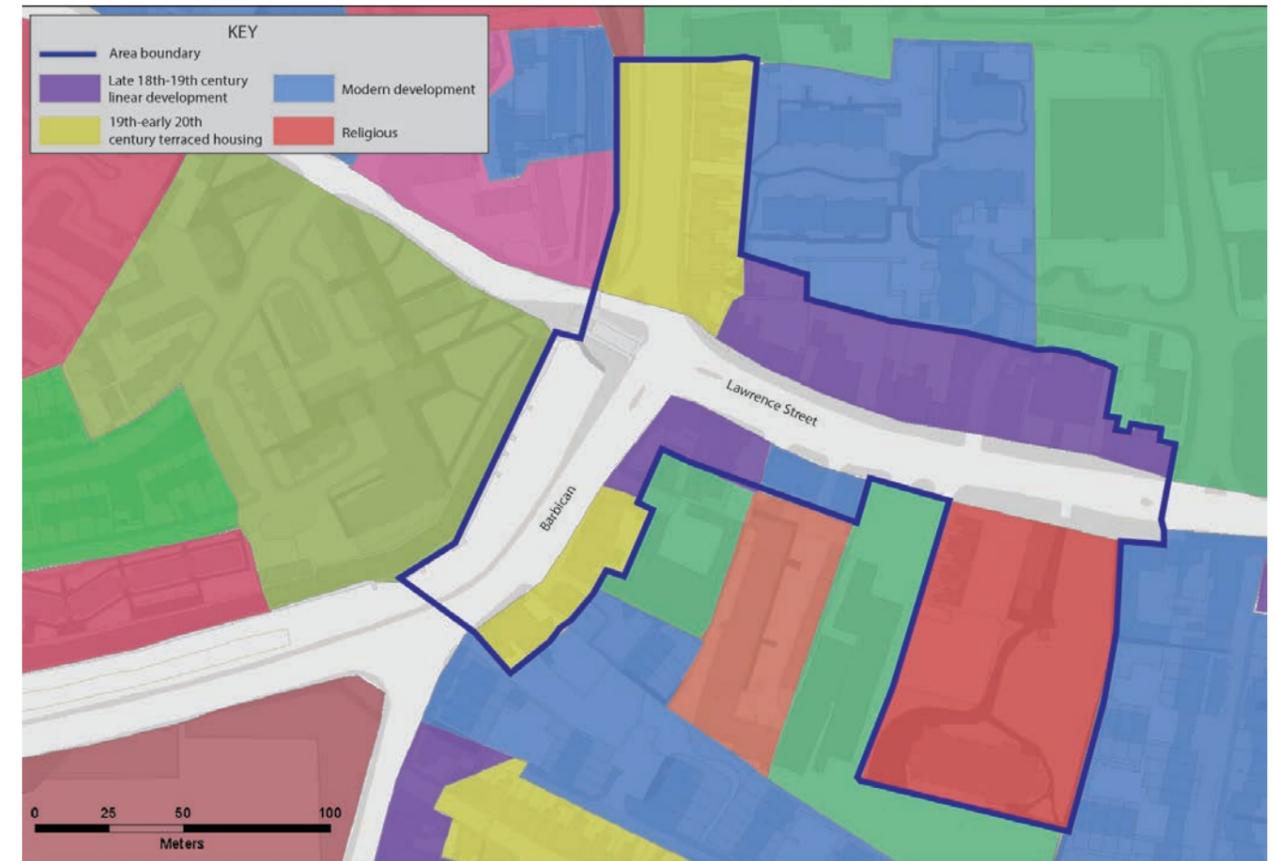
Below: Plan showing the Broad Type characterisation of the area. White roadways indicate roads or lanes visible on the 1852 Ordnance Survey Plan.

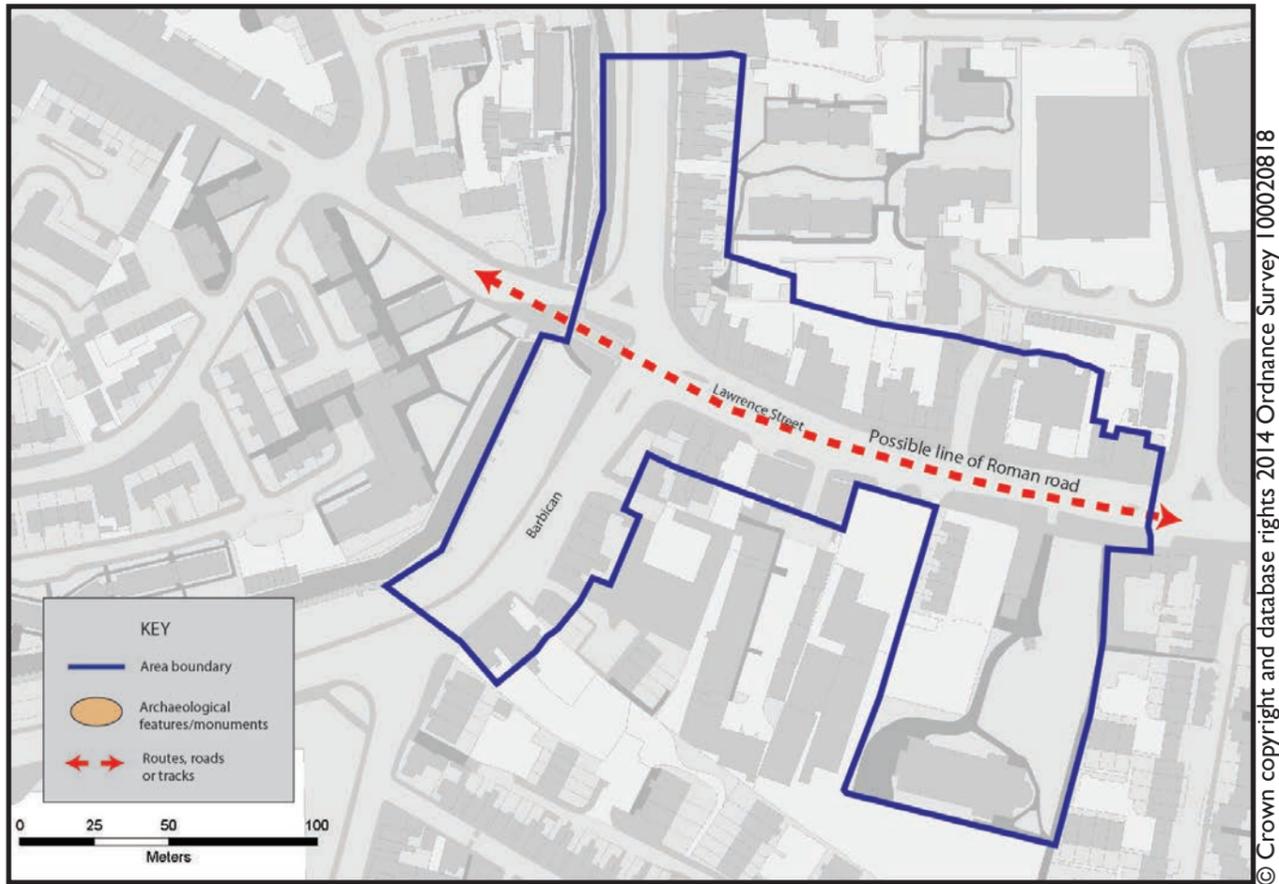
Above: The Roman landscape.

There is scant evidence of Roman activity within this area other than the Roman road. Limited evidence of land division has been found suggesting a reversion back to open land. Residual Roman pottery was located on the former Reg Vardy site on the south side of Lawrence Street (EYO4108). Further east, outside the character area, the DC Cook site (EYO247) produced evidence of possible Roman occupation and sherds of 8th century pottery. Possible evidence for Roman clay quarries located in the Leake Street area (EYO2235).

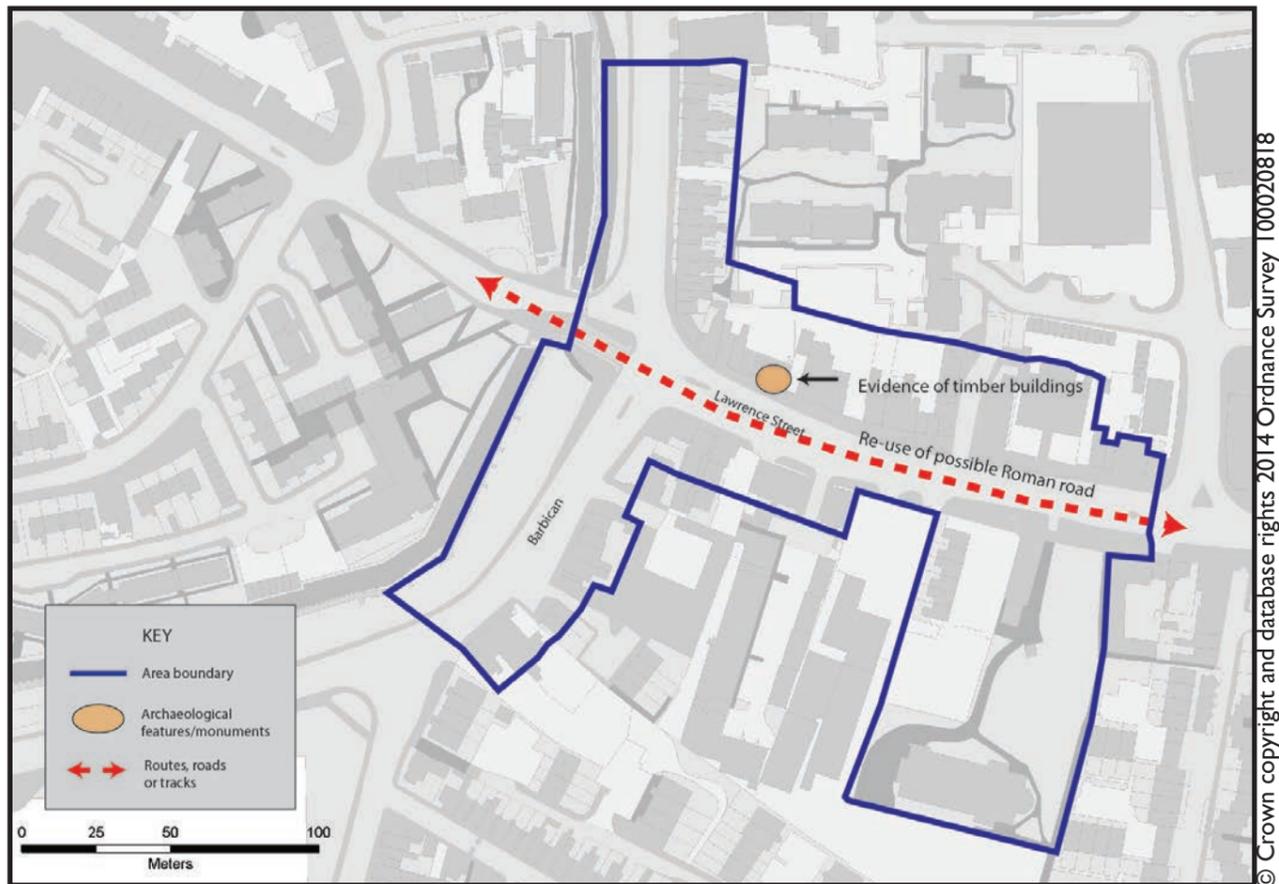
Below: The Anglo-Scandinavian landscape.

The Lawrence Street/Leake Street watching brief also yielded evidence of Anglo-Scandinavian timber buildings situated beneath the foundations of several medieval structures. An investigation slightly further north, beneath Heron House also produced wet and dry evidence for Anglo-Scandinavian timber structures ranging between 0.7m and 1.9m in thickness (EYO2228-2239). These discoveries indicate that the extensive settlement along Walmgate continued at least to this point.

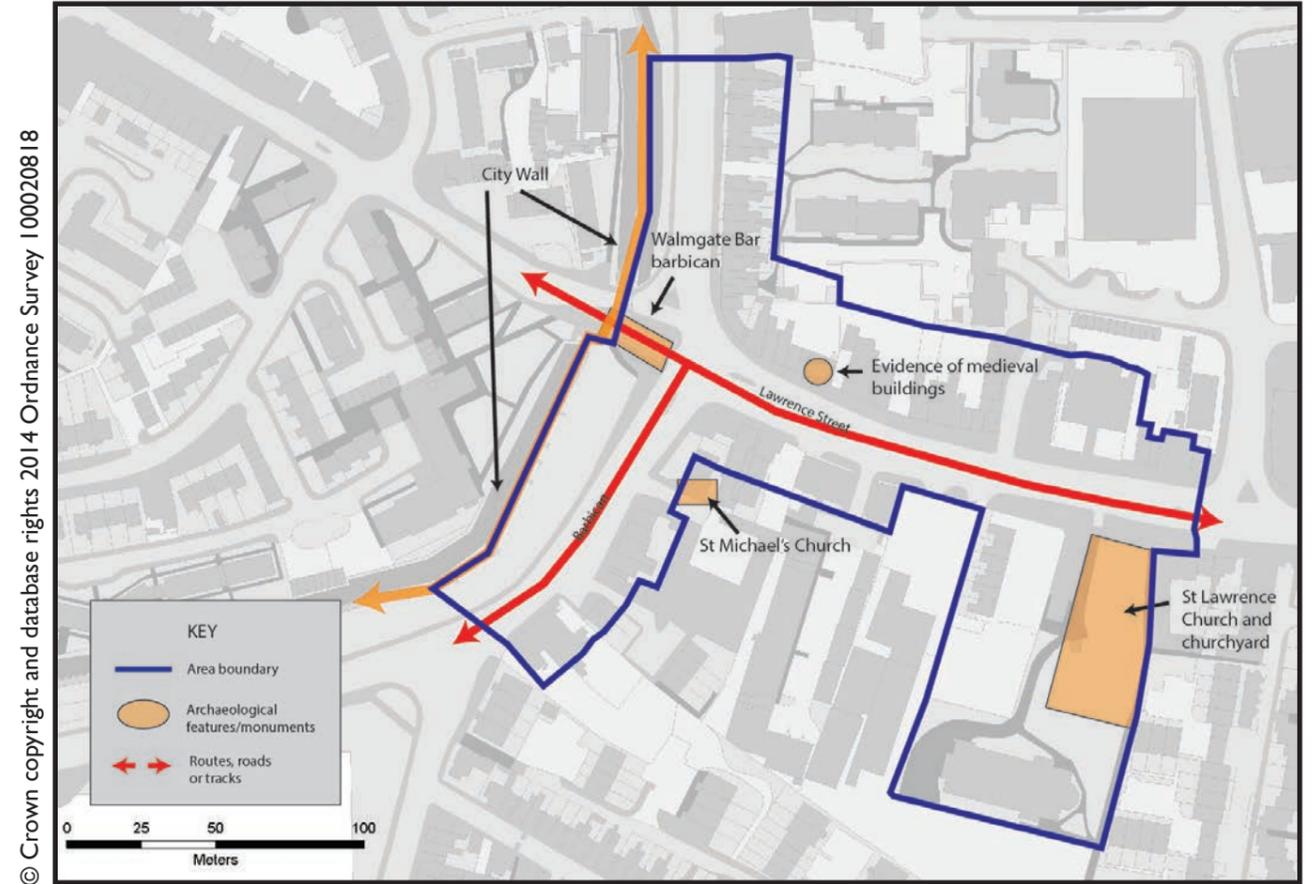
Above: The medieval landscape.

Walmgate Bar contains masonry from the mid-12th century and would have been a gateway cut through the Norman earthwork defences, since the city wall did not enclose the Walmgate area until the late 14th century. The barbican is a 14th century addition.

Medieval pits and linear features were found in some trenches dug on the former Reg Vardy Site on the south side of Lawrence Street (EYO4108) and the Lawrence Street/Leake Street watching brief uncovered remains of several buildings. This has provided clear evidence of continuous occupation on this part of Lawrence Street since the Anglo-Scandinavian period.

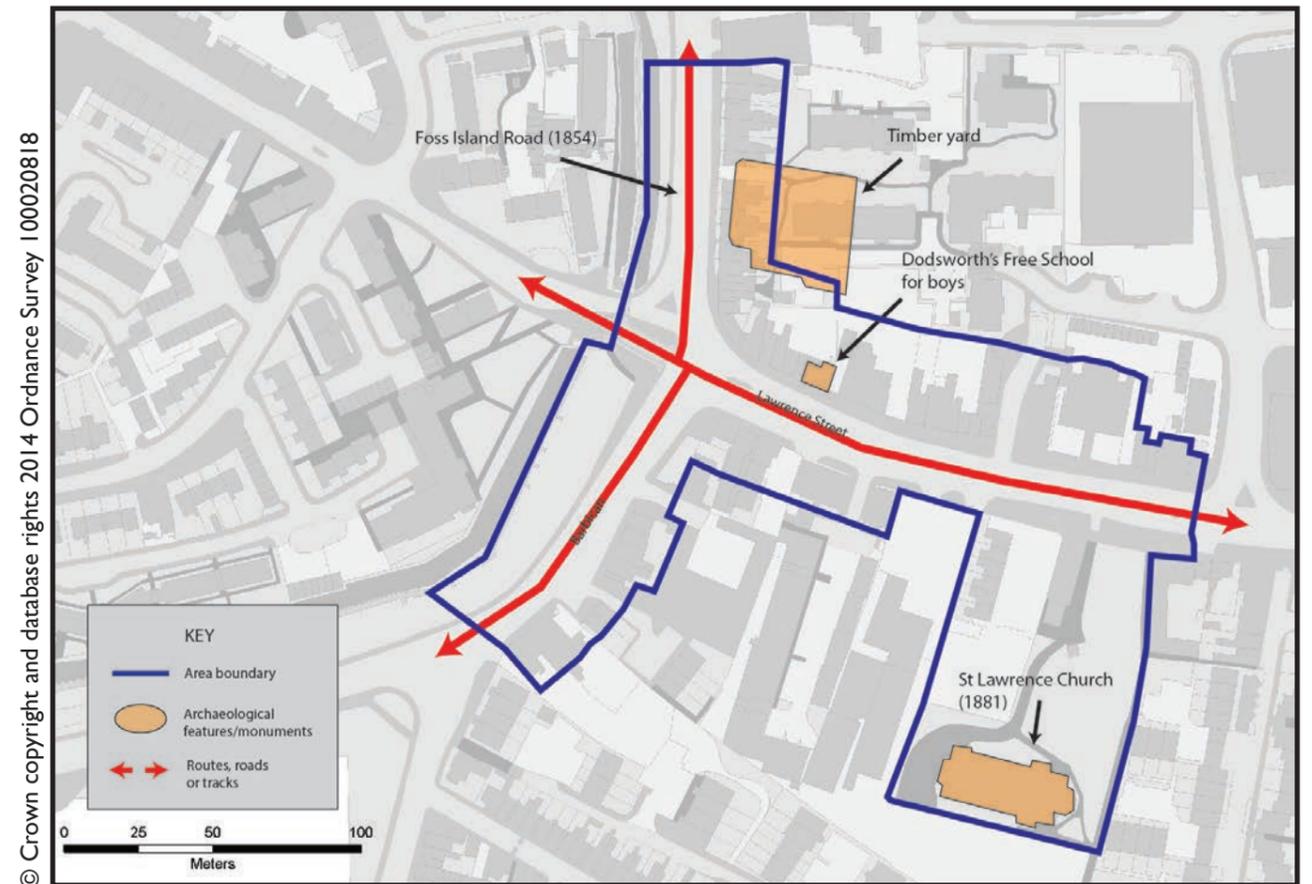
Below: The post-medieval landscape.

Medieval domestic and commercial buildings on Lawrence Street were substantially damaged during the English Civil War siege of 1644. Batteries were set up on Lamel Hill to the east and in St. Lawrence's Churchyard to bombard the Walmgate area. A possible earthwork related to the Civil War defence of the city was revealed on the former Reg Vardy Site (EYO4108). The medieval buildings were destroyed by fire to create a clear area between the Royalist defenders and the attacking Parliamentarians. Walmgate Bar itself was badly damaged but later restored. Today it is one of York's most complete bars, retaining its barbican, portcullis and 15th century inner gates.

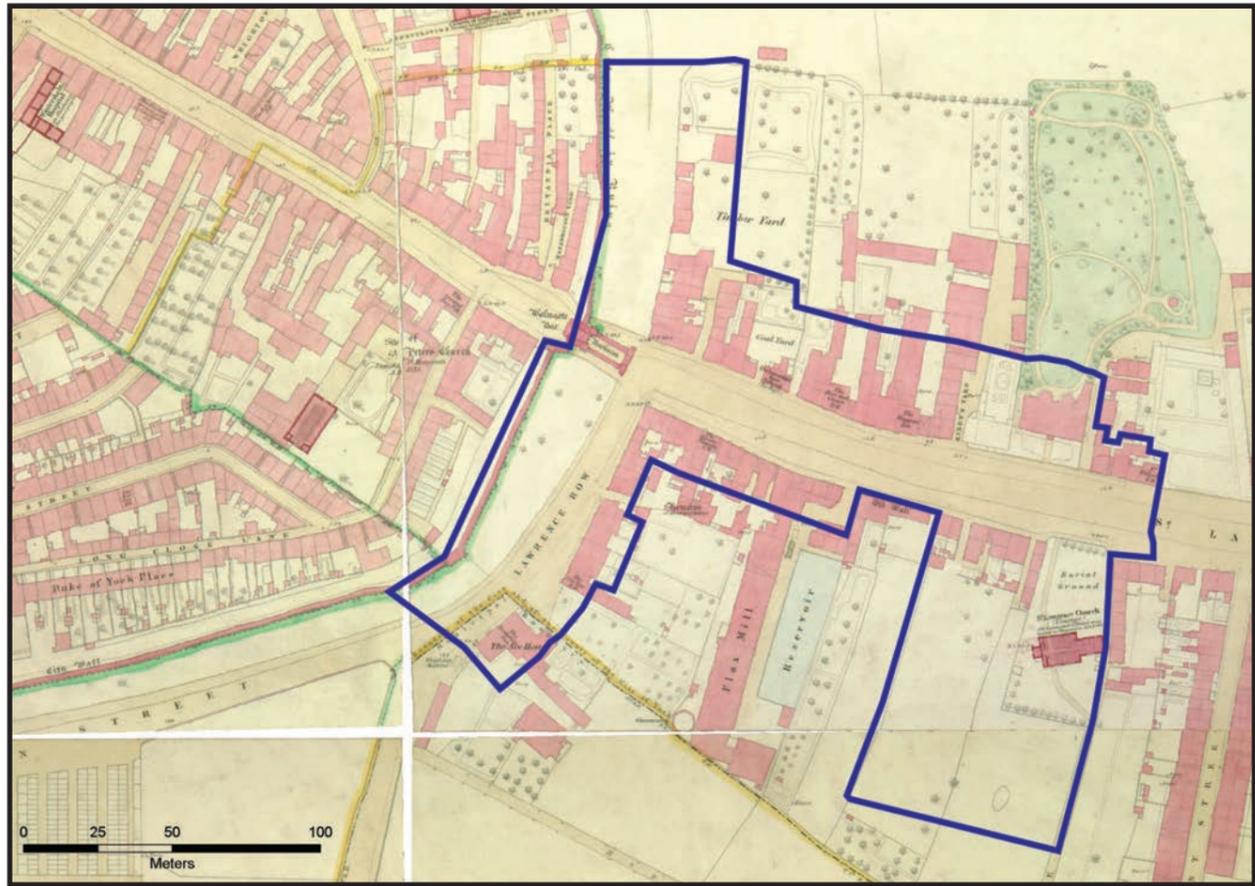
Above: The 1852 landscape.

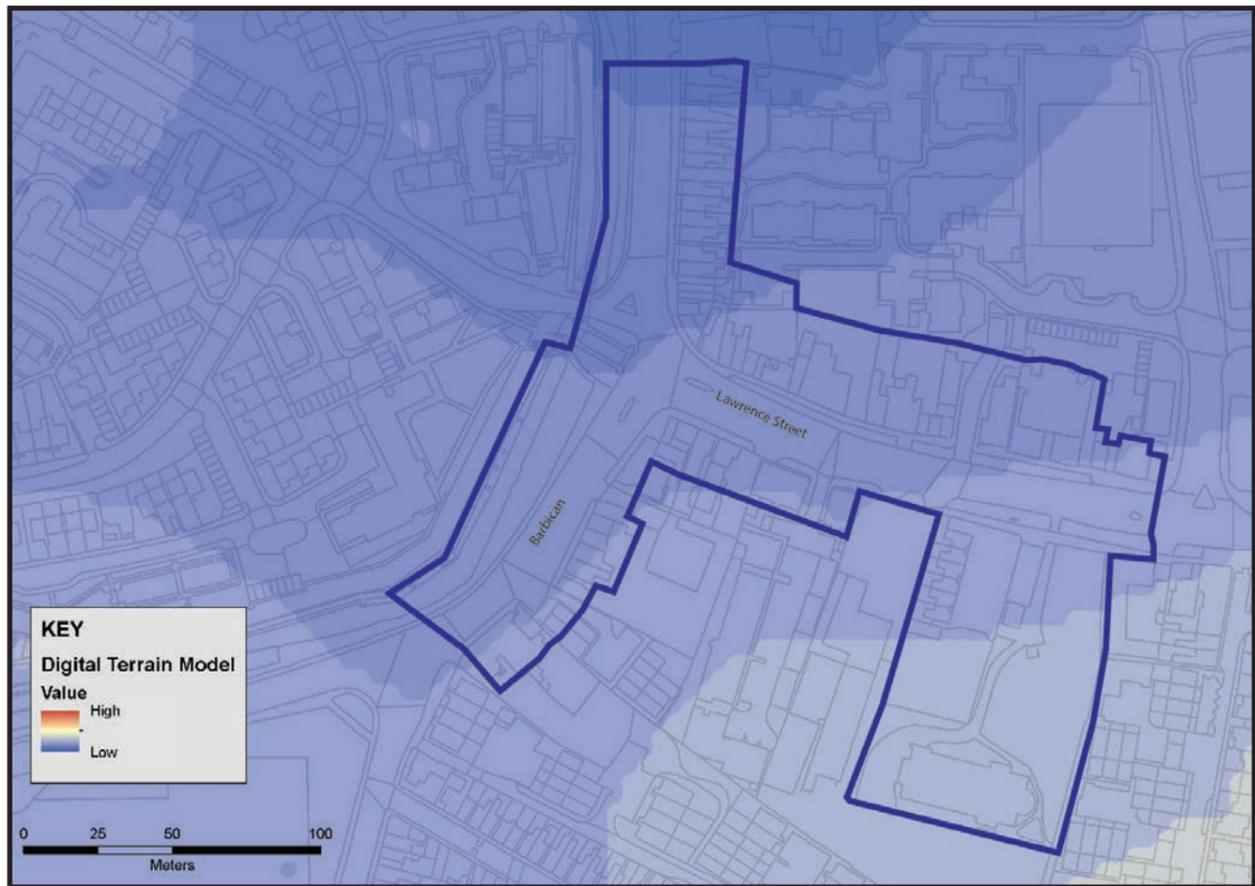
Below: The general topography showing the relatively high position of this area.

**Overview:** Walmgate Bar occupies slightly higher ground away from the River Foss in the south-east Extramural area as identified by Ove Arup Archaeology and Development Study. The study suggests that archaeological deposits dating between the Anglian and medieval periods exist at an average depth of c.1.5m below ground level.

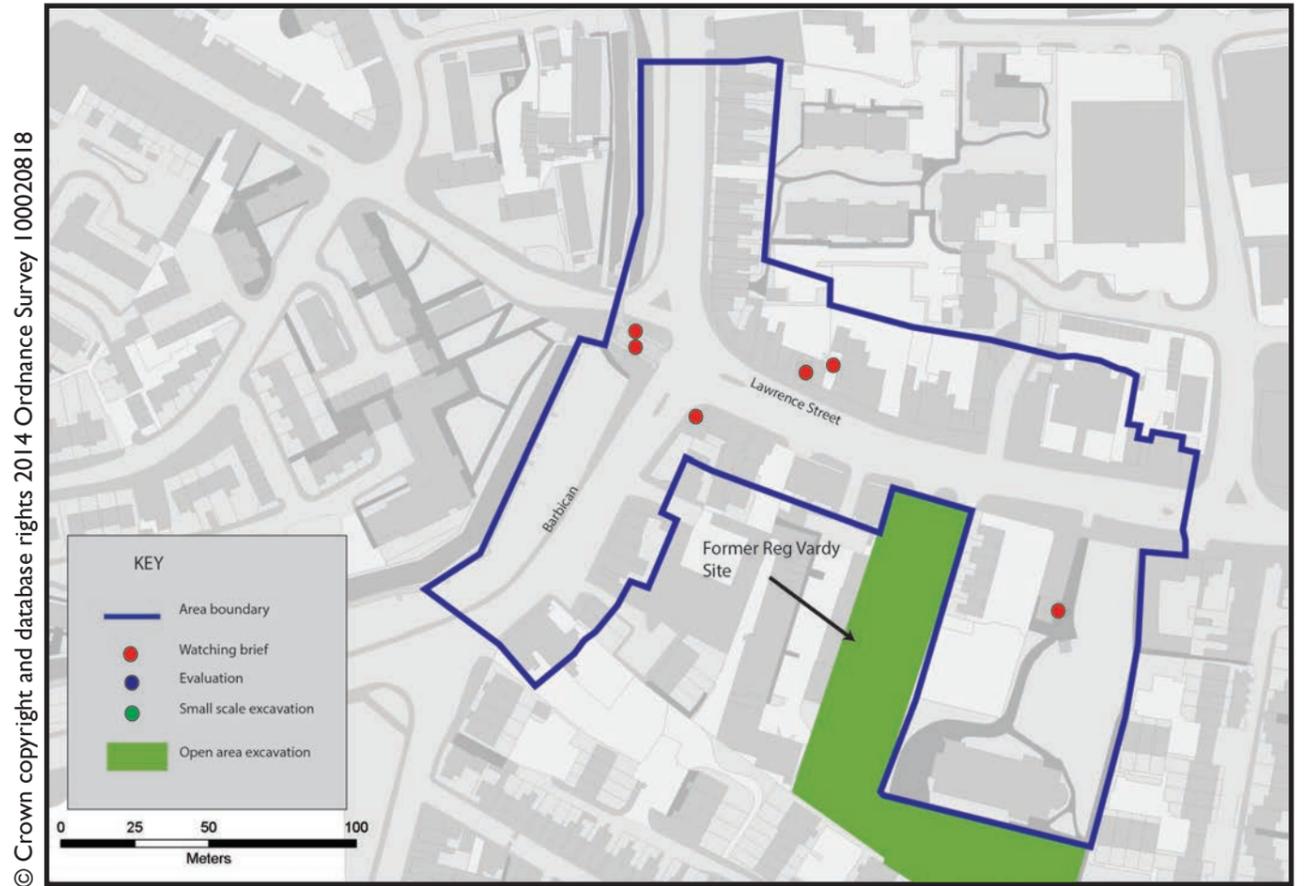
Above: The location of archaeological interventions recorded on the City of York Historic Environment Record.

**Interventions (recorded on HER April 2013):** There are approximately 6 interventions recorded on the City of York Historic Environment Record (HER). Few of the interventions are recorded in any detail and a brief examination of some grey literature suggests several interventions are yet to be recorded in the HER. See Appendix 1 for HER summary.

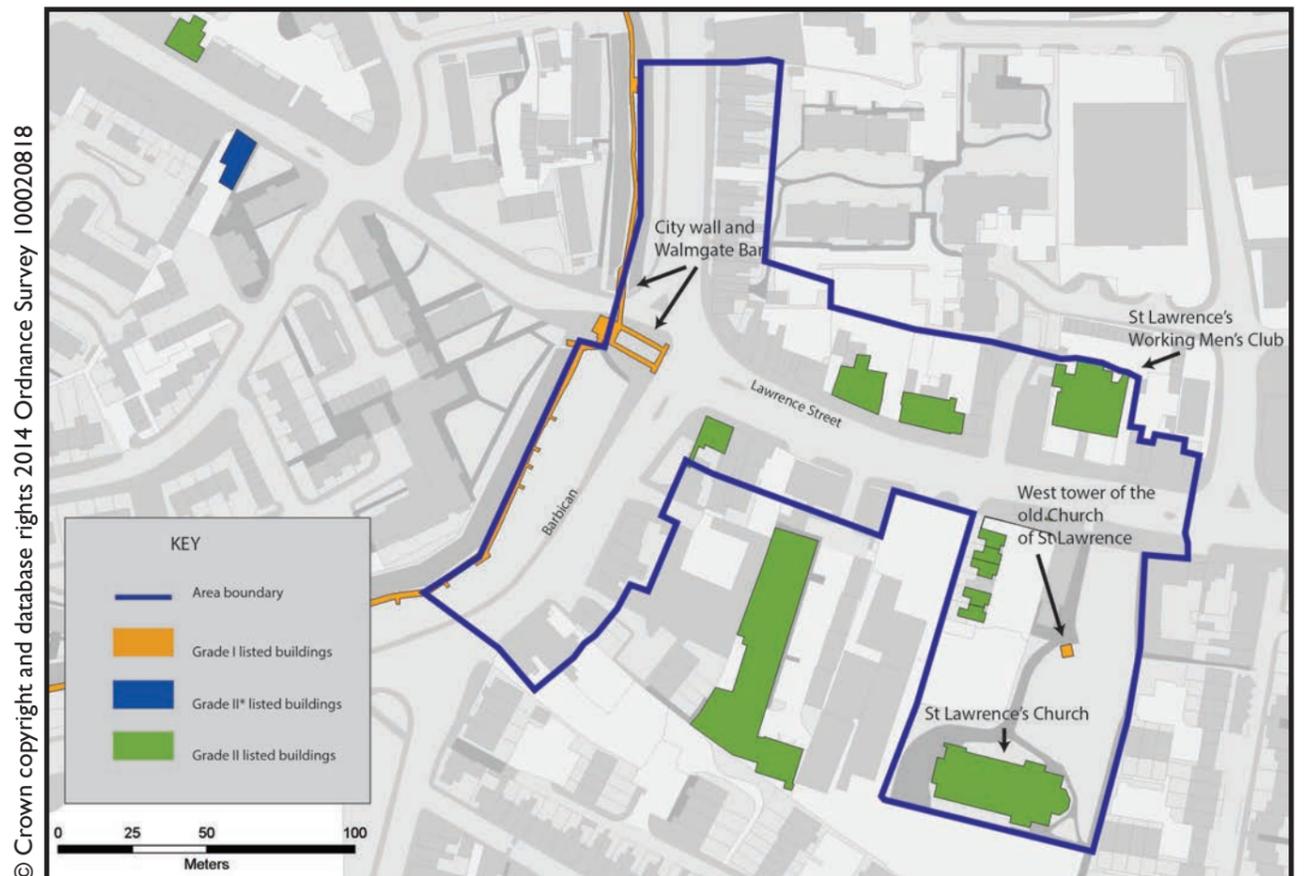
Below: Location of listed buildings. Note the Grade I listed structures.
