York Walls

Conservation Management Plan
for the City of York Council

November 2021

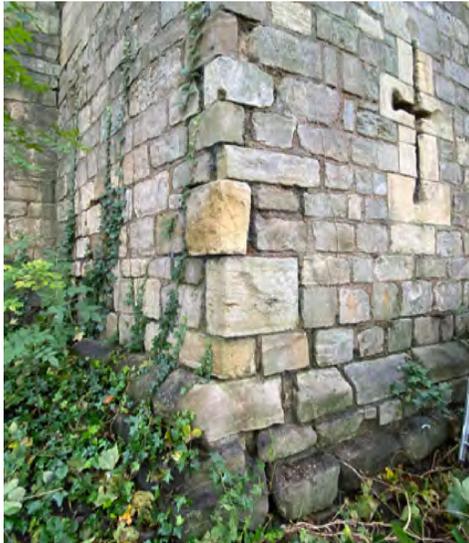
3.01 Unstable foundation

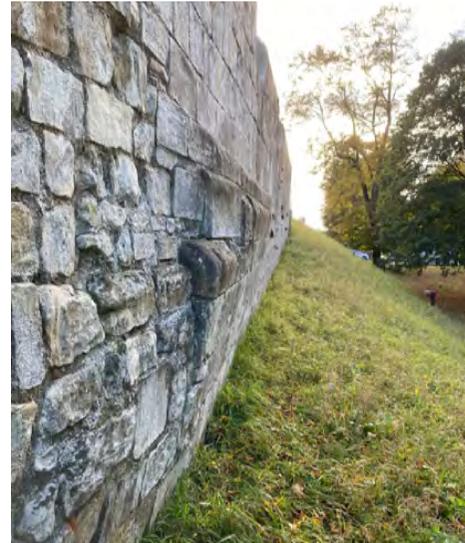
3.03 Bulging

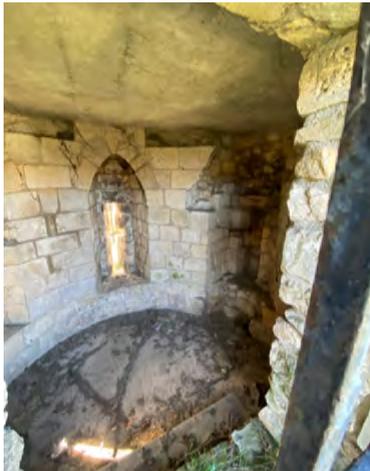
3.05 Concrete slabs

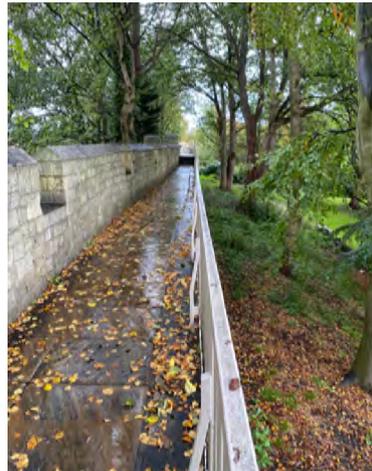
3.06 No movement joints to railings

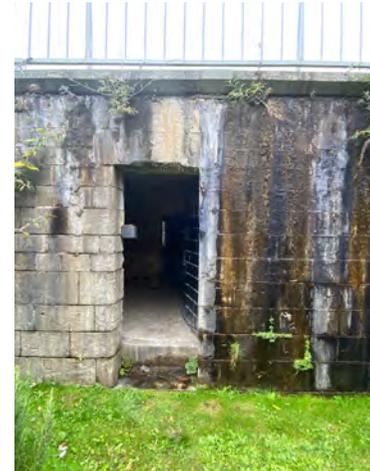
3.08 Edge stones with no drip detail

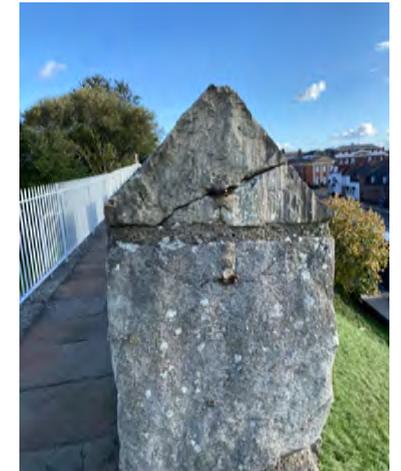
3.09 Ferrous Metal detail

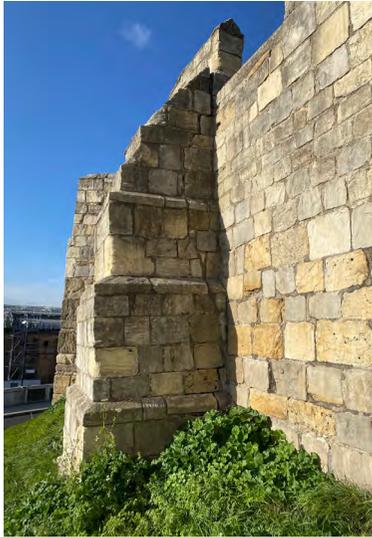
3.10 Structural Movement

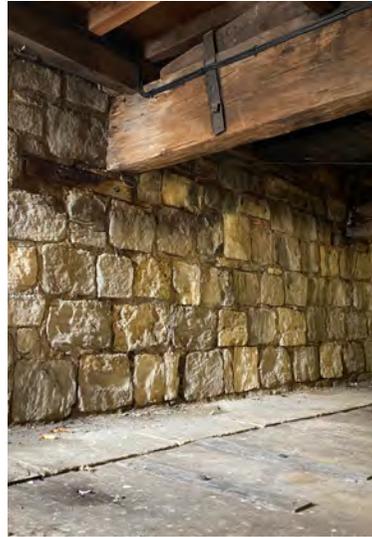
3.11 Water ingress and saturation

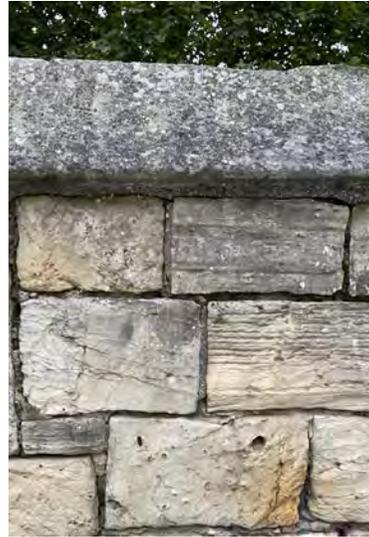
3.12 Open joints

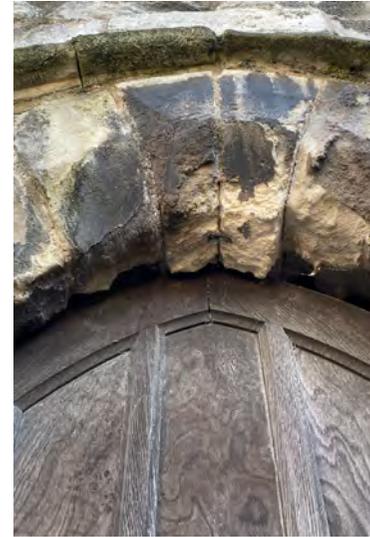
3.13 Sulphuric Crust

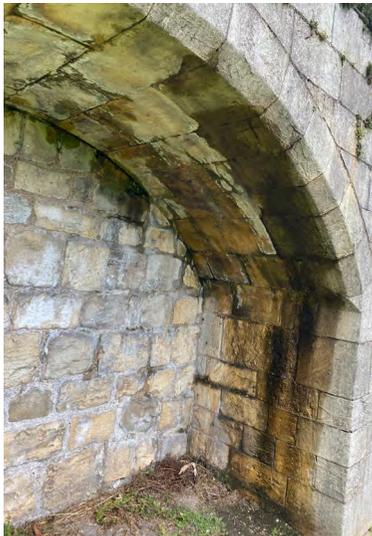
3.15 Salt Movement and Saturated Masonry

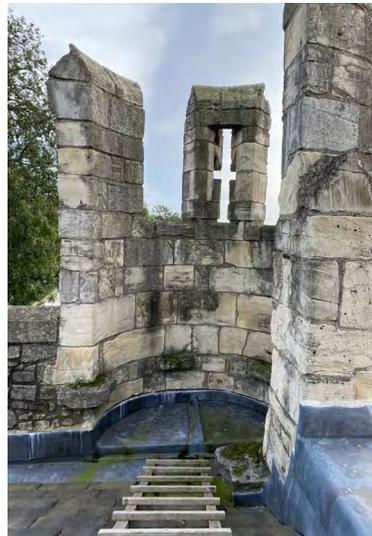
3.16 Wind vortex

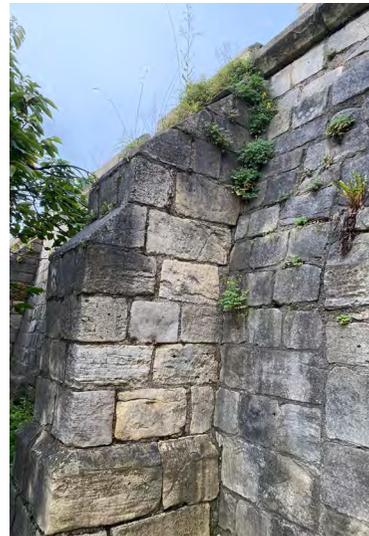
3.17 Vegetation Jacking

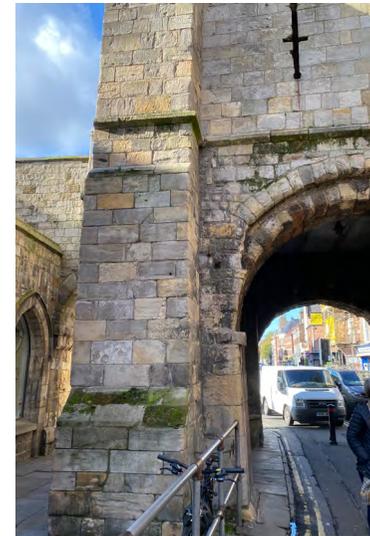
3.18 Vibration

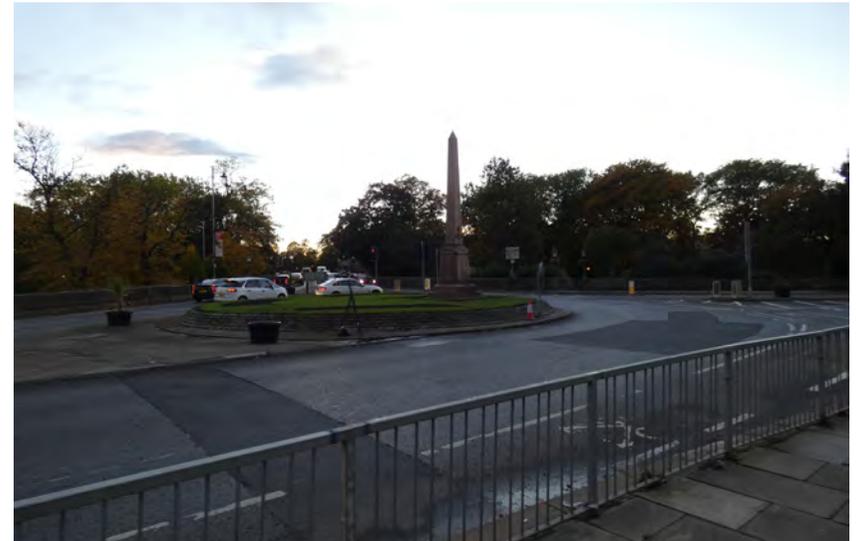
Section 19 also has a distinctive and highly significant setting, with the York Castle site, Clifford's Tower, the Castle Museum and Debtor's/Female Prisons and the Crown Court, part framed by the curtain wall and the Foss and weir lock, whilst the Ouse lies to the west. The modern road network, street clutter, surface car parking detract from the setting and the low quality landscaping to St George's Field is neutral at best [**Plates 3.38 & 3.39**].

3.38 Section 19, View of road network and street furniture

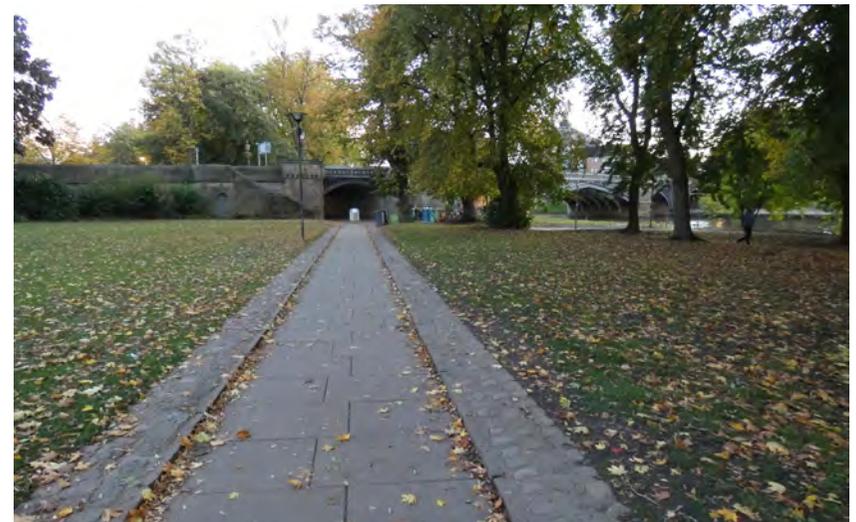
3.39 Section 19, St George's Field

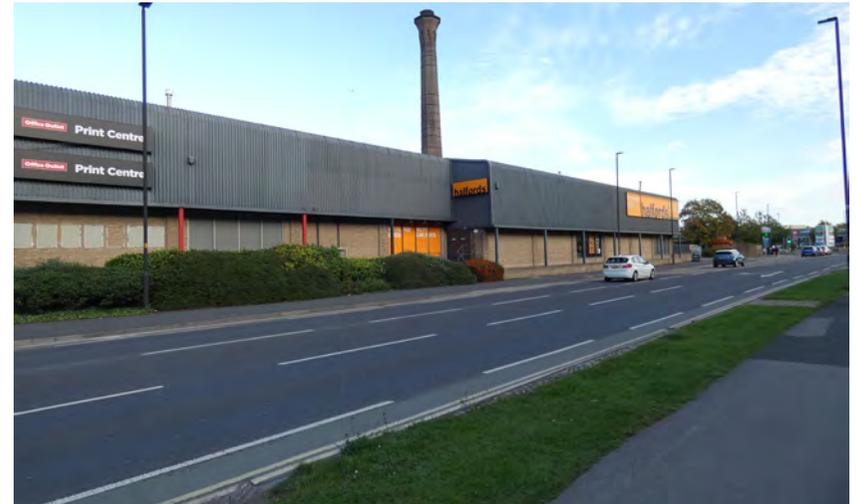
Sections 13-18 are lined by modern commercial development along Foss Island Road, Paragon Street, parts of Fishergate and Piccadilly. The 'Destructor Tower' (Grade II) is a key landmark in this otherwise low-scale area and features in many views. 20th century housing developments are also located within the setting, some of which contribute to the understanding of the historic development of the areas in relation to slum clearance, municipal housing and nearby philanthropic housing initiatives, however most of the later-20th century developments detract from the setting of the walls **[Plates 3.40 & 3.41]**.

3.40 Section 13, Late-20th century Commercial Development and the Destructor Tower beyond

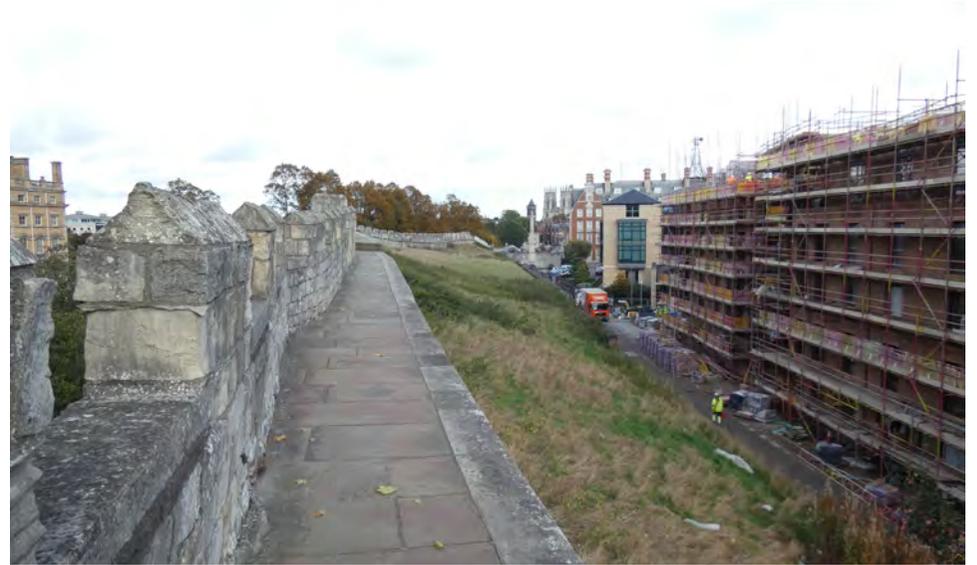
Inappropriately sited development and the lack of good design for modern structures has had an impact on views of or from the monuments. Examples of large-scale 20th and early-21st century development within the setting includes Stephenson House, Westgate Apartments and the CYC Council Offices near **Section 5**, the Barbican near **Section 15** and Travelodge near Fishergate Postern Tower - which visually compete in scale, in some cases use inappropriate materials and dominate the setting of the walls **[Plate 3.42]**. Recent developments within the setting of the walls include McQuade's Court adjacent to the wall walk in **Section 15** and Hudson Quarter Development adjacent to **Section 5**; both are situated close to the walls and dwarf them in scale and, in the case of the latter, visually compete with the parapet of the walls in views from the station **[see Plates 3.23 and 3.43]**.

3.43 Section 5, Hudson Quarter Development

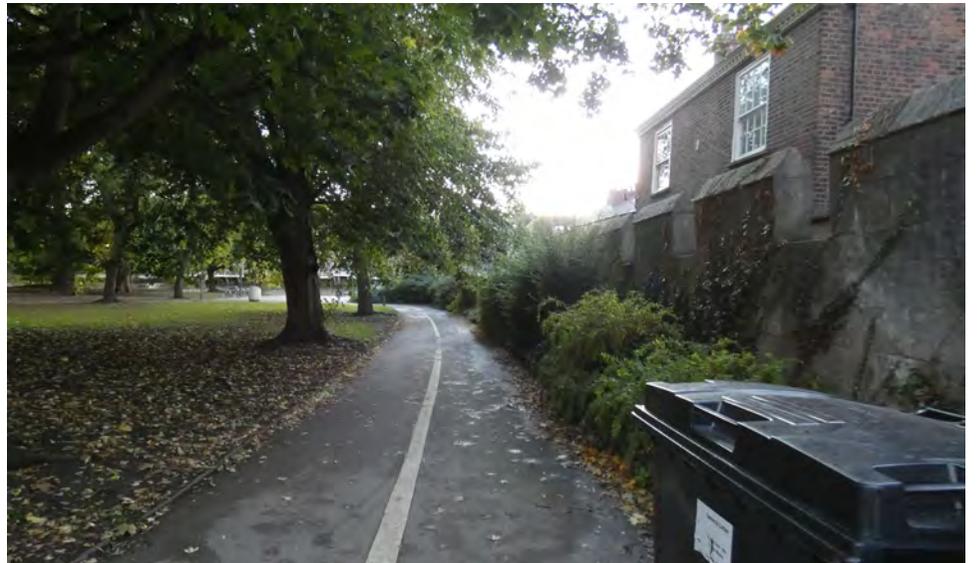
Furthermore, unmanaged trees and planting detract from the setting or conceal key views such as those in **Section 10** towards the Minster and to the rear of Gillygate and planting within St George's Field (**Section 19 [Plate 3.45]**).

3.45 Section 19, Planting and bins adjacent to City Wall

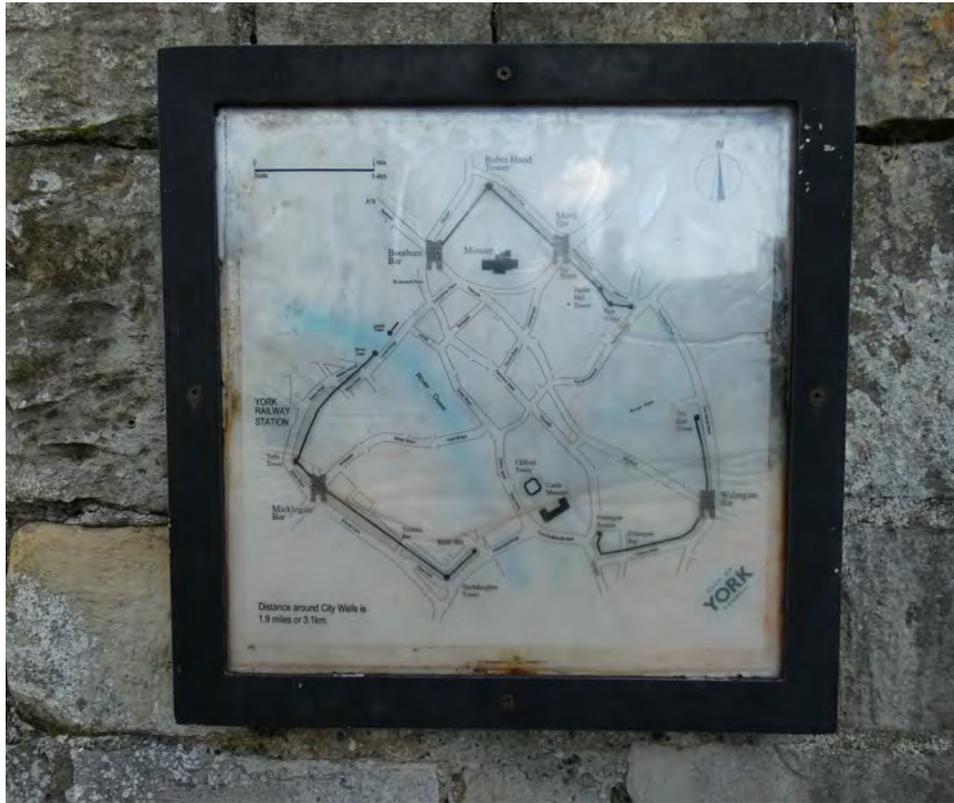
3.47 Section 14, Sun-faded map at Red Tower

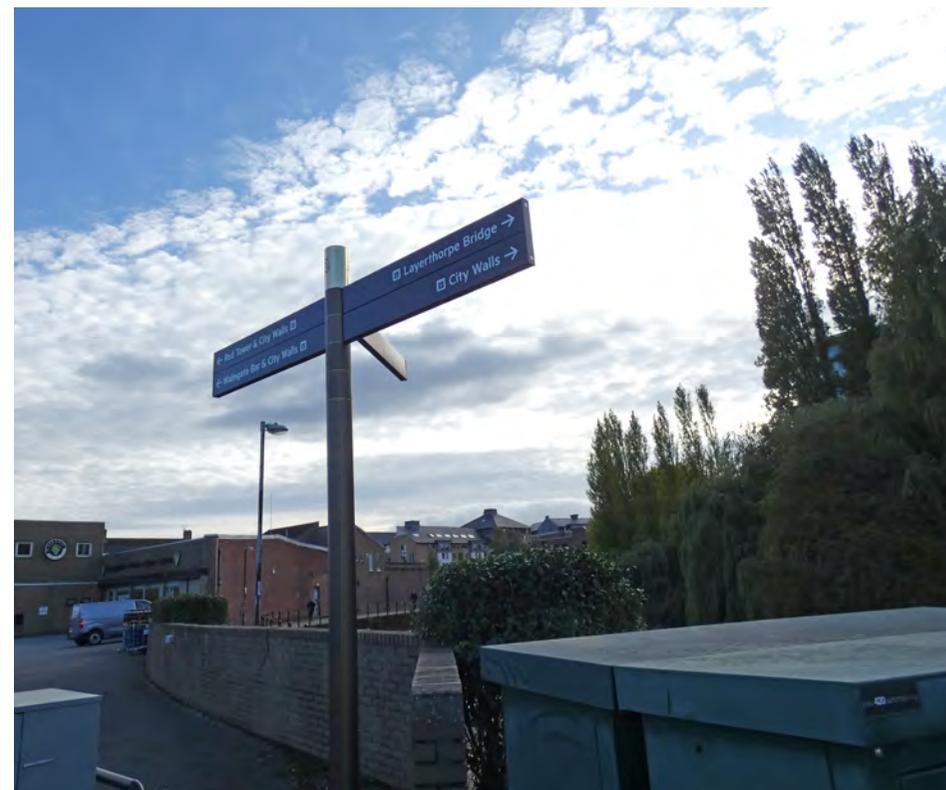
A signage survey of the walls was conducted in 2002 and it appears that no overarching review has been carried out since the installation of the interpretation boards in c.2006. While they have certainly helped to improve the consistency and presentation of information about the walls, the panels are still limited in their accessibility - as noted below there is little in the way of information for those who are visually impaired. Naming of the key features, bars and towers could be improved across the wall circuit, and could be done with subtle, tactile signage. Successful new finger post street signage, which directs visitors towards the wall walk or its key features, has been introduced in a few areas as part of a city-wide signage strategy (part-implemented), namely by the Red Tower, on Rosemary Place and Palmer Street within the Hungate development area [**Plate 3.49**].

3.49 Section 13, new CYC street sign

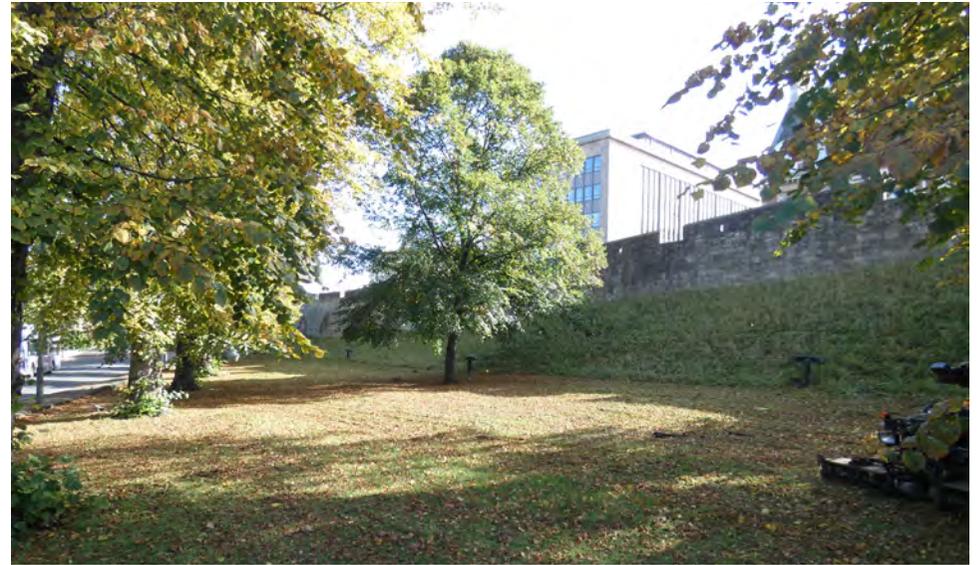
3.58 Section 5, Erosion to rampart

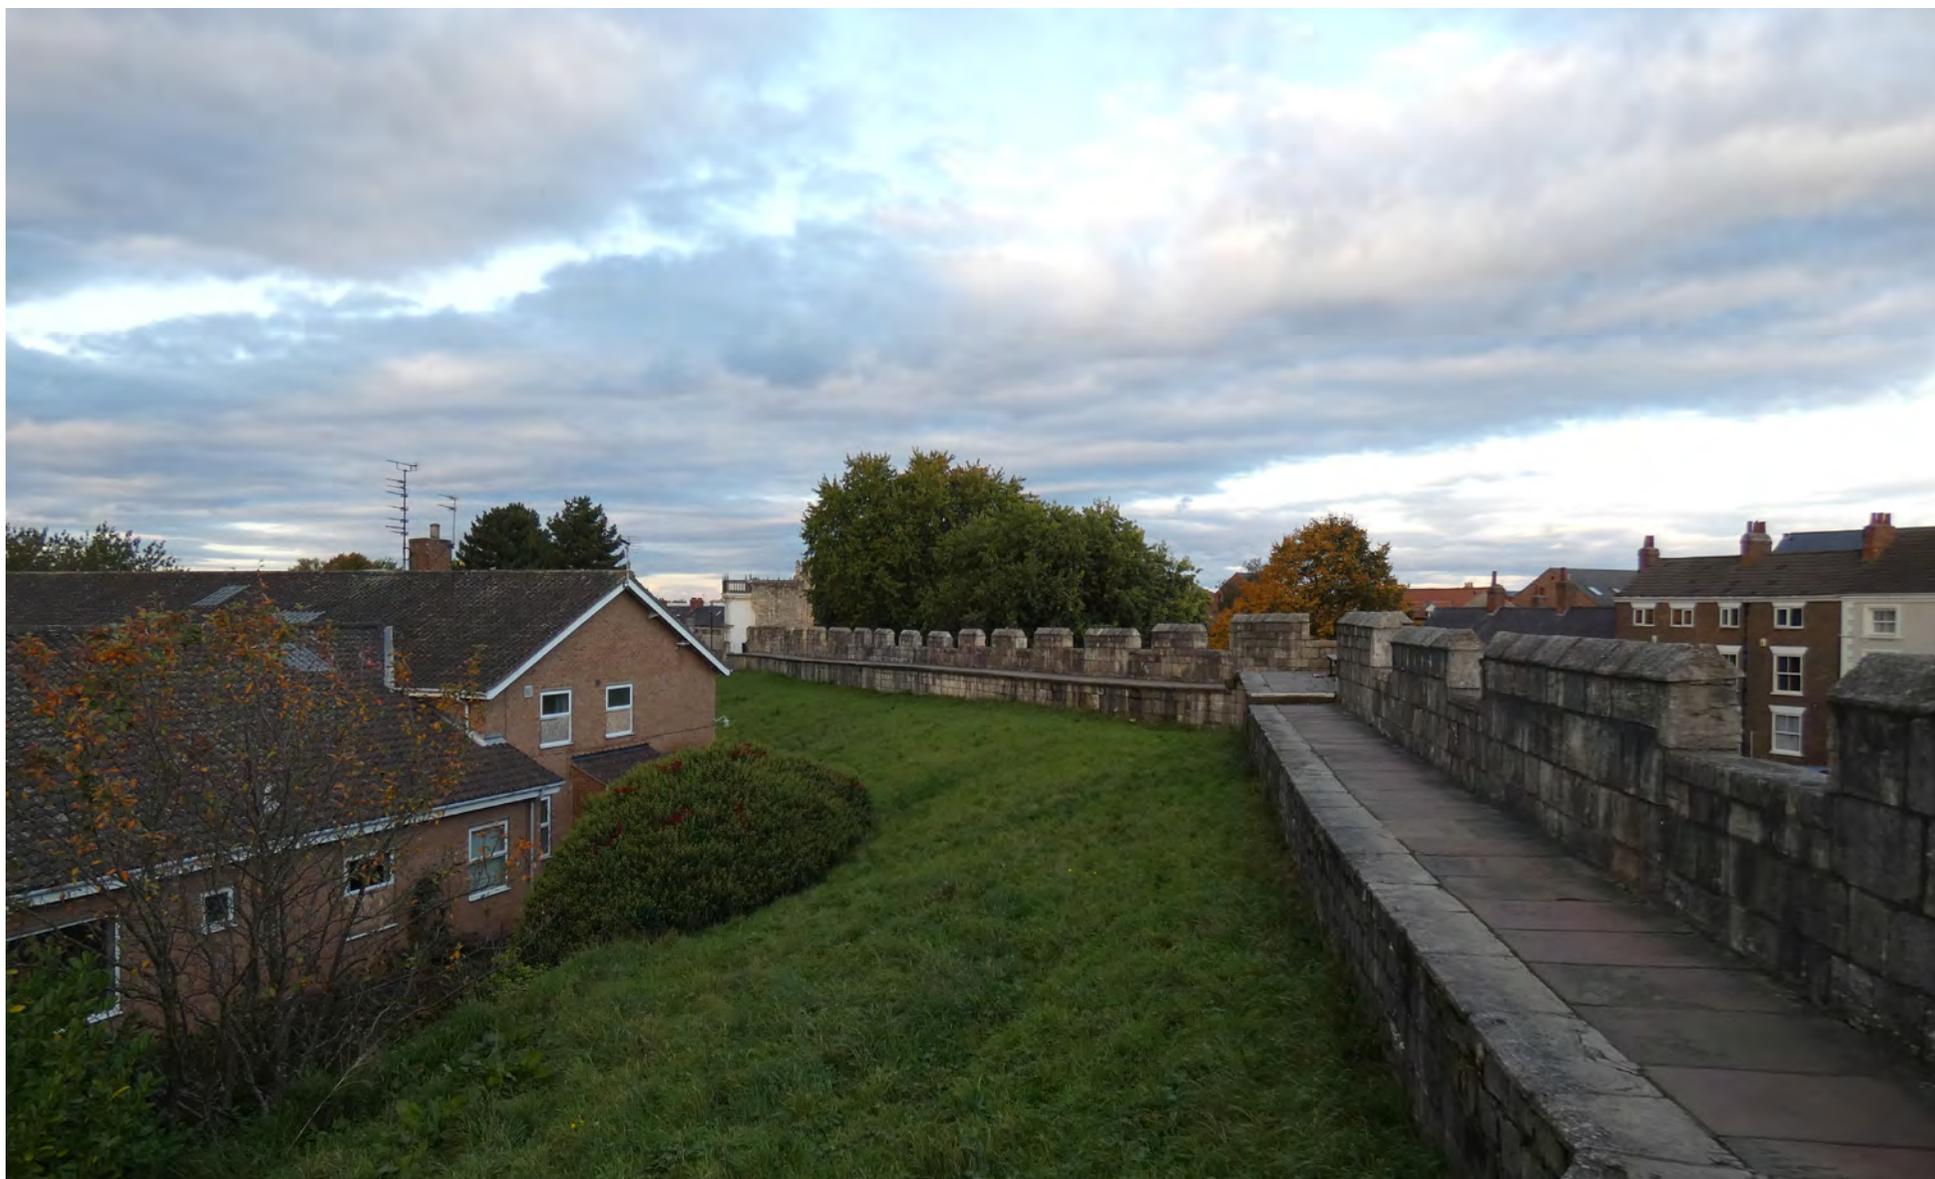
3.60 Section 17, 1970s housing development cutting into ramparts

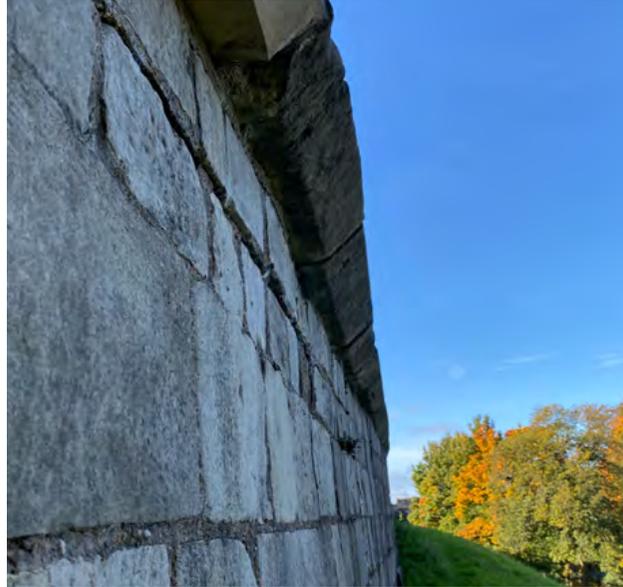
Edge stones moving outwards

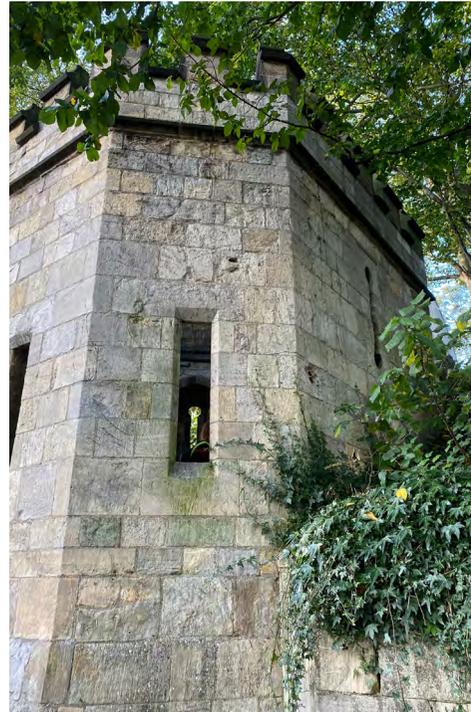
Element	Rating	Comments
External Masonry	M2	Ivy growth to north side. Blocked arrow slit to north side. Trees in close proximity to crenulations. 3no. heavily weathered stones. Cut off railings to entrance steps causing cracking to the surrounding stone from rust jacking. Low level wall to north side has 1 movement crack along joints. Crenelated stones appear to be Victorian sandstone.
Internal Masonry	M2	Eroded stones to reveals of windows (assumed from wind erosion ¹). Vegetation growing at high level. 3 rusting fixings on north side. Steps to access walk way in good condition.
External Mortar	P2	Low level mortar missing at base above tarmac pavement. Low level wall to north side has open joints and 1 large movement crack and one fractured quoin from rusting cramp.
Internal Mortar	P1	Few areas of cementitious repair but no obvious accelerated decay. Generally flush and sound.
Flagstone (walkway)	F1	Entrance steps weathered but fair. Landing is pooling water and could drain water better.

North side vegetation growth and stone weathering

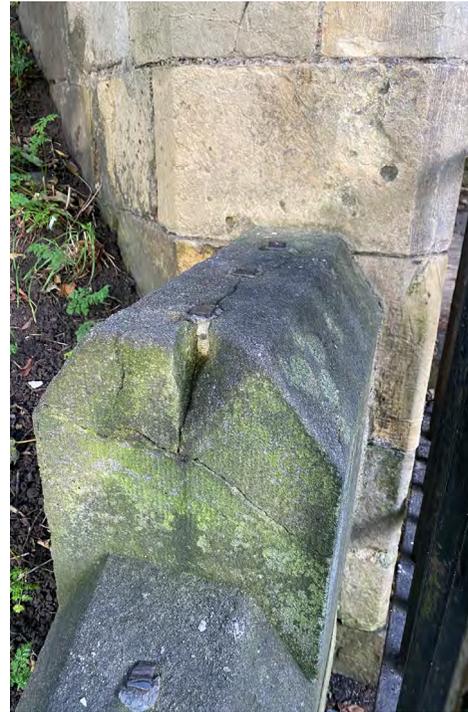
Rust jacking to removed railings

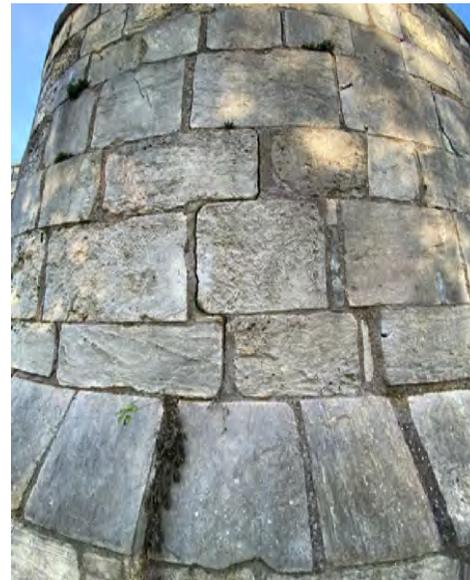
Element	Rating	Comments
External Masonry	M4	Major movement cracks all around.
Internal Masonry	M4	Large movement cracks
External Mortar	P4	Open joints along movement cracks. Brittle cementitious mortar (pebble dash).
Internal Mortar	P4	Large movement cracks
Flagstone (walkway)	F4	Large cracks opening up and mortar falling in.
Railings		No railings
Doors		No internal room
Railings	RA2	Missing iron railings to entrance steps on one side. Modern tube hand rail. Rusting painted railings on north side of steps.
Doors	D1	Black painted metal gate.
Windows	W2	Open openings. See Internal masonry notes above.

South elevation cracking

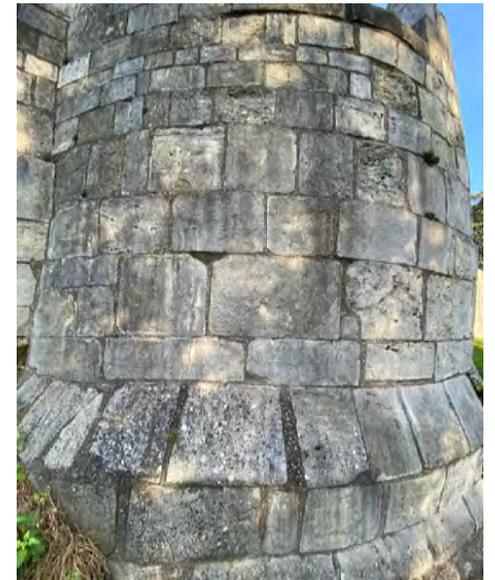
South west side with historic movement

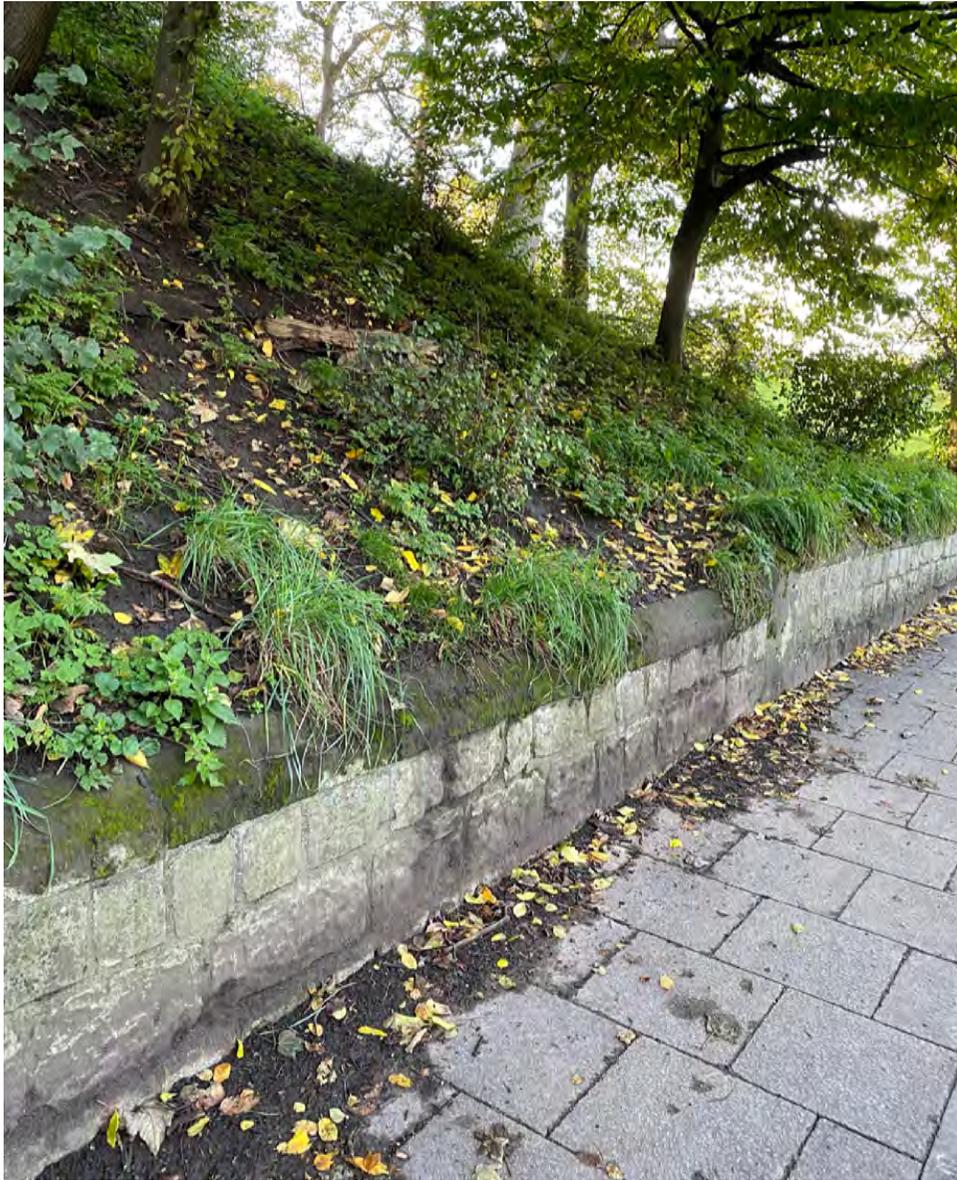
Element	Rating	Comments
Internal Ramparts (earth)	R2	Circular mound (motte). Mature sycamore trees cover the slope holding the ground together. Rotten timbers believed to be for retaining. Low retaining stone walls at pavement side. Earth from mound is beginning to go over the top of the wall. Flat grass covered top to mound with clearing within the trees. Mud paths give access to the top. No direct access (locked gate and rotten timber steps) to or from the wall walkway although well used as a short cut by locals.
Railings	RA1	1.8m grey painted railings with sharp finials separate the motte from the wall walkway.
Features		Has an archaeology survey been carried out?

Earth migration over perimeter wall

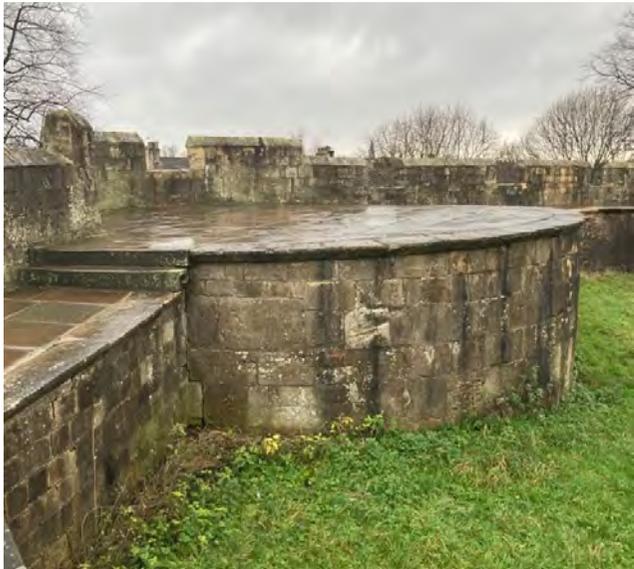
Element	Rating	Comments
External Masonry	M3	Fair condition. Few fractured stones. Movement cracks to joints with wall on either side
Internal Masonry	M2	Weathered in controlled way. Cracked sill stones.
External Mortar	P3	Cementitious mortar and movement cracks to joints with neighbouring walls.
Internal Mortar	P1	Cementitious but in good condition.
Flagstone (walkway)	F2	Few failed joints.
Railings		No railings.
Doors	D4	Rotten thick planked timber door. Metal cage door over. Both doors broken with ply door over for security.
Windows		No windows
Ceiling	C3	Very wet stone barrel vaulted ceiling.
Internal Walls	I2	Wet stone walls assumed to be causing accelerated decay mechanisms.
Internal Floors	FL3	Earth floor with debris.
Features	FE1	Stone fire place in north west corner. No accelerated decay mechanisms.

Cracking to east junction with wall

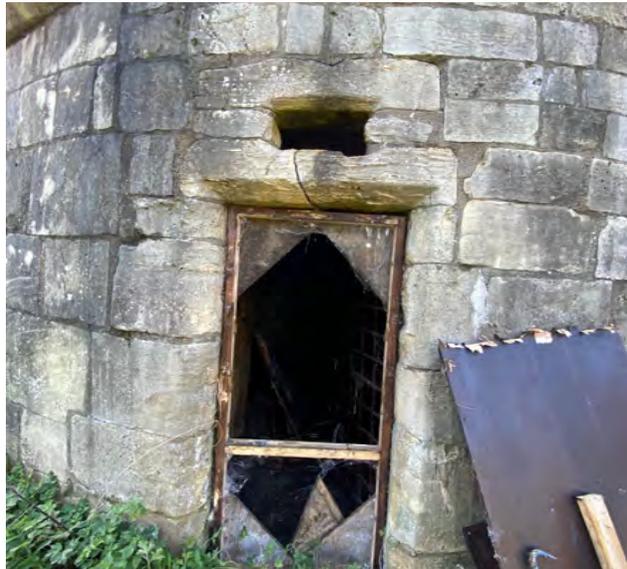
Entrance with cracked lintel

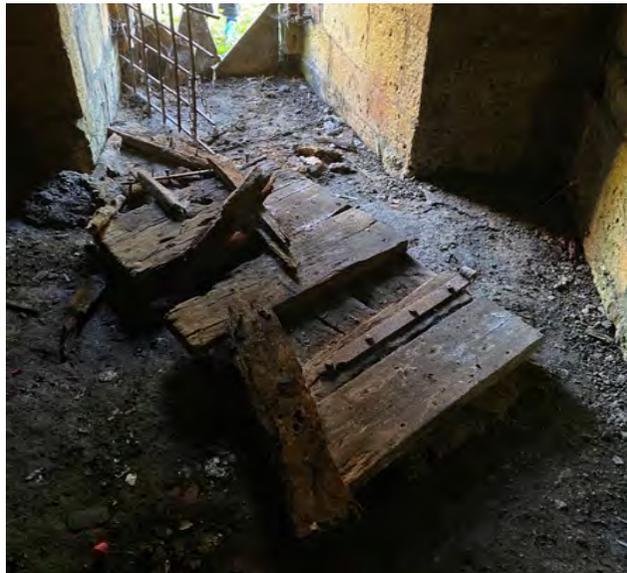
Rotting timber door

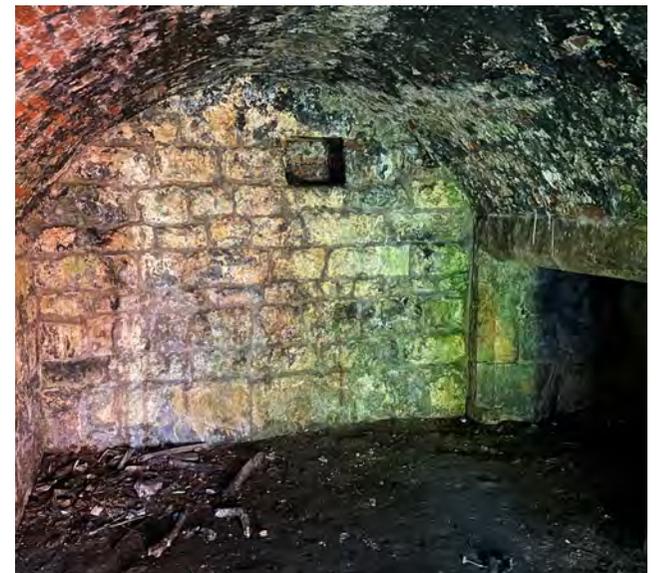
Saturated internal room

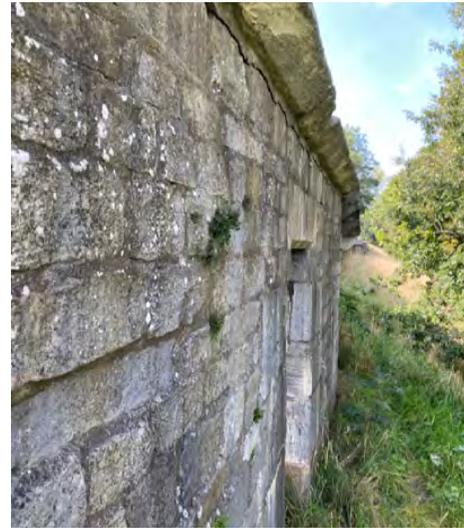
Mortar joint below edges stones moving outwards

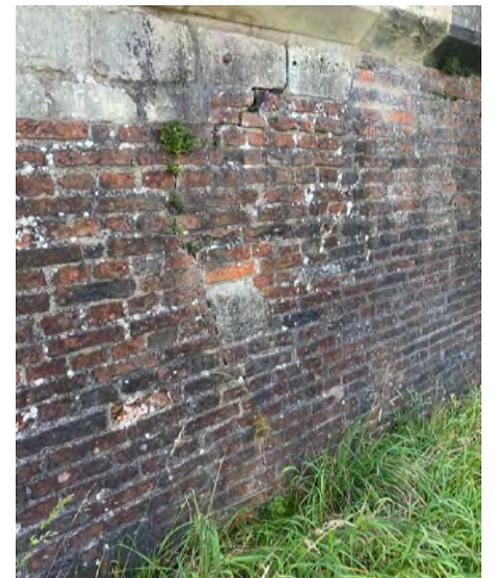
Vertical cracks through infill structure

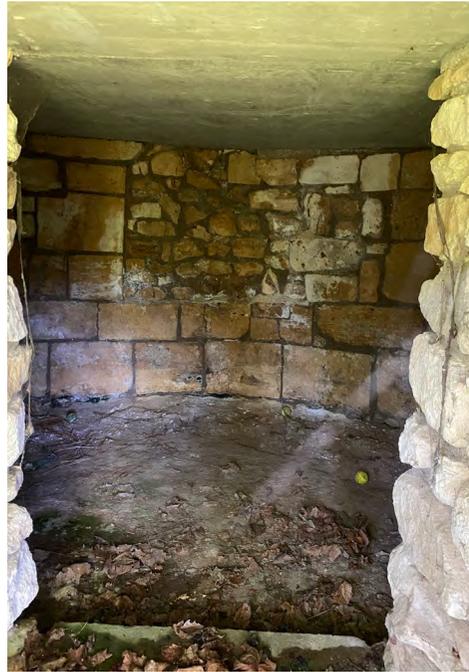
Interior with concrete ceiling

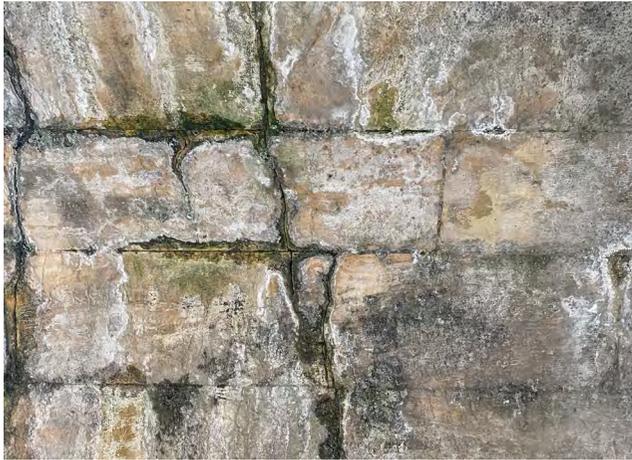
Door	RO2	Metal gate's black paint finish has failed and is rusting.
Features	FE3	Arches: salt movement at high level from water ingress. Few fracturing stones. Algae growth at low level. Cracks through southern arch. Cracks to exterior of northern pier which has 5 cracked stones.

Cracks along stone arches

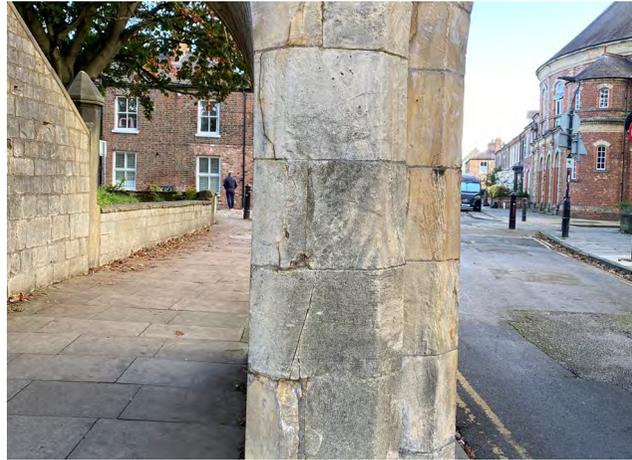
Fractured stones to archway piers

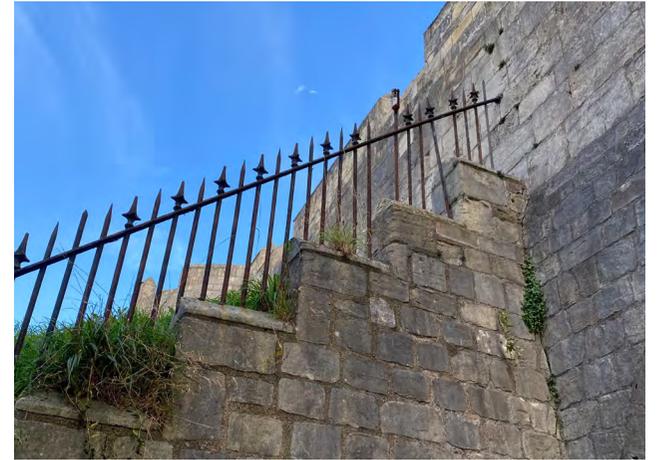
Missing railings

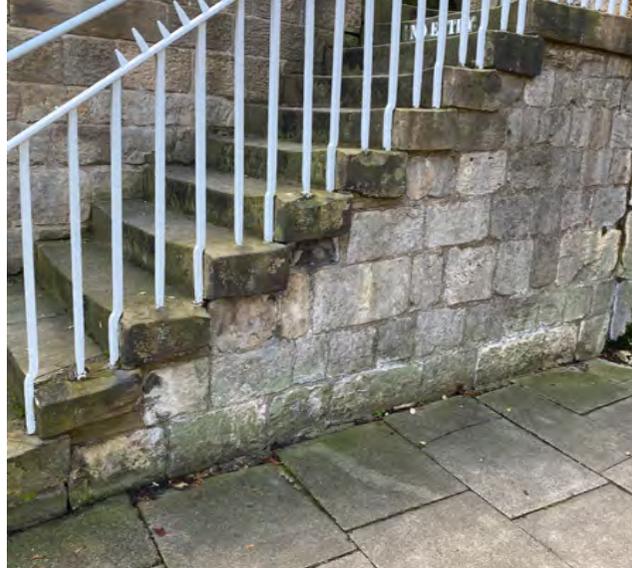
Element	Rating	Comments
External Masonry	M1	Fair condition. See condition of arches below.
Internal Masonry	M2	Brick structure for steps on south side. Edges of multiple steps have cracked from metal railings expanding. Vegetation and moss growth over arches below walkway caused by water ingress and saturated masonry. See condition of arches below.
External Mortar	P1	Fair condition. See condition of arches below.
Internal Mortar	P2	Salt movement under brick steps. Cement mortar repairs at low level in arches. See condition of arches below.
Flagstone (walkway)	F1	As Section 3 notes
Railings	RA3	Internal Railings: Modern railings with square top along walkway. Spikes to stone copings at low level of staircase give an aggressive atmosphere to the Bar and causing damage to stones. Historic railings at low level with spikes. Modern round handrail to internal face. External Railings: metal railings to northern side have almost lost all their paint finish and are rusting with 2 missing and 2 broken spindles.

Rust jacking

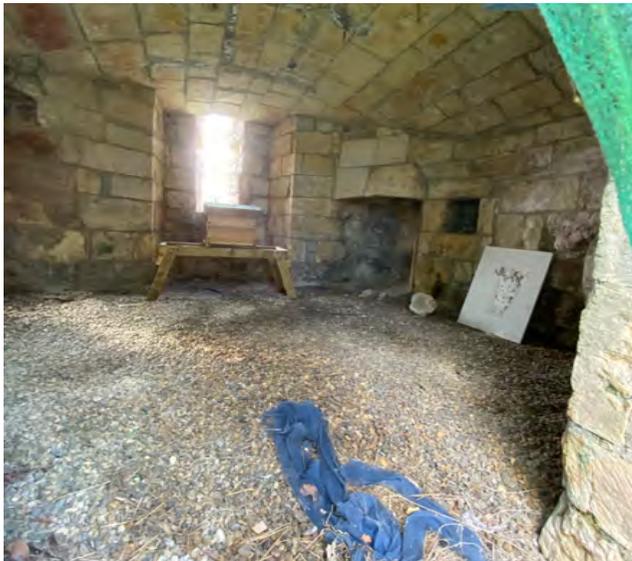
Element	Rating	Comments
External Masonry	M2	Fair condition. Few individually eroding stones. Two spalling stones to arrow slits.
Internal Masonry	M1	Fair condition. Salt movement staining.
External Mortar	P1	Fair condition. Cement pebble dash mortar.
Internal Mortar	P2	Brittle cement mortar with cracks and vegetation.
Flagstone (walkway)	F3	Recently replaced edge stones in cement mortar have moved out by 2cm. Wide cracking joints. Few broken corners to flags.
Railings		No railings
Doors	D2	Rusting metal gate. Locked. Netting to inside face for bees.
Windows	W1	Vertical iron bars. Otherwise open.
Ceiling	C2	Stone barrel vaulted ceiling. Salts showing water ingress.
Internal Walls	I1	Exposed stone in good condition.
Internal Floors	FL1	Gravel finish. Dry. Bee hive.
Features	FE1	Corner fireplace. Assume erosion within chimney due to evidence of stone dust pile on floor.

Fireplace

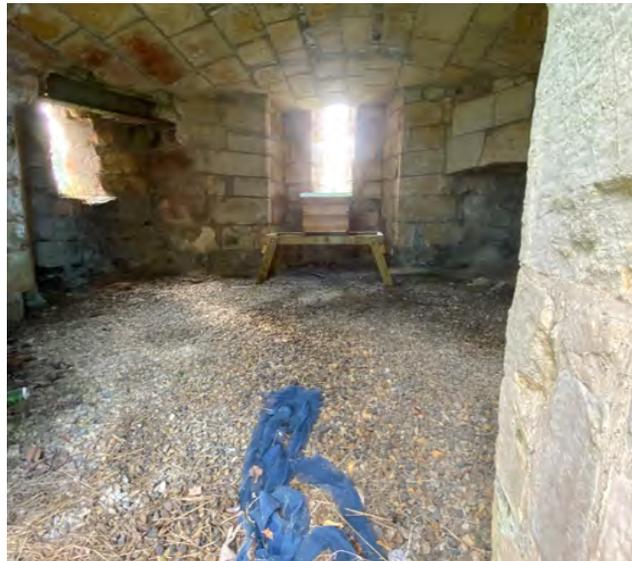
Steel lintel to embrasure

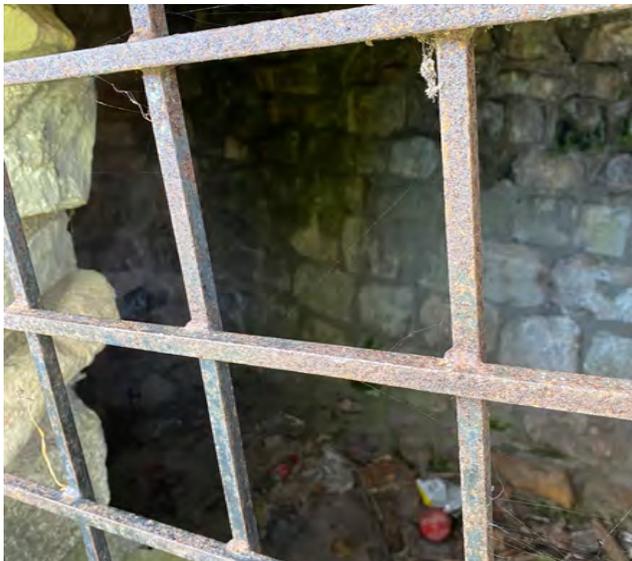
Rusting metal cage door, small internal area with no embrasures

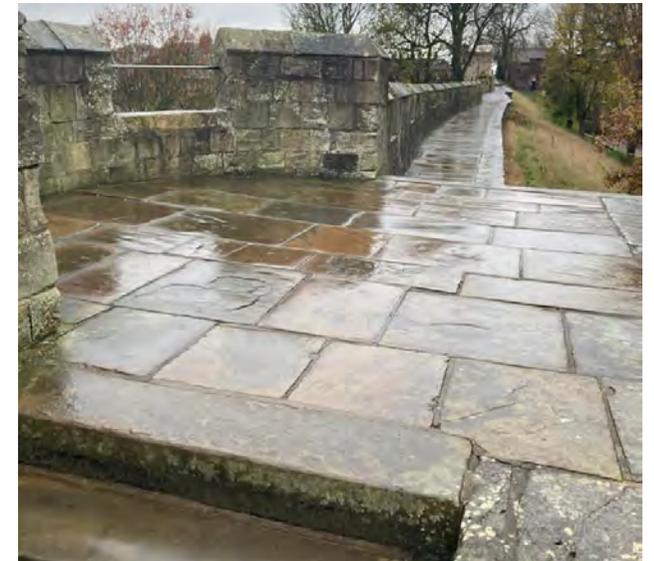
Metal bars to crenels

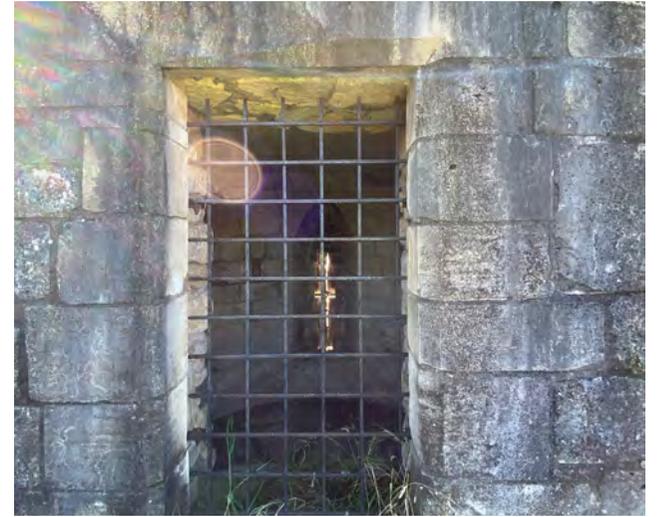
External entrance with fractured lintel

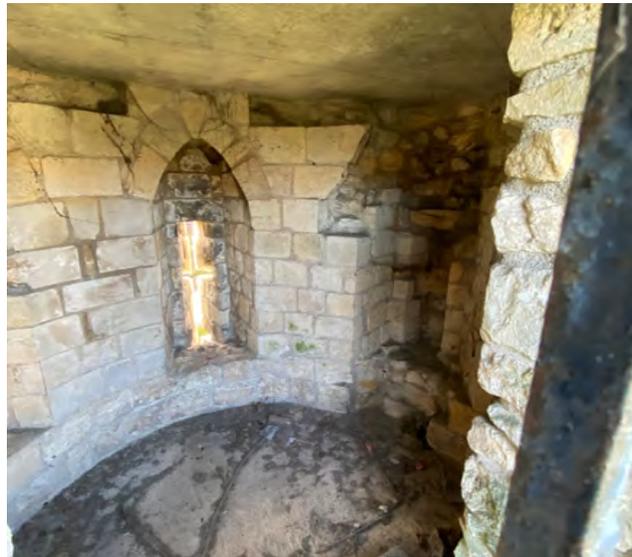
Missing masonry details to embrasures

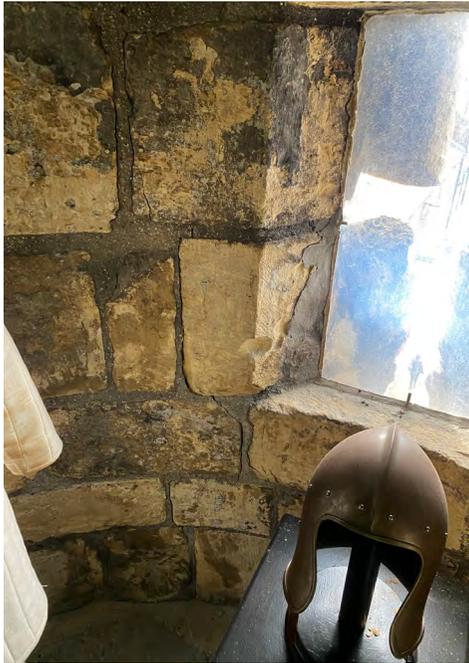
Cracks within turrets

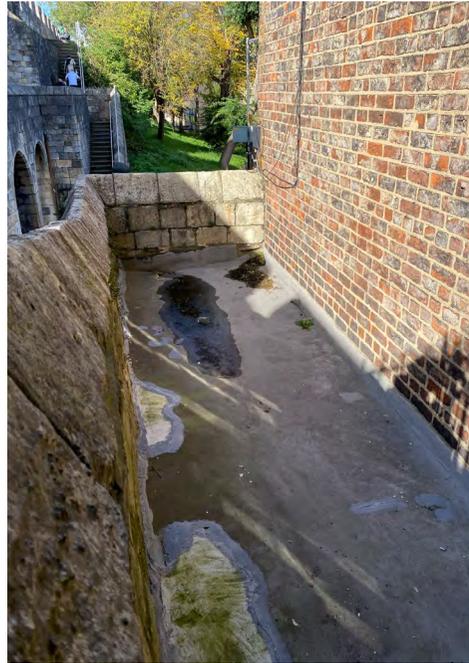
Failed asphalt roof next to eastern stair

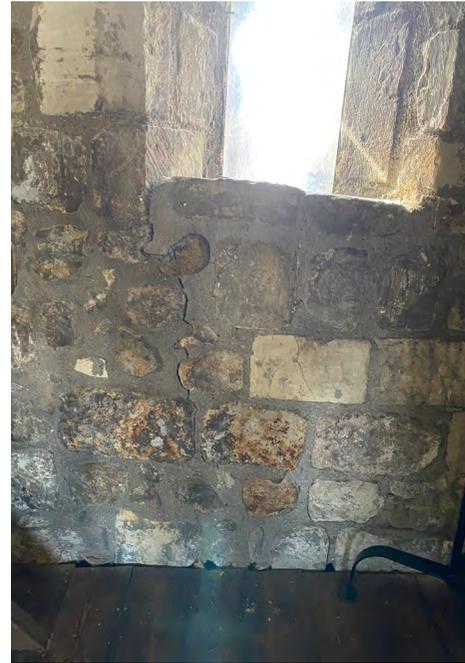
Internal cracking around windows with cloudy Perspex

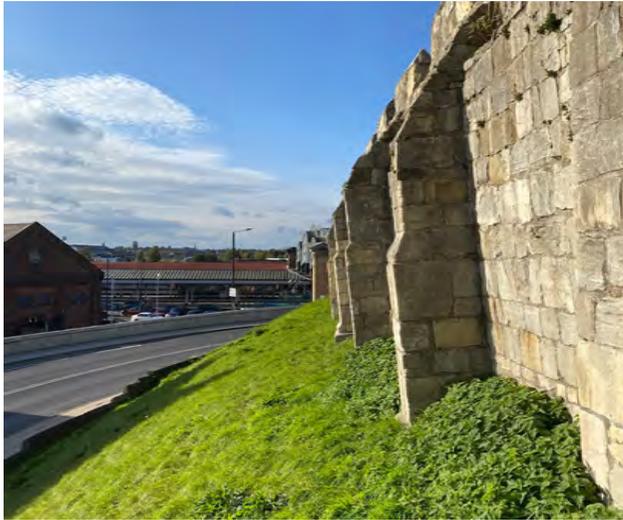
Dramatic leaning of wall east of Tofts Tower

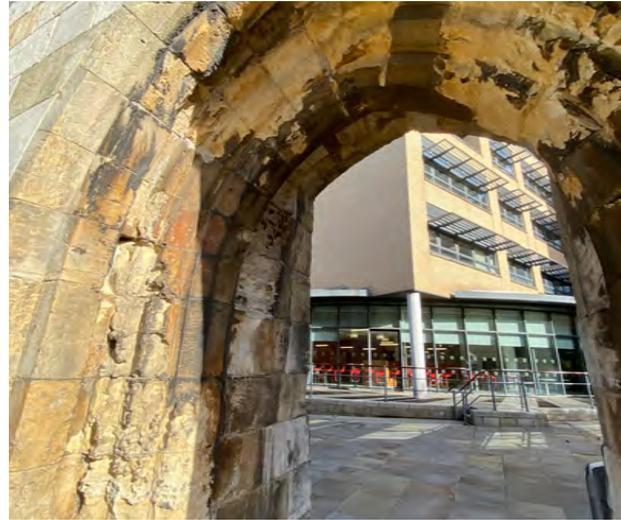
Heavily weathered stones to Victorian pedestrian arch between railway arches

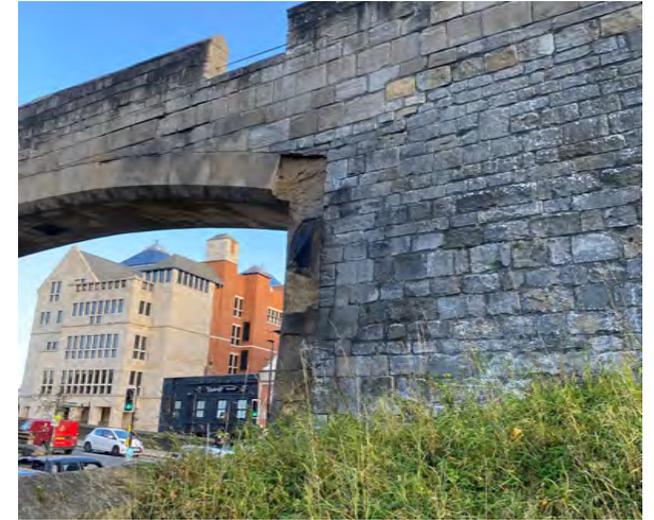
Spalling stone from rust jacking from concentrated water
