York Walls

Conservation Management Plan
for the City of York Council

November 2021

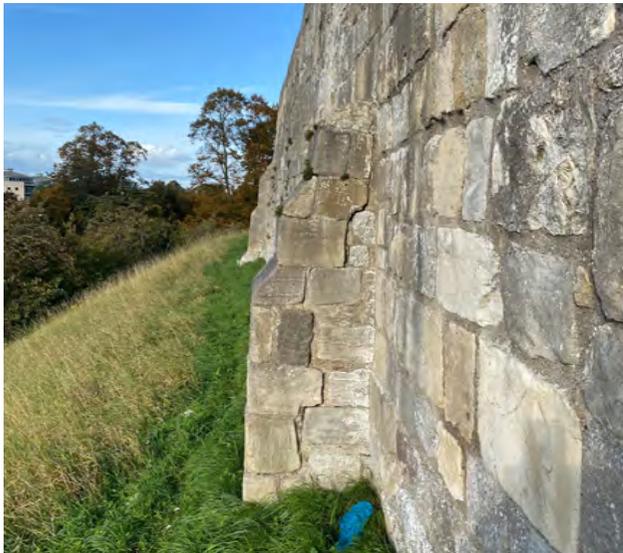
Structural movement to buttress between Tower 15 and 16

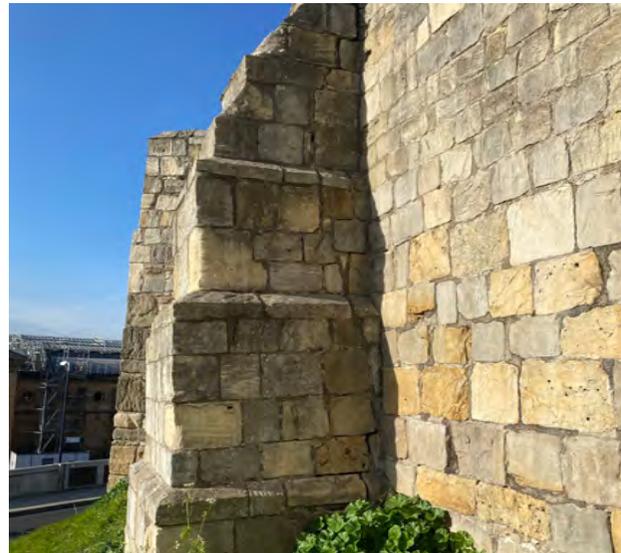
Structural movement to buttress next to Tofts Tower

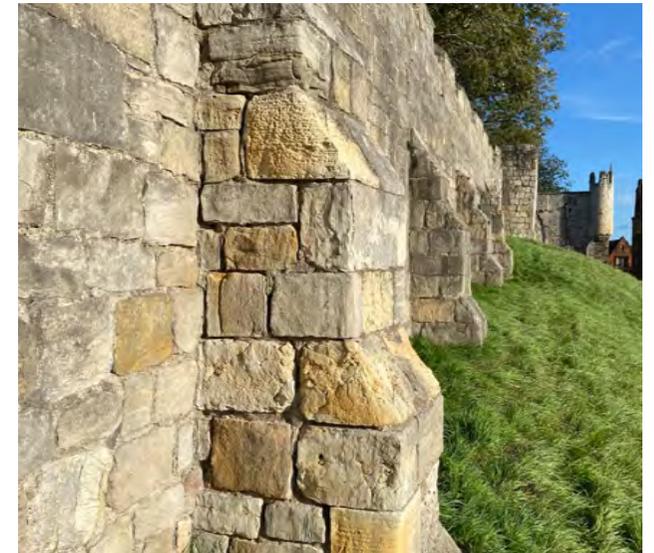
Element	Rating	Comments
External Masonry	M4	Open joints to first buttress from Micklegate bar showing signs of movement. Most to all buttresses on wall between Tofts Tower (Tower 13) and Micklegate Bar have large movement cracks running through them vertically. The buttresses at the Tofts Tower end are leaning out dramatically. There are also a number of vertical cracks in the wall in this area. 1 number eroded sill to crenel south of Tower 12. Stones to railway arch are eroding and losing their sectional depth caused by water tracking down through the structure or down the wall faces. 1 number eroding stone over railway arch. Corroding metal fixings at low level at base of railway arch. Stone doorway reveal and pointed arch between railway arches is heavily eroded. Rusting fixings at high level above doorway. Western road arch (built 1874 chainage 1120-1150) has 7no. stones that have lost all or some of their faces caused by a concentration of water to the eastern top corner causing metal cramps to corrode and expand. Stones eroding around movement crack east of western road arch (Built 1874 chainage 1120-1150). Historic movement crack west of western road arch (Built 1874 chainage 1120-1150). Buttress on 1000m chainage has evidence of movement with slipped footing stone. Movement crack east of buttress between Tower 15 and 16. Small buttress east of Tower 15 has significant movement cracks. Movement crack east of old Victorian signal box.

Structural movement to buttresses between Micklegate Bar and Tofts Tower

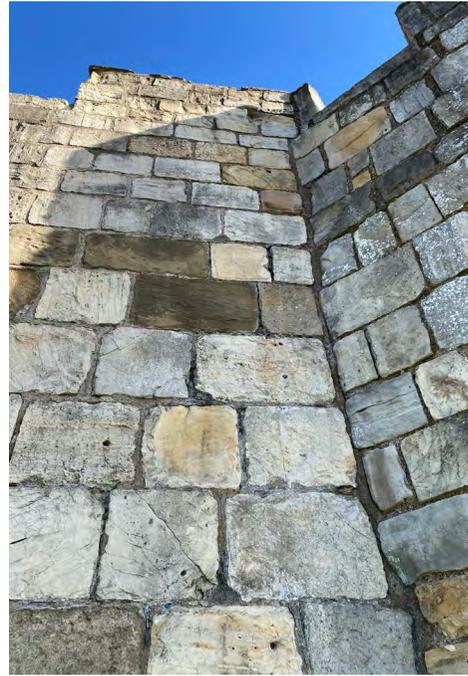
South eastern elevation vertical crack

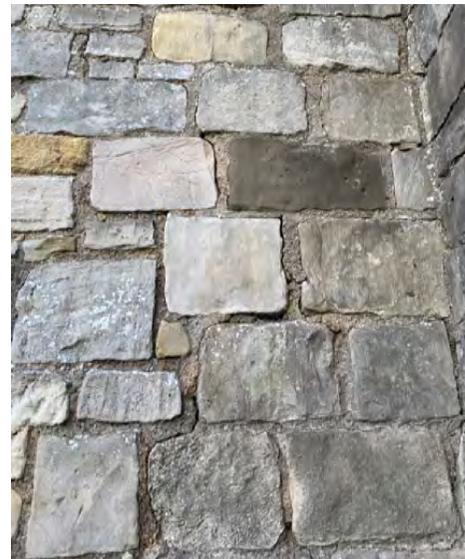
Significant movement crack to south west elevation

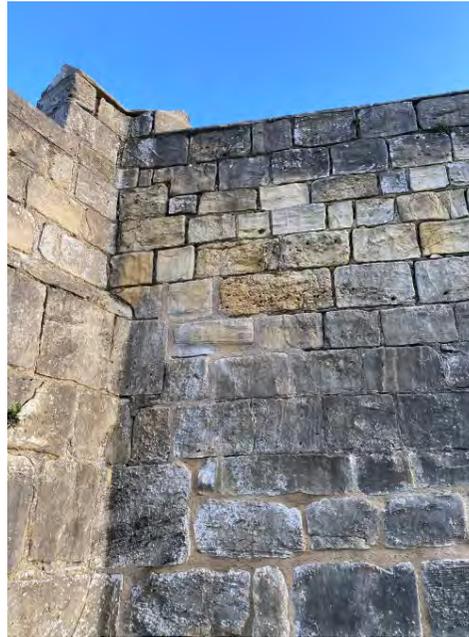
Open joints to southern wall connection

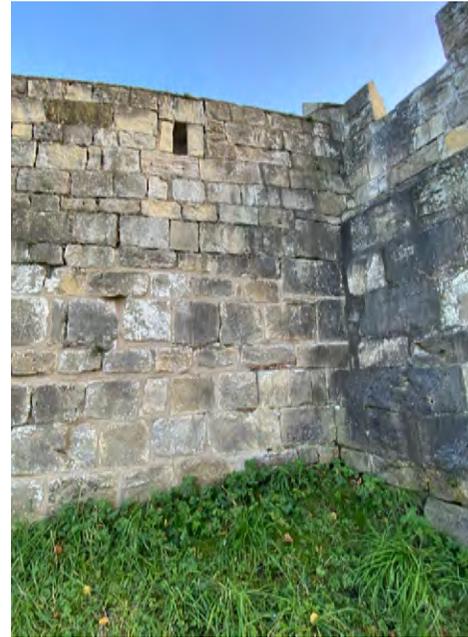
Open joints to wall north of tower

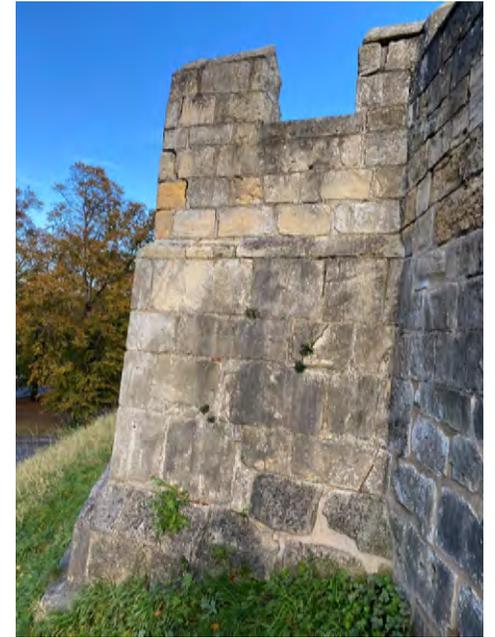
Structural cracks to south west elevation

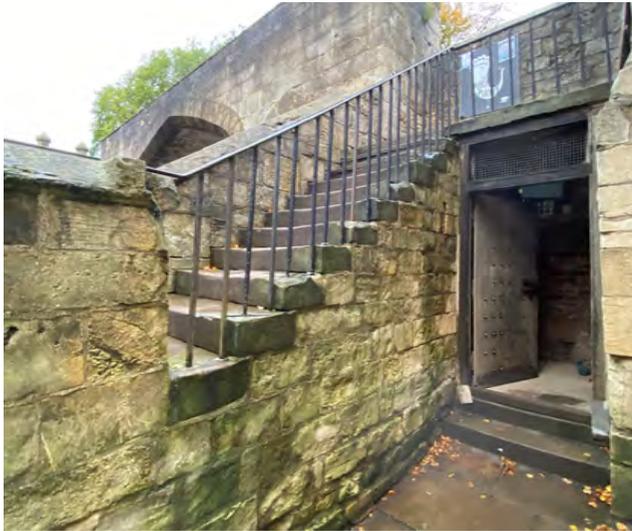
Fractured stones to steps from rust jacking to railings

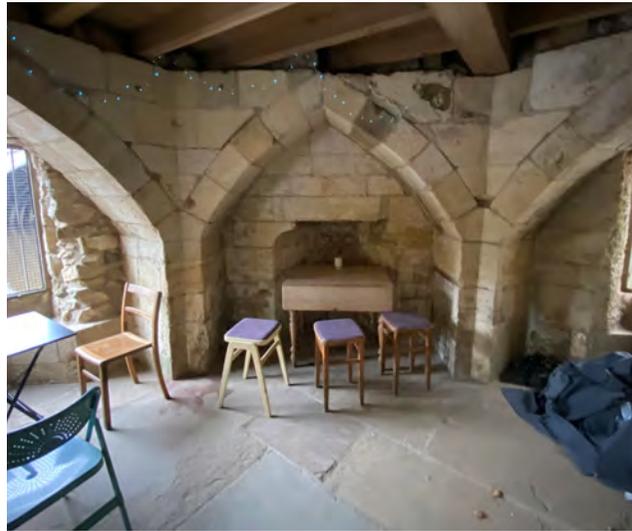
Ground floor fireplace and windows

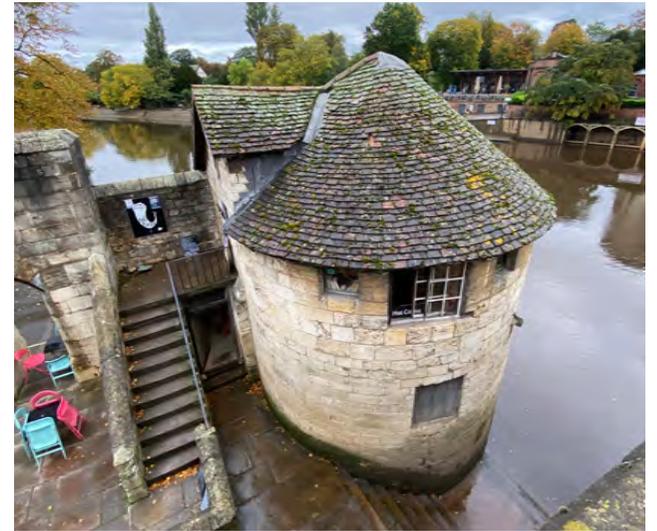
Roof	RO2	Clay tiles, covered with moss growth. Timber barge boards beginning to rot. Number of cracked and slipped tiles.
Doors	D1	Lower timber door in fair condition. First floor the same and in good condition.
Windows	W2	First Floor: Fixed and Yorkshire sash windows. Ground floor openings have metal mesh grilles within gothic arch reveals.
Ceiling	C1	New exposed oak structure at ground level. First floor exposed timber roof structure, painted white plaster between rafters.
Internal Walls	I1	Exposed stone walls in good condition. Ground floor low level shows signs of algae growth but generally dry.
Internal Floors	FL1	Stone flag floor at ground floor. New oak boards under stone flags at first floor.
Services	S3	No running water. Water currently collected from another site and carried into the tower. Floods once or twice a year.
Features	FE1	Fireplace at ground floor. No running water! Floods once or twice a year.

Moss growth and missing tiles to roof

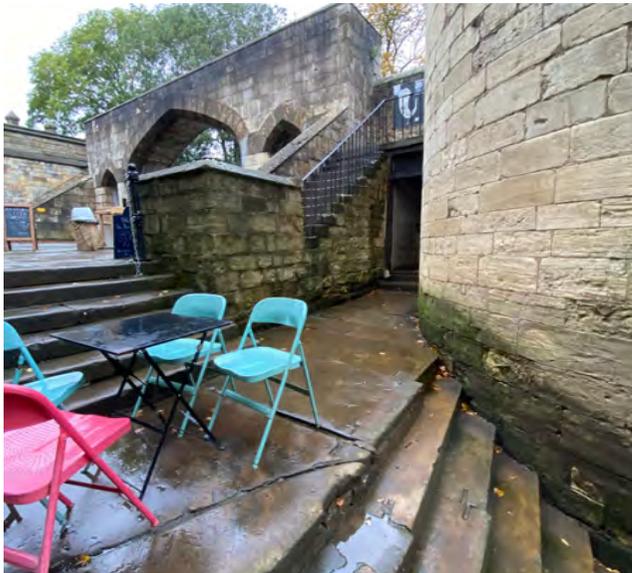
Movement to steps to river with missing cramps

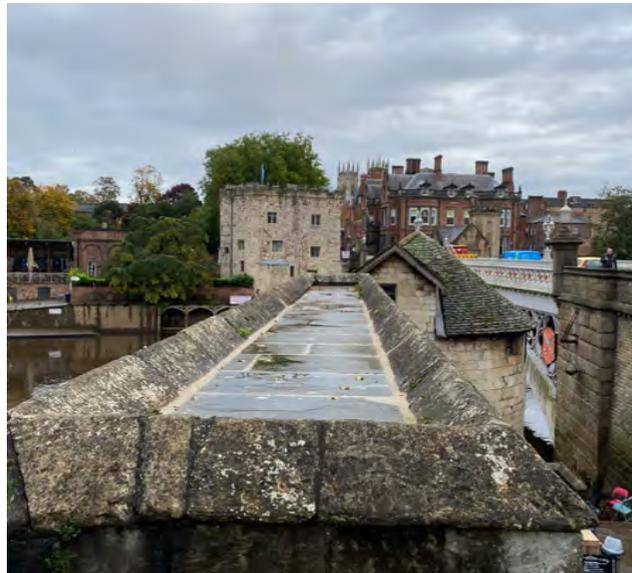
Roof over road arch

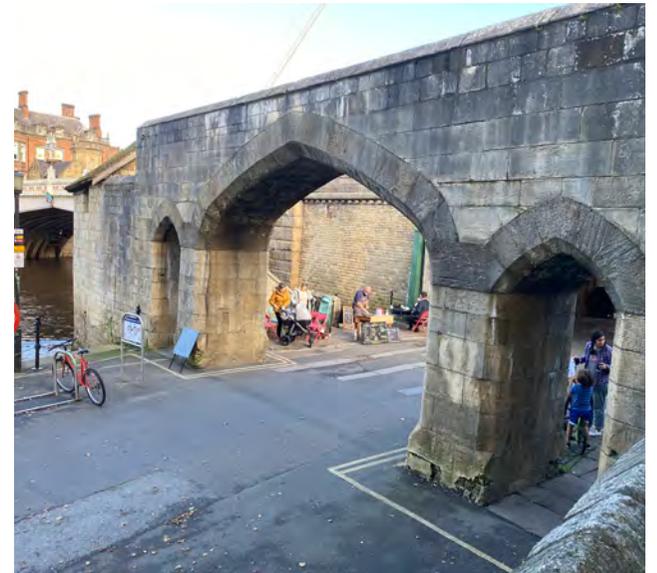
Water saturation to stones of road arch

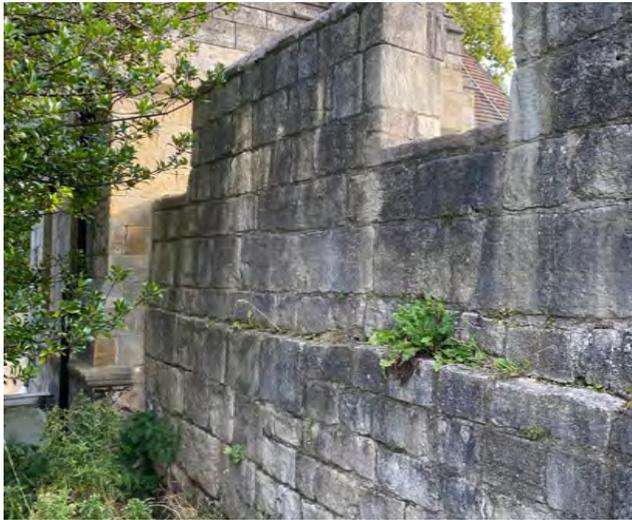
External wall with horizontal ledge

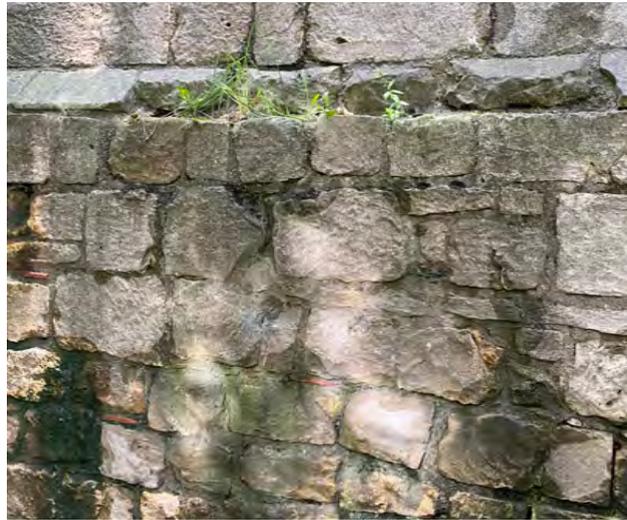
Fractured stones allowing vegetation growth

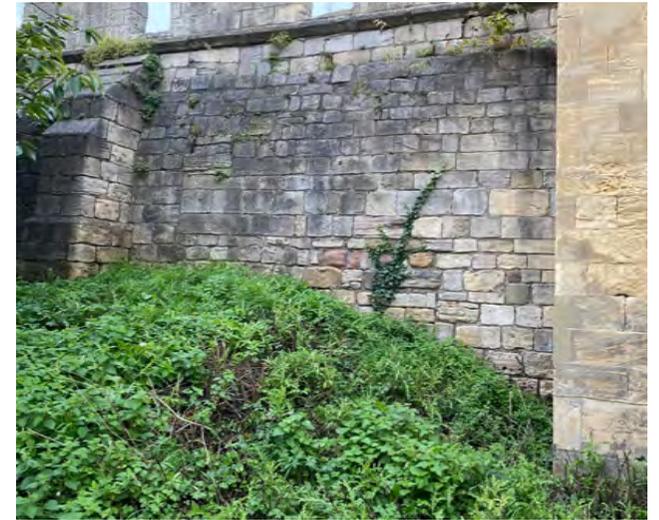
General open joints and vegetation growth

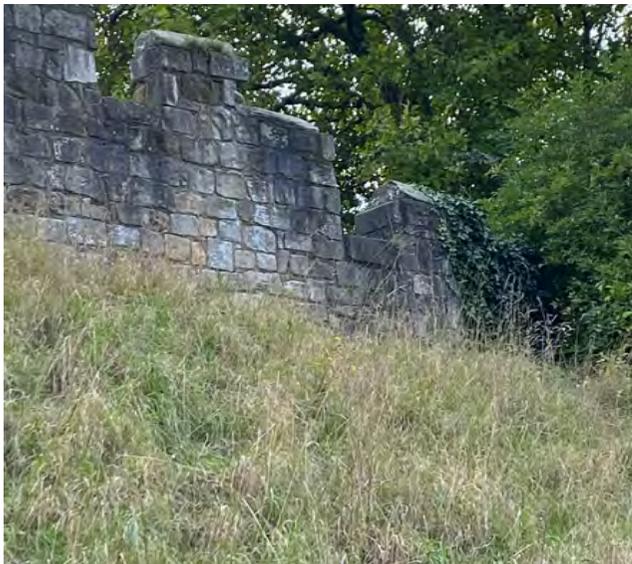
Missing section of merlon

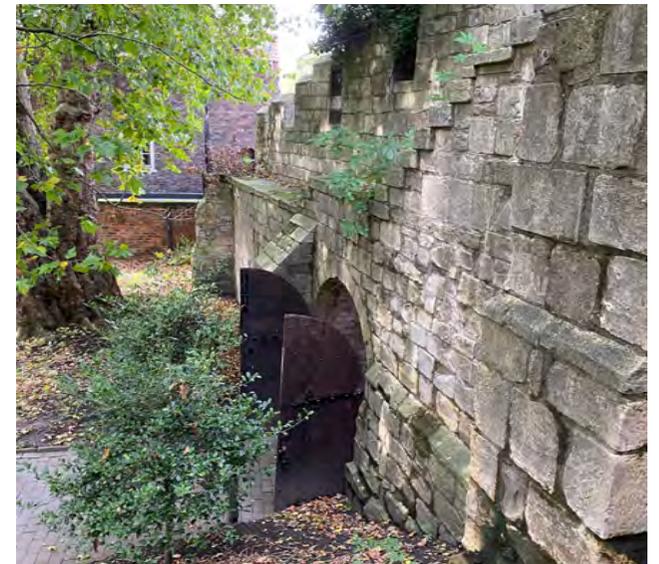
Vegetation to walkway

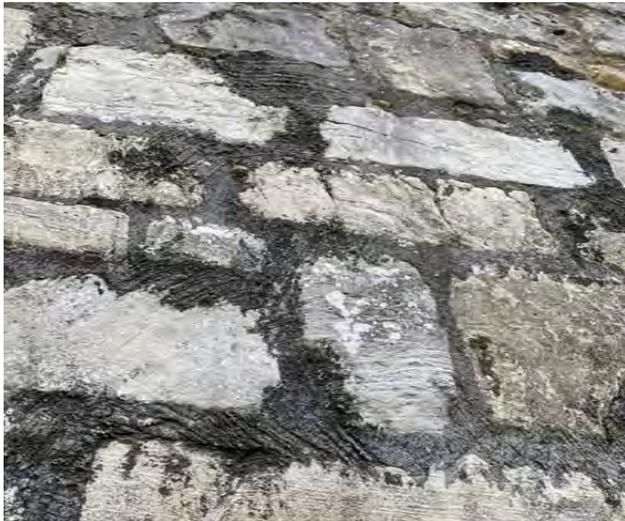
Dark cement mortar north of Multiangular tower

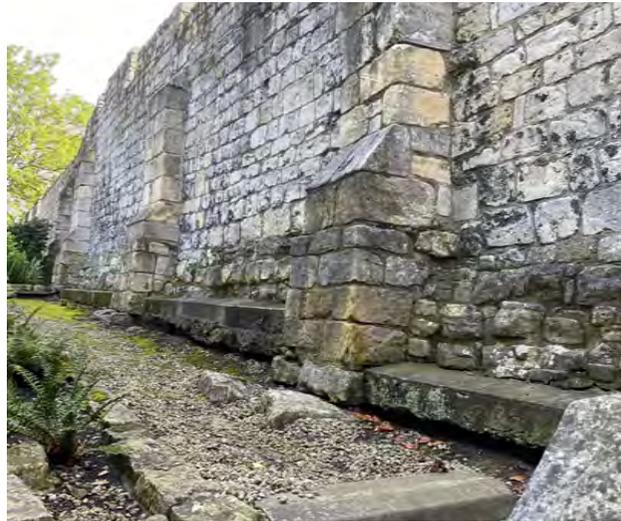
Erosion from under concrete footings

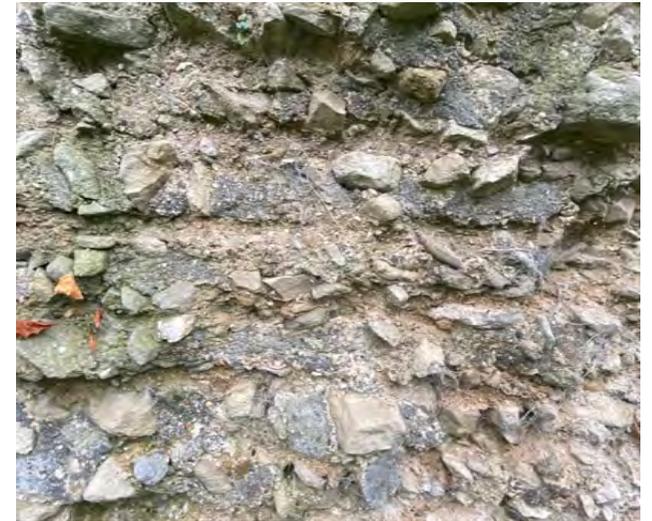
Exposed rubble wall actively falling away and eroding south of multiangular tower

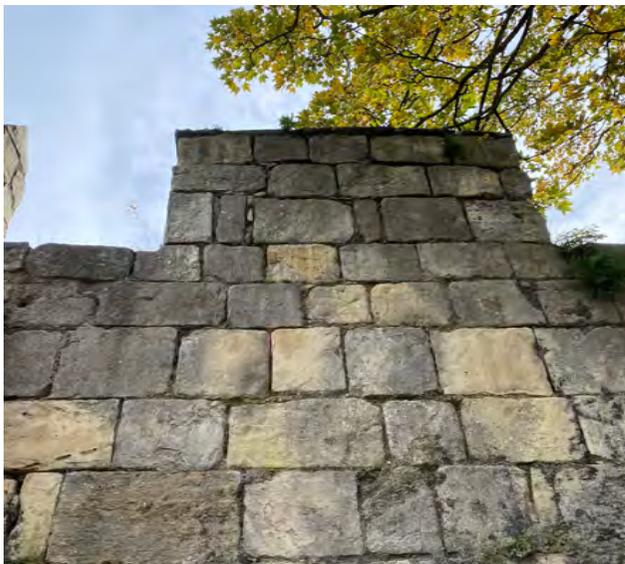
Open joints to merlon opposite Kings Manor

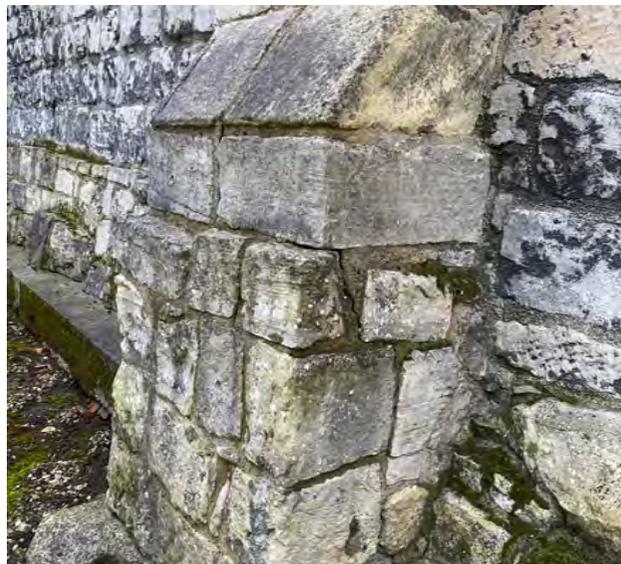
Structural movement to buttresses

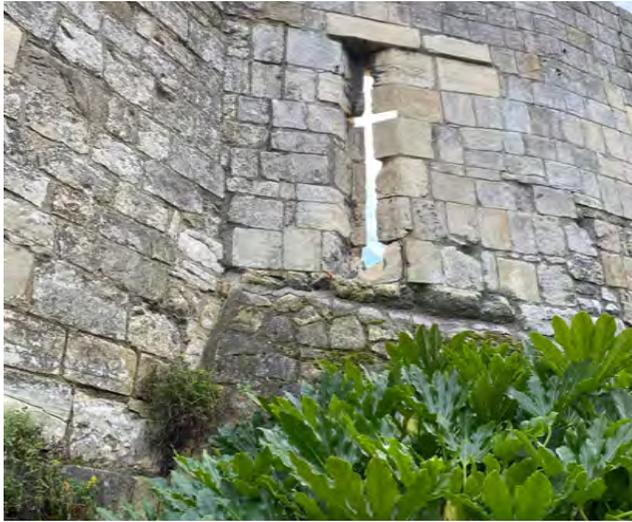
Failing cementitious mortar to north junction

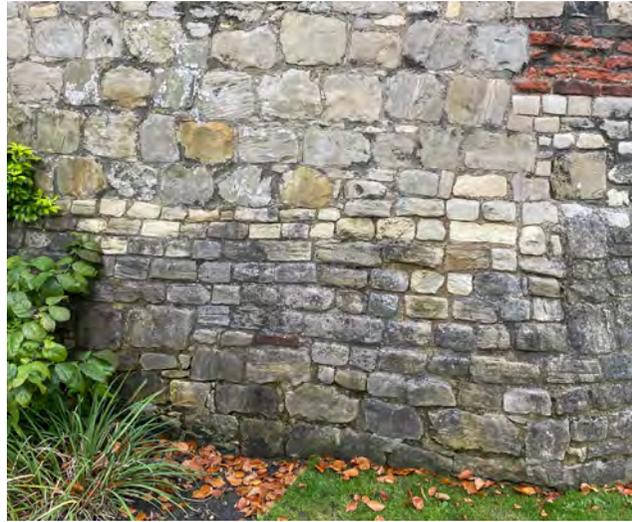
Open joints at low level externally

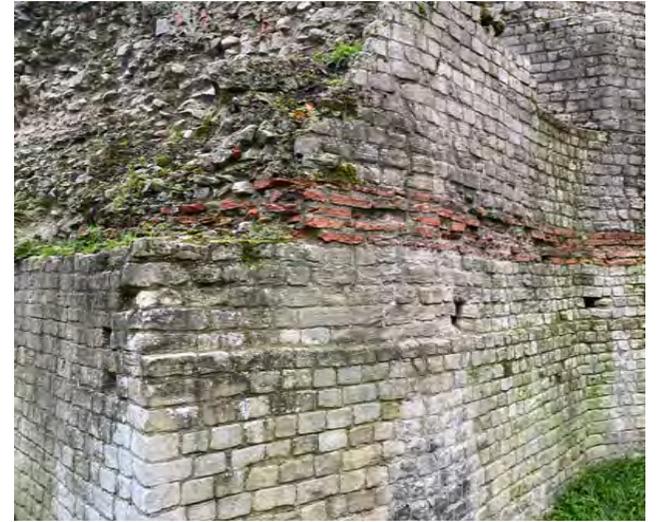
South internal corner with open core masonry

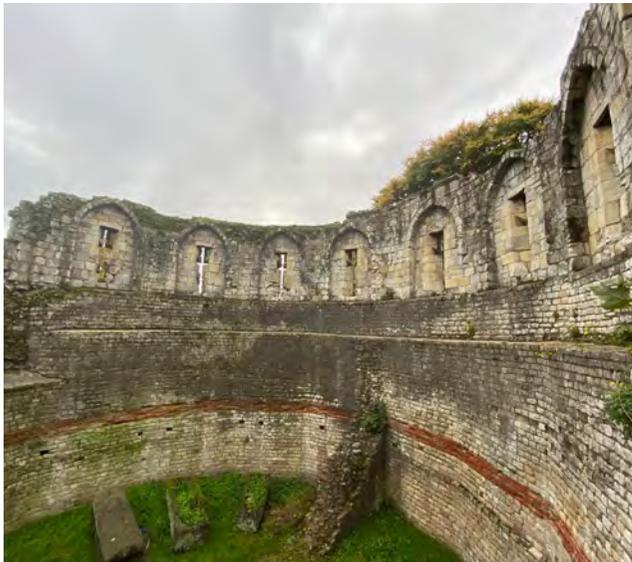
Vegetation growth from flanching level

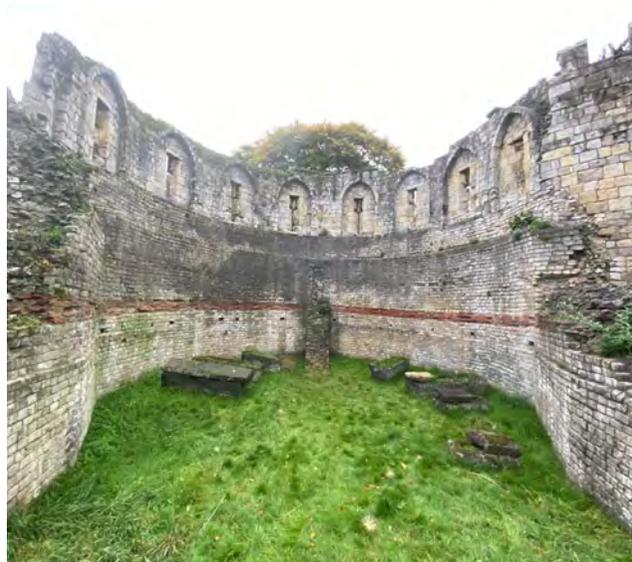
Vegetation growth

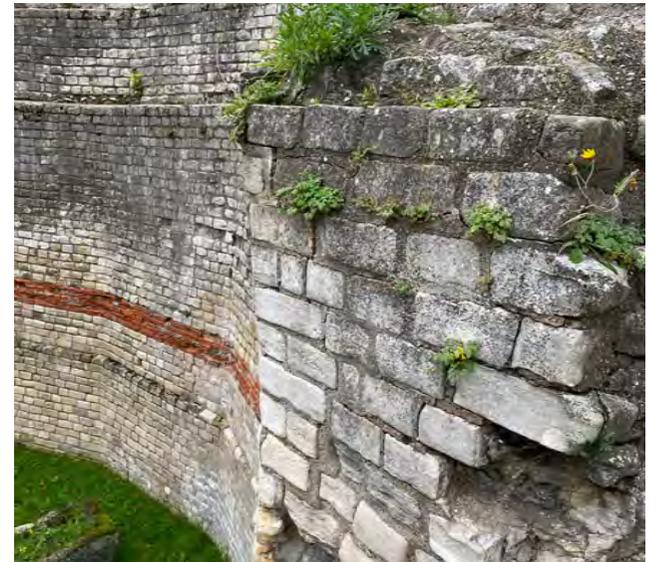
Vegetation jacking and areas of masonry falling away

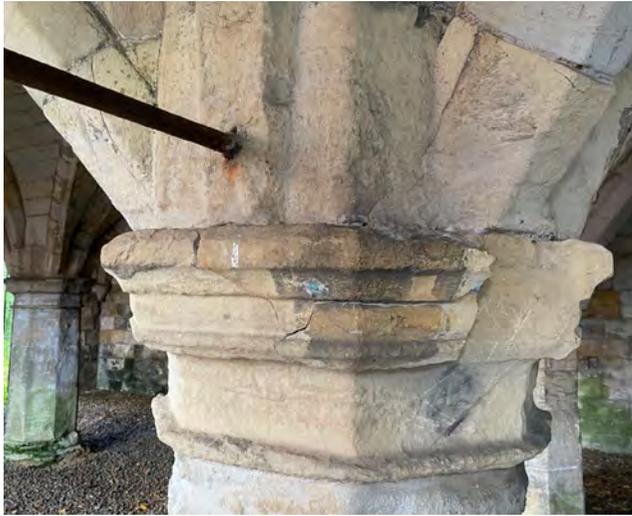
Fractured stone to column capitals

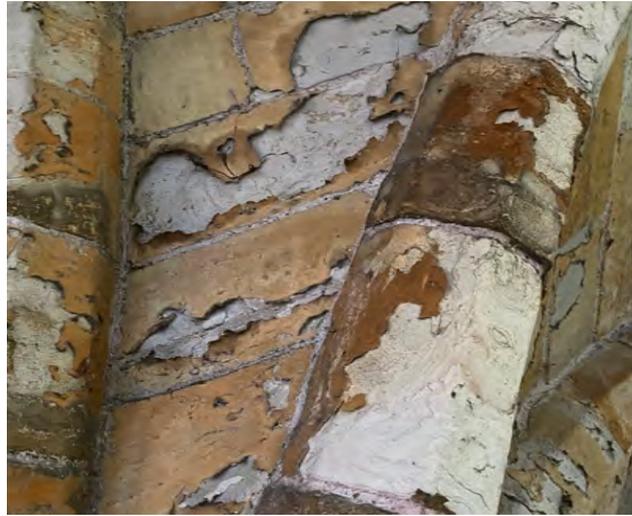
Friable stone behind surface crust

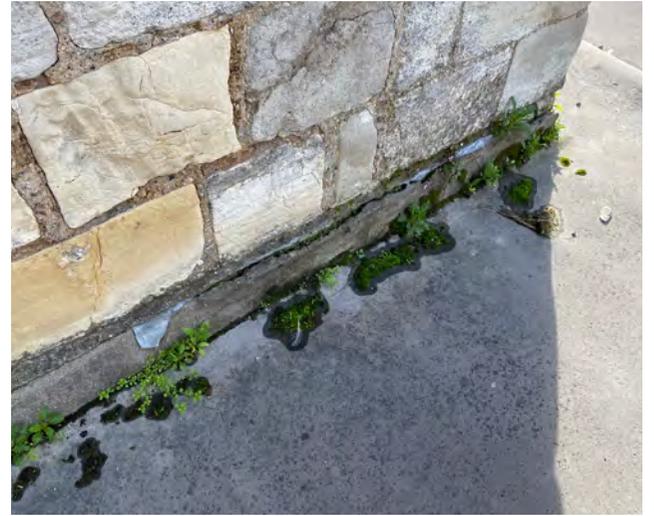
Missing lead and failing junction between asphalt and walls

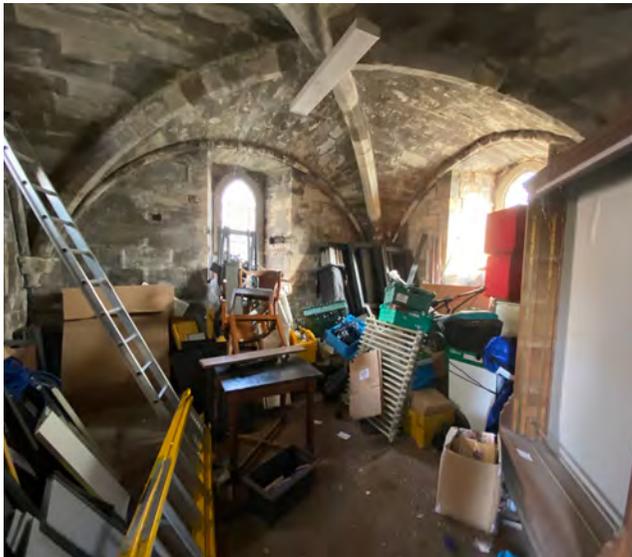
Storage covering walls and floor

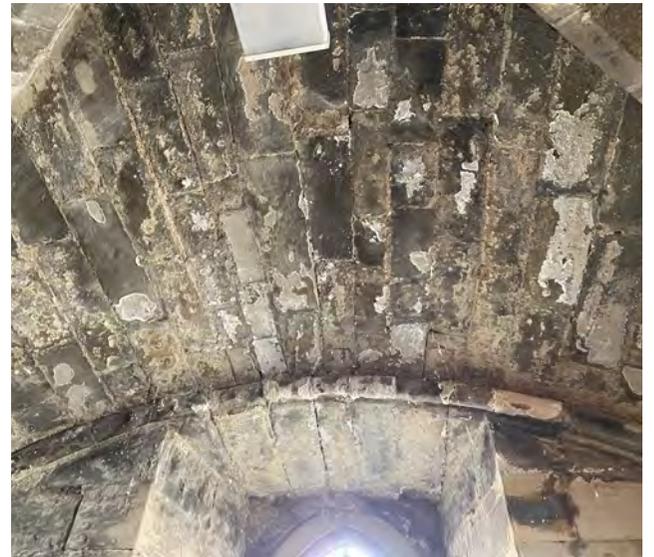
Water ingress to ceiling of Crypt

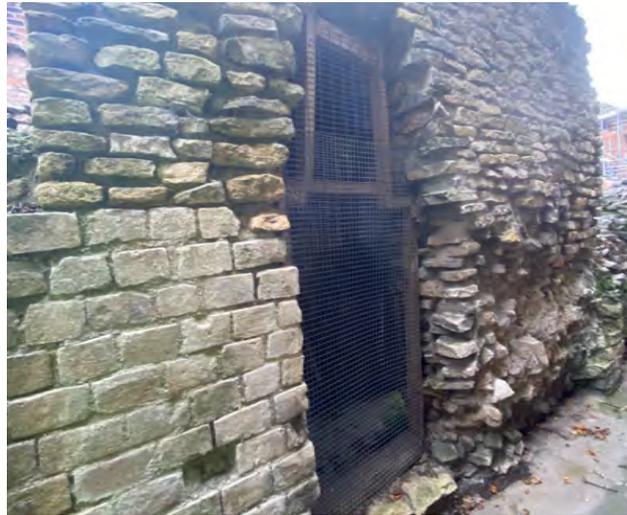
Mix of Roman and Anglian construction with areas of open rubble core

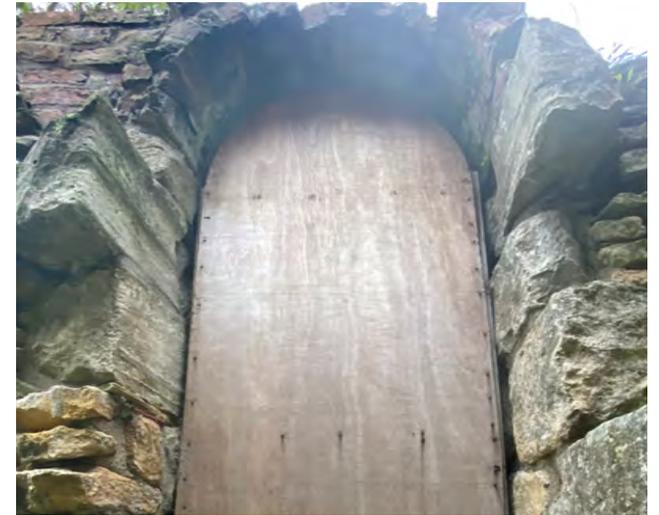
Ply over 1839 tunnel opening

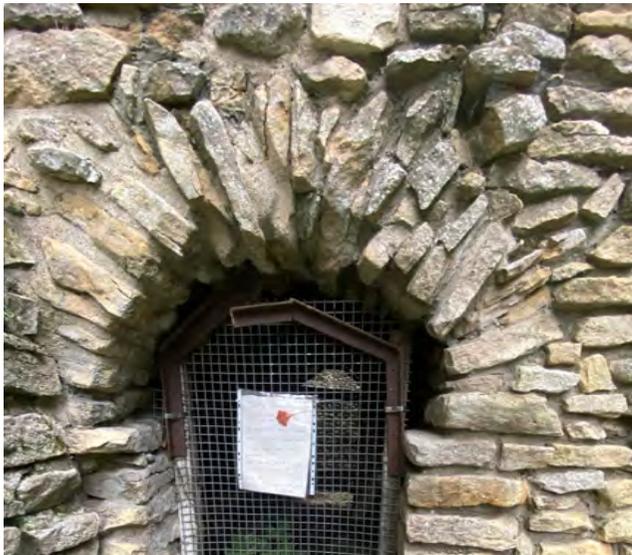
Recessed mortar joints

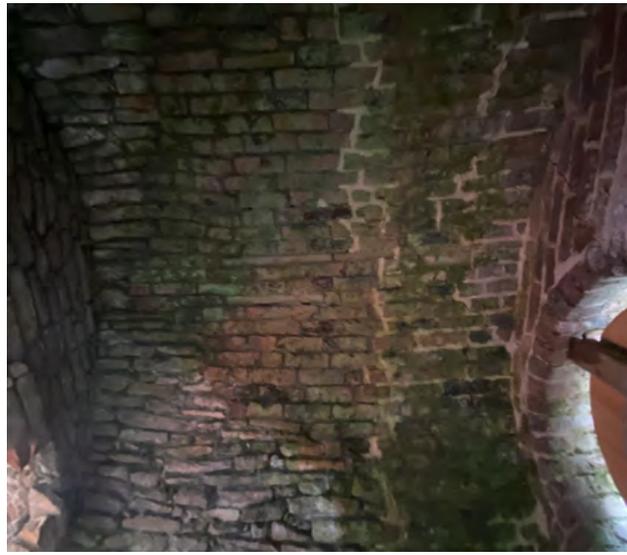
Structural movement cracks to brick barrel vault

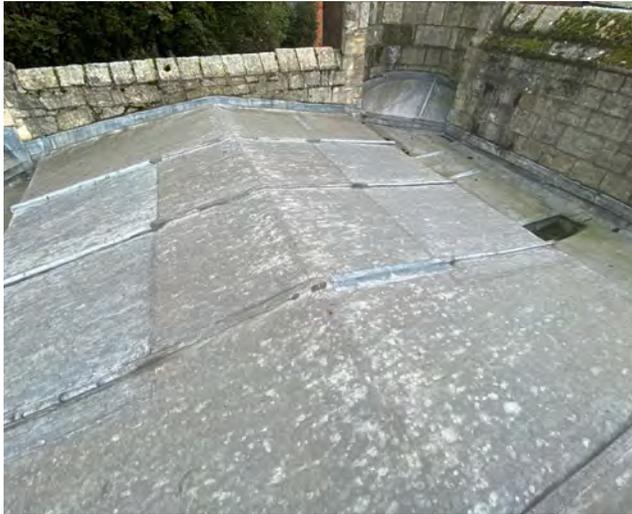
Leaking thin lead roof

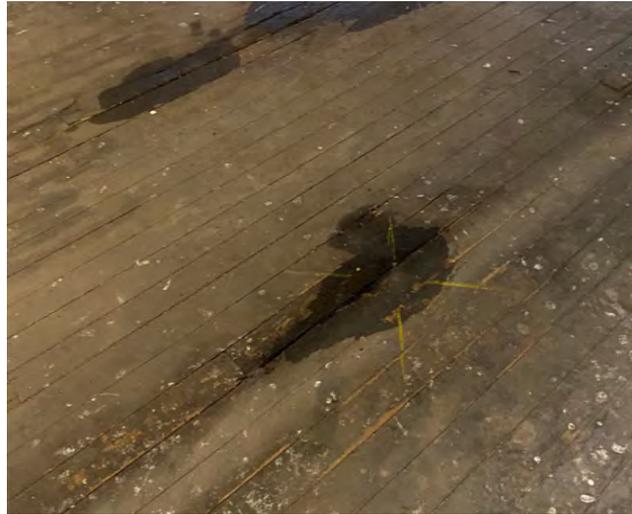
Multiple areas of water ingress from roof onto timber structure below

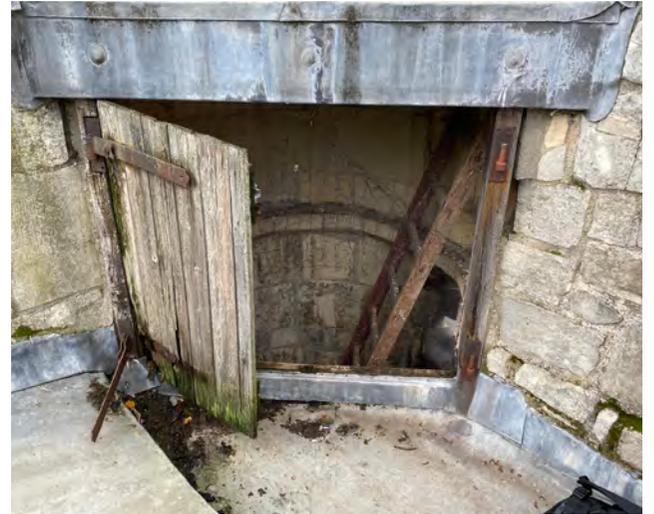
No covering to access hatch to roof which is allowing water in

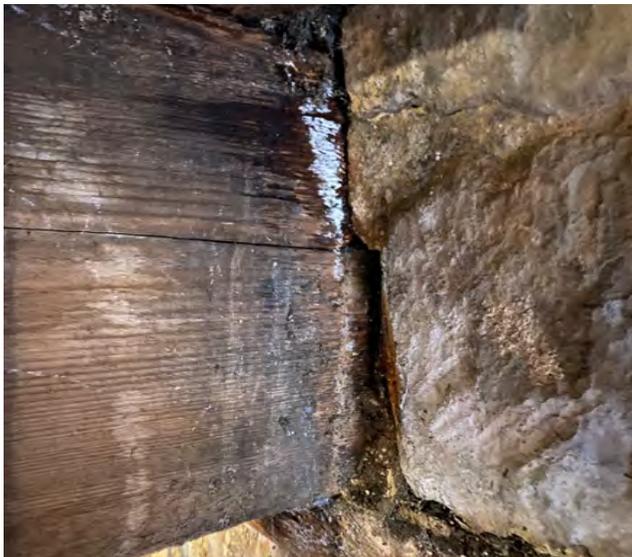
North west primary timber beam rotten within masonry pocket

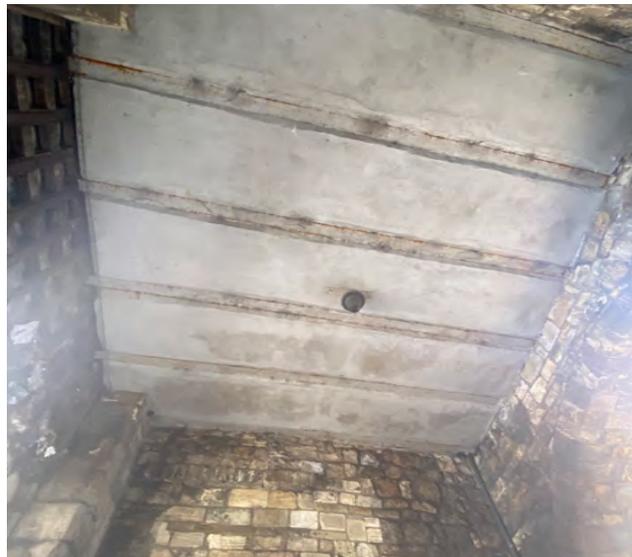
Rusting steel and concrete structure to carriageway

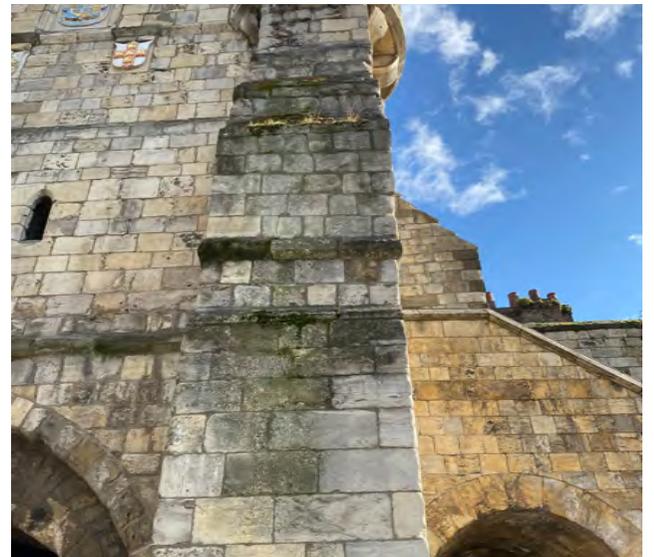
Structural movement cracks running up tower

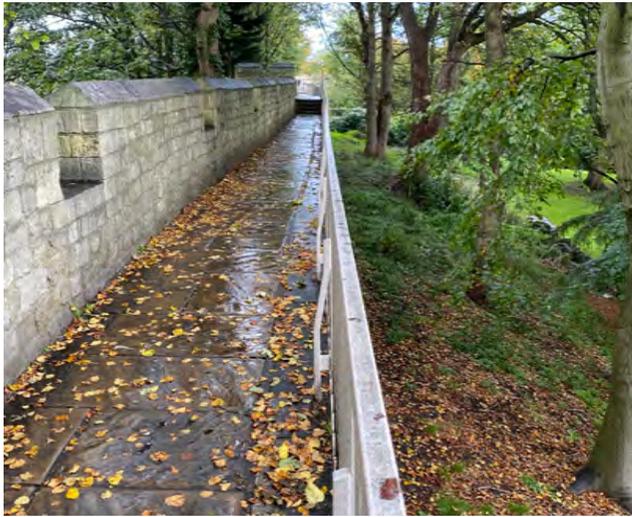
Element	Rating	Comments
Railings	RA2	rusting modern railings. continuous with no movement joints. show signs of bowing and now in tension from walkway construction movement. tower walls and arches are rotating outwards, the continuous railing is now pulling entire length outwards as well. Bootham Bar: broken fixing into chimney. Robin Hood Tower to Monk Bar: square section, galvanised and painted - areas of rust and failing paint finish. Railing fixed into brick building near Monk Bar is insecure and rusting.
Notes		Stored historic iron railings within arches between Bootham Bar and Robin Hood Tower. Ice House not surveyed

Bending railings with no movement joints

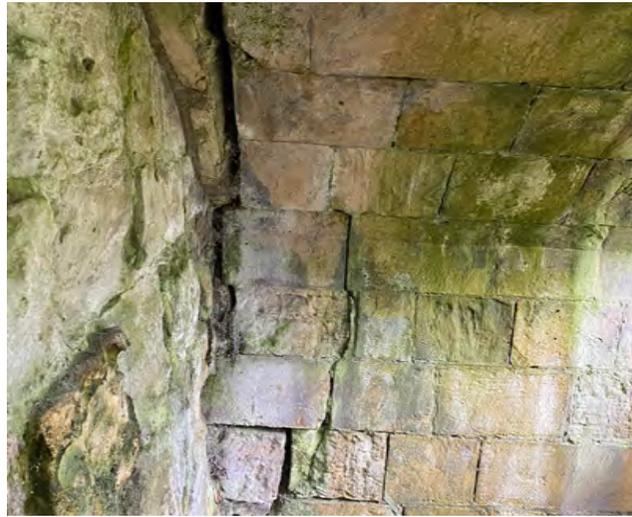
Joint failure between Victorian and Medieval structure

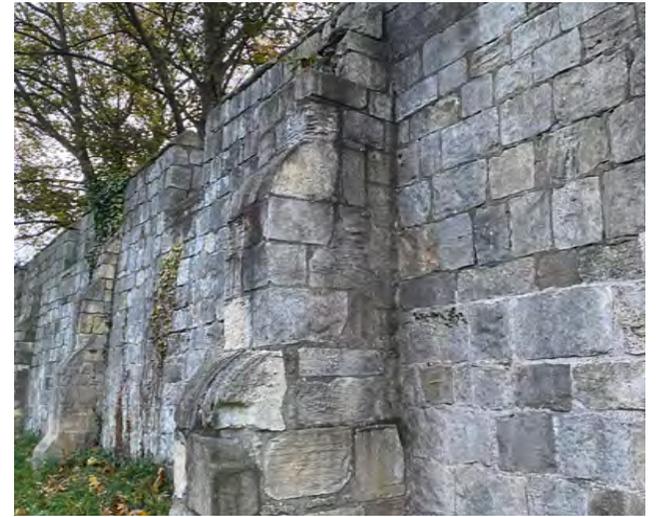
Missing masonry from buttress east of Robin Hood Tower

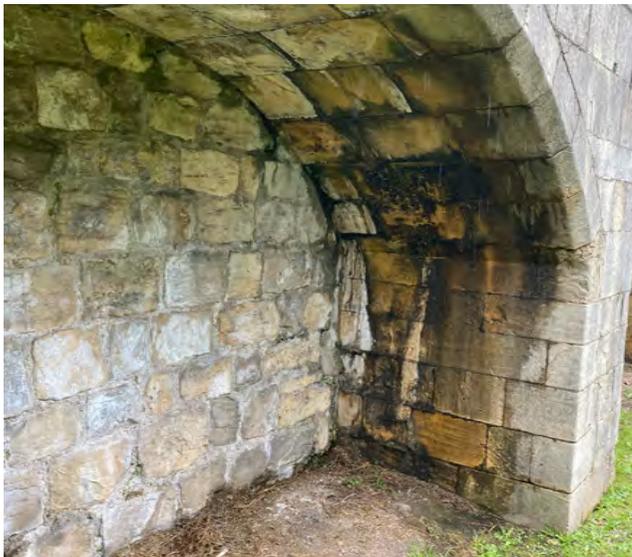
Saturation to interior of internal arches

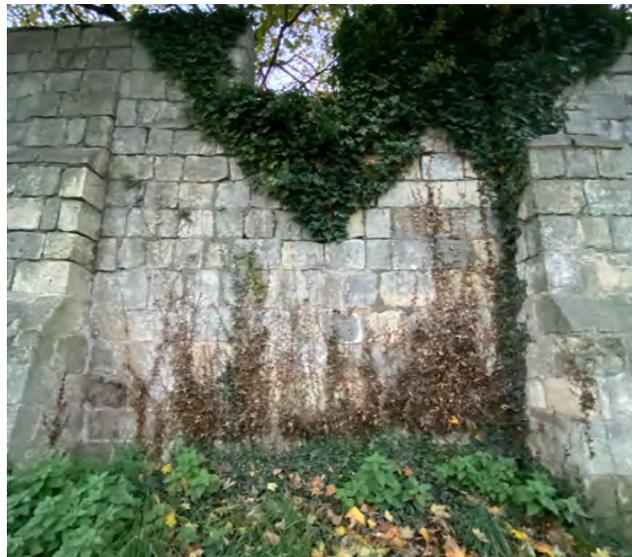
Vegetation jacking

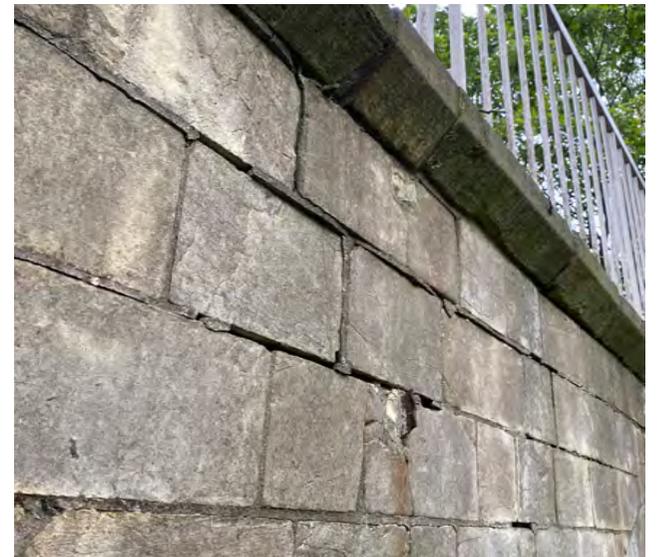
Walkway and top three courses of brick are moving outwards

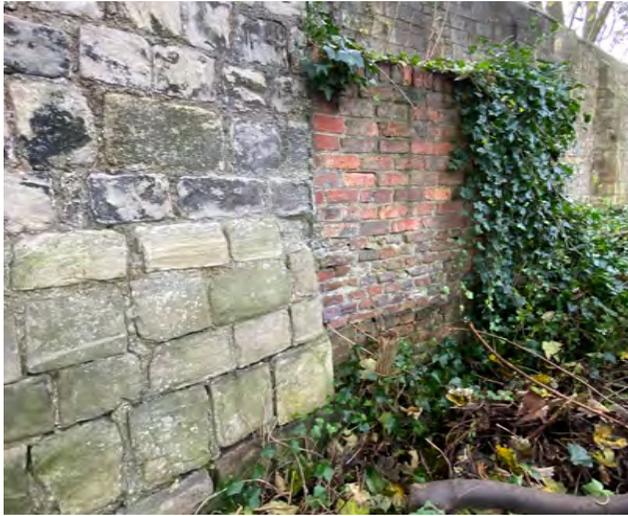
Brick structure to south west

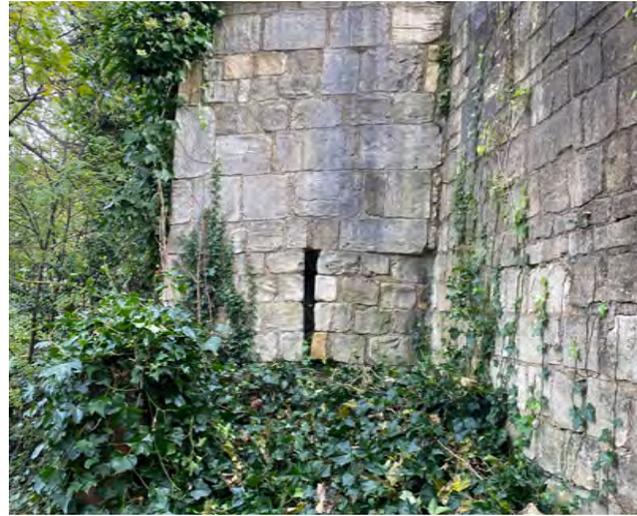
Low level vegetation growth

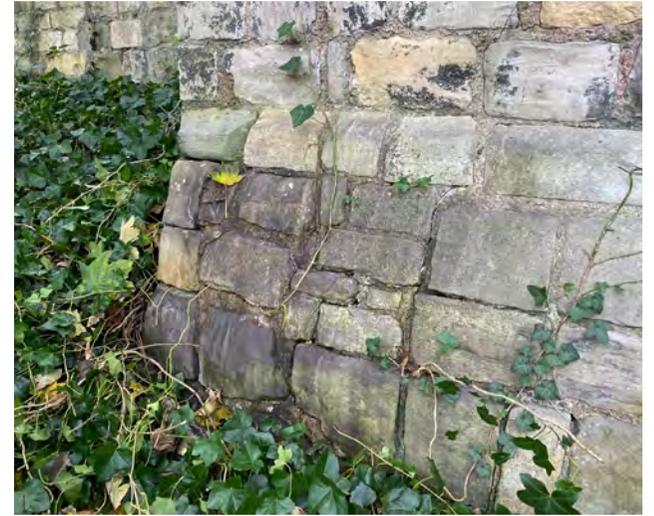
Spreading at corner foundations

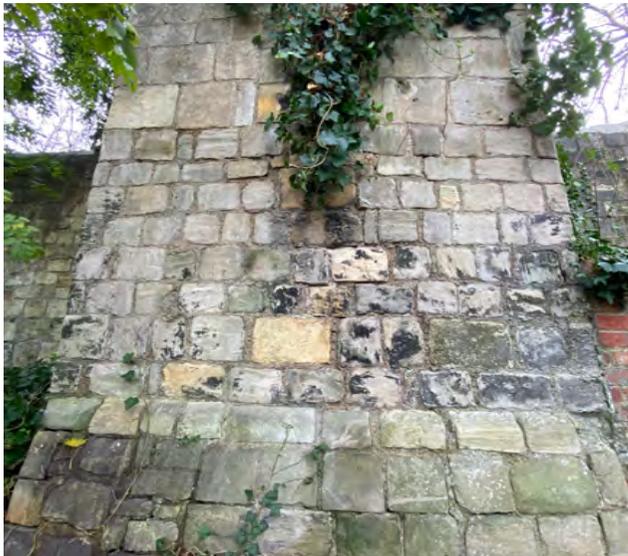
Vegetation growth and open joints to west elevation

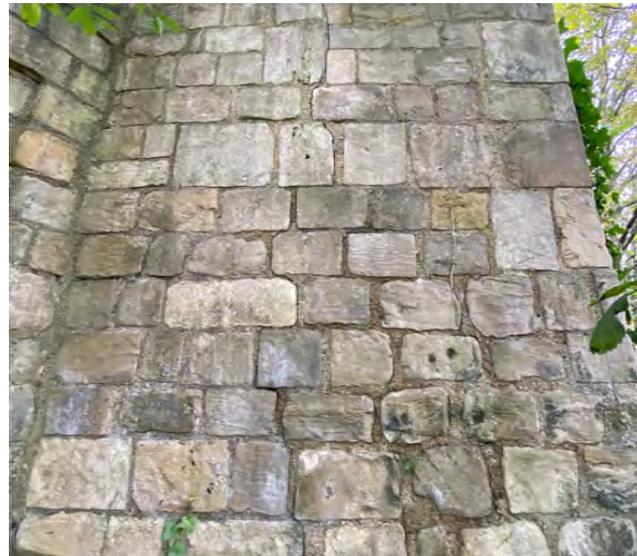
Vertical cracks to north elevation

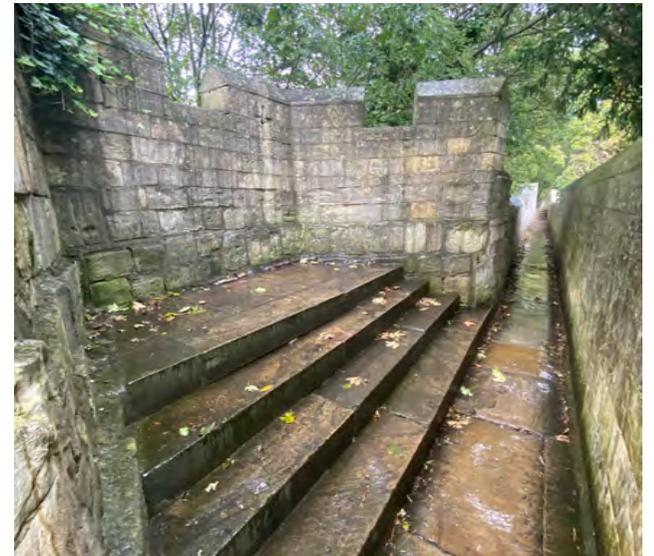
Walkway level with open joints and modern graffiti

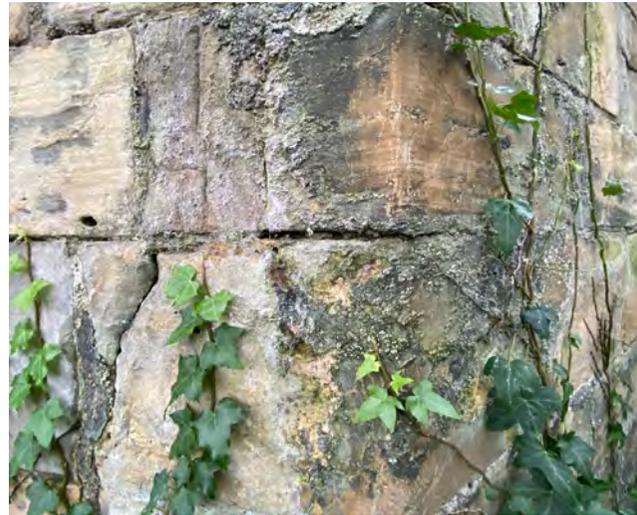
Salt movement and failing mortar from saturation

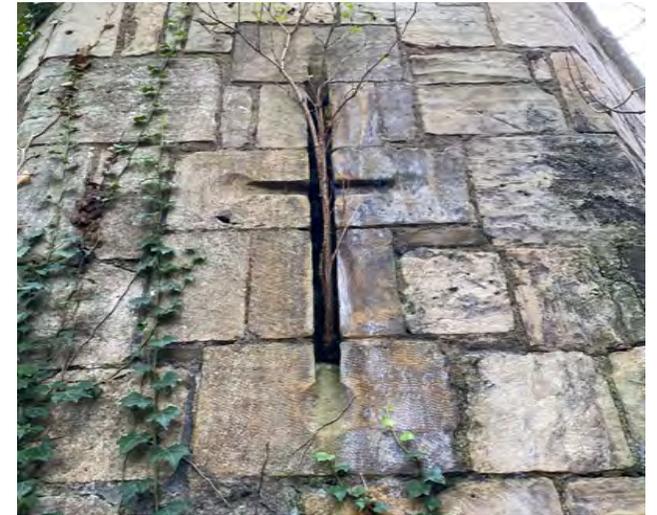
Vegetation growth from arrow slit

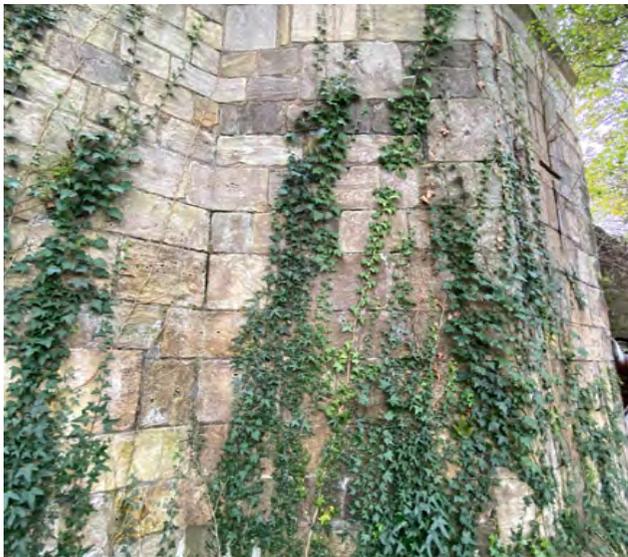
Vertical movement cracks

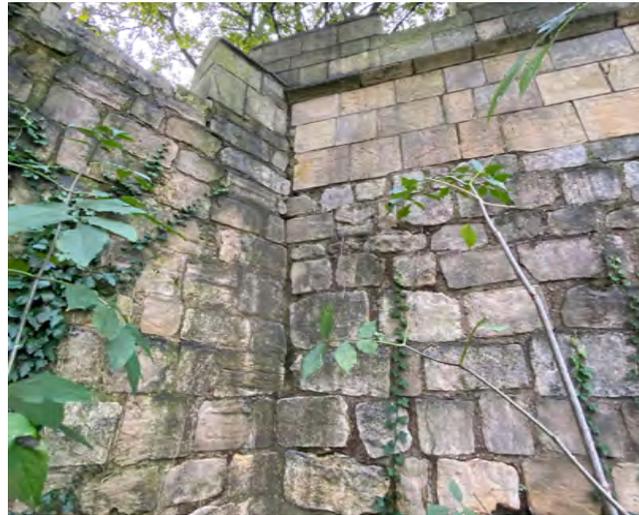
Movement cracks to wall junction north of tower

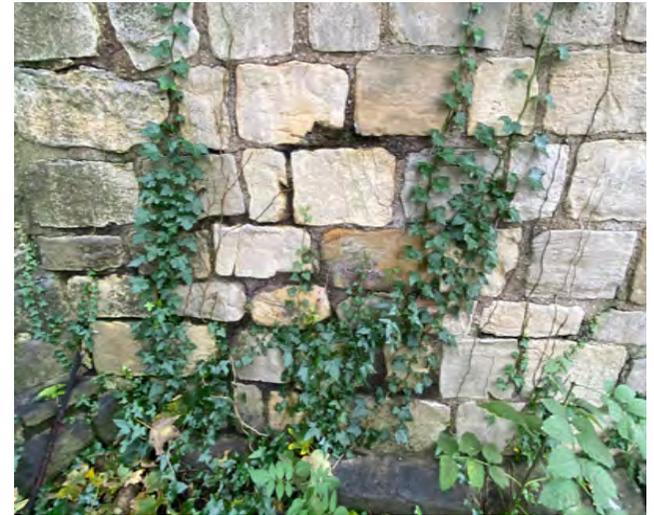
External Mortar	P4	Saturated 60s cementitious mortar. Failing and crumbling away from water ingress. Open 50-60mm joints to movement cracks.
Internal Mortar	P3	Same issues as wider Section 10.
Flagstone (walkway)	F2	Few open joints. Water pools at joint with edge stone forcing water into construction. Wide joints to steps on either side showing signs of historic movement.
Railings	RA3	Rusting modern railings.
Windows	W1	Infilled core behind arrow slits.
Interior		No interior. Infilled in masonry.

Saturated masonry at low level with failing mortar

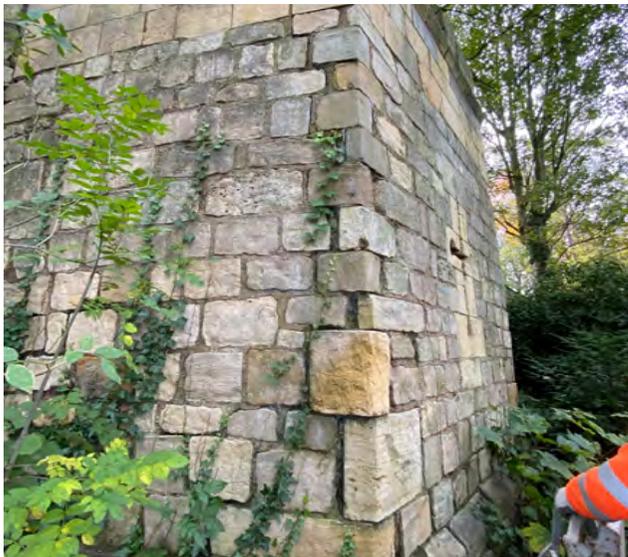
Separation of masonry around the quoins of tower
