York Walls

Conservation Management Plan
for the City of York Council

November 2021

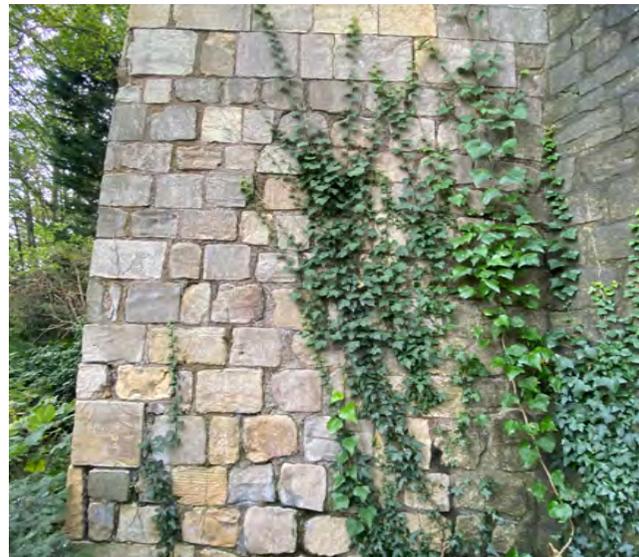
Vertical cracks to southern elevation

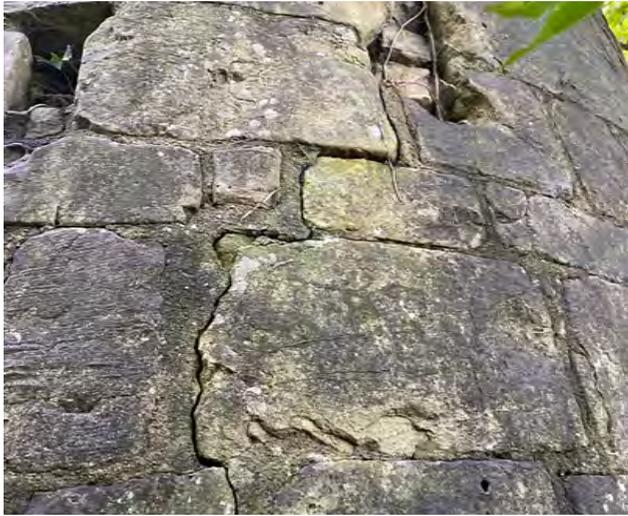
Alteration to arrow slits

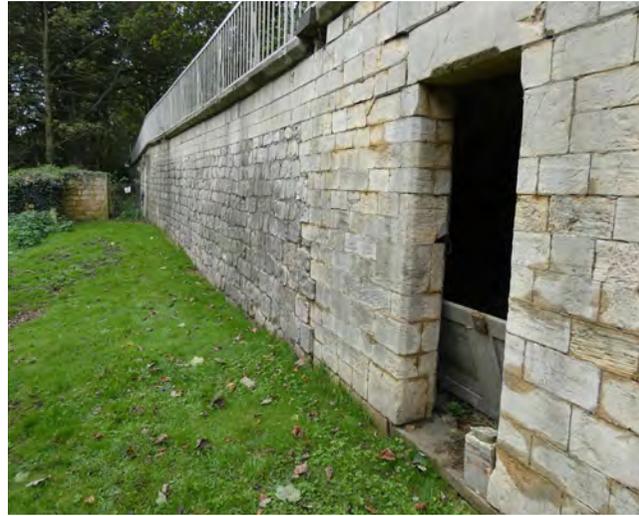
Entrance door, structural movement, fractured stones and failing mortar

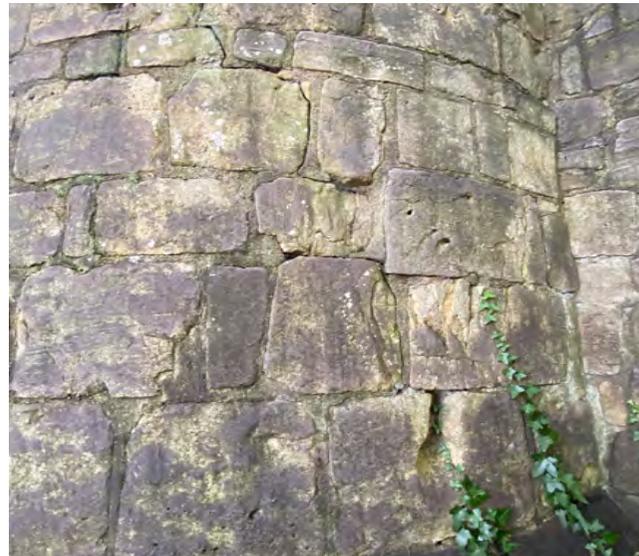
Vertical cracks to southern external elevation

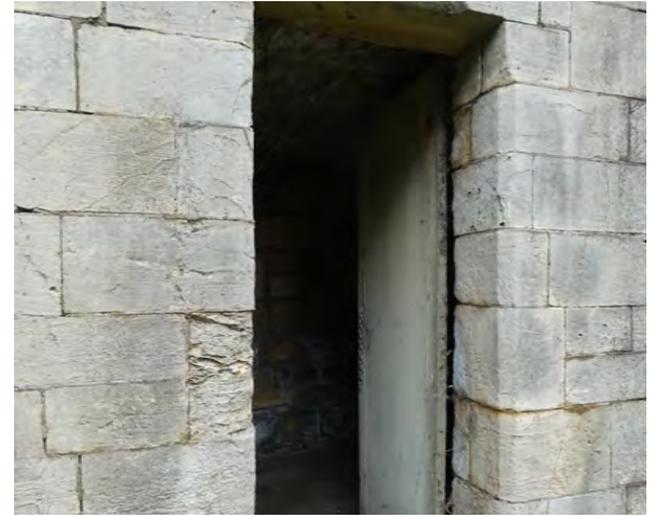
Entrance door

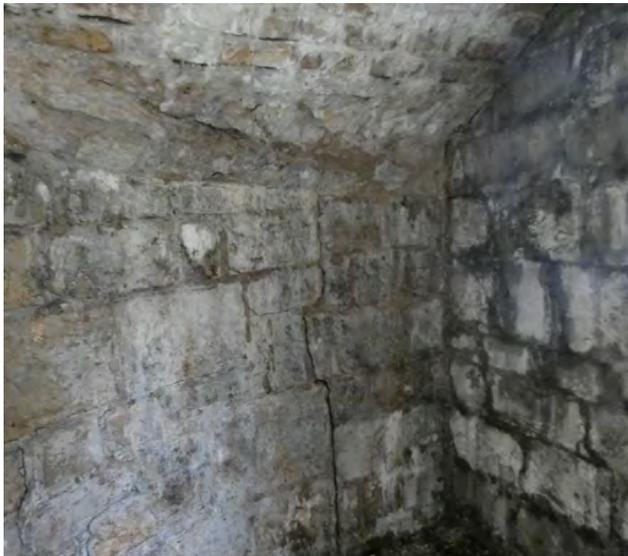
Structural movement to internal walls

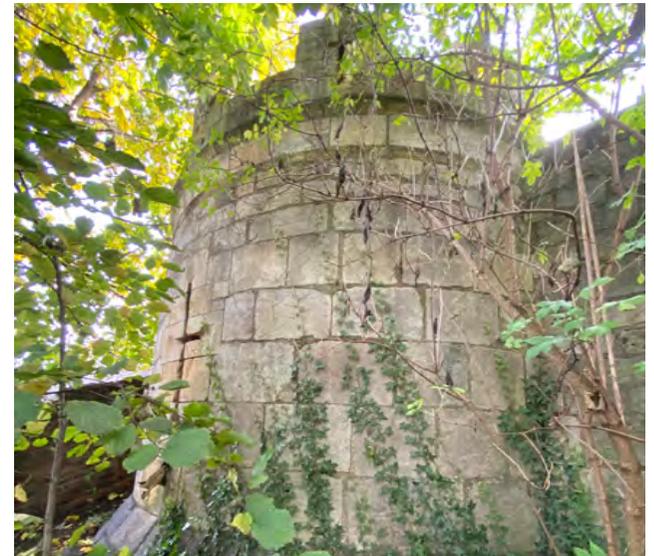
Western elevation with vegetation growth

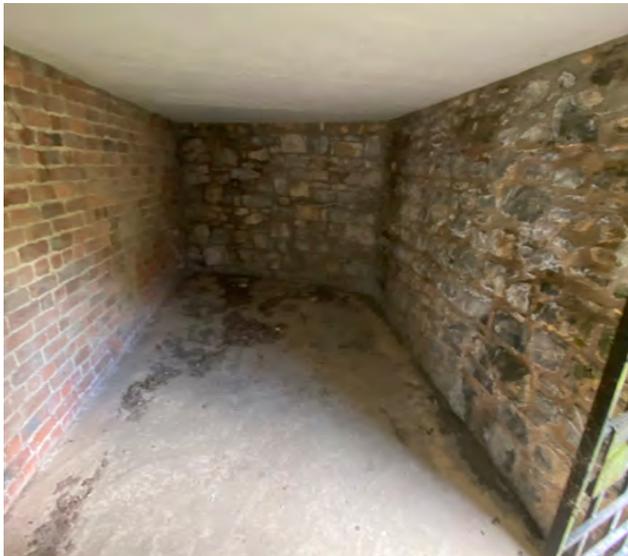
Small and short internal spaces with sloping floors

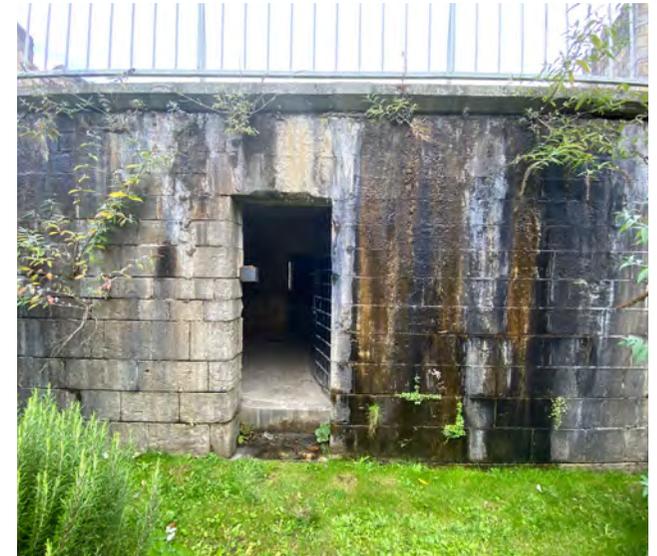
Element	Rating	Comments
External Masonry	M1	Good condition. Historic fractured stones and movement cracks assumed to have been repaired.
Internal Masonry	M2	Significant water staining and organic growth, concentrated from water proofing to walkway above. Vegetation growth from open mortar joints. Parapet level recently repaired.
External Mortar	P2	General loss of surface to mortar with a few open joints. Cementitious mortar.
Internal Mortar	P2	Loss of surface to mortar. Open joints.
Flagstone (walkway)	F2	Open perpend joints. Few open joints.
Railings	RA1	Modern, square section.
Doors	D1	Metal cage gate.
Windows	W1	Open arrow slits.
Ceiling	C2	White painted modern construction (assume steel and concrete) in pastiche of timber construction with edge ovolo details.
Internal Walls	I2	Exposed stone outer walls. Engineering brick piers in cement mortar. Brick spine wall in historic brick and cementitious mortar. Concrete lintel over door. External stone wall saturated.

Water falling over surface on internal wall

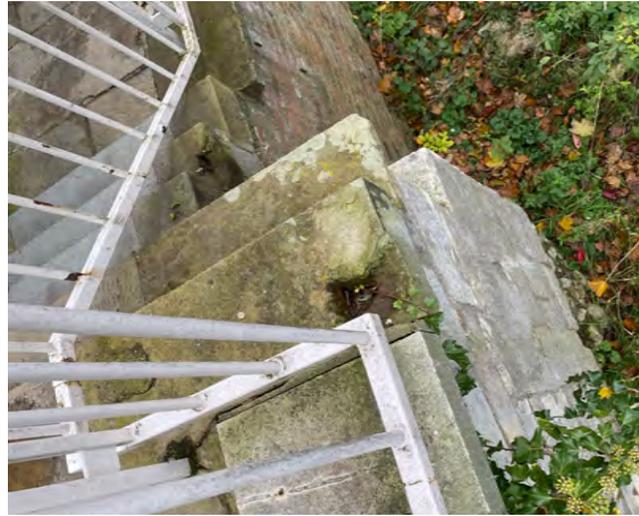
Fracture stone remains from historic railings

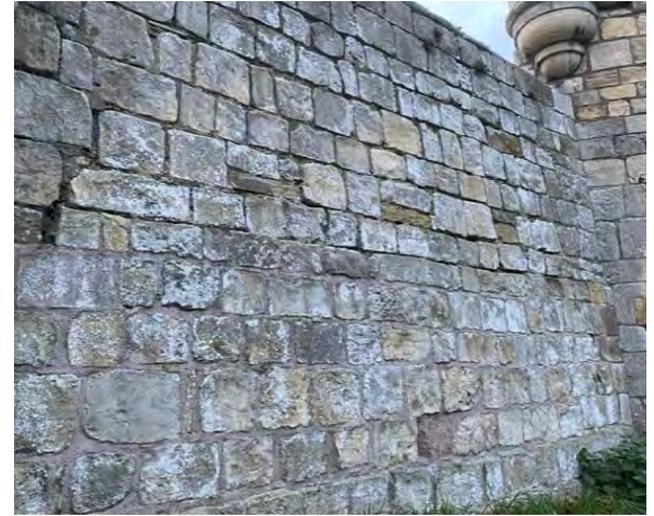
Open joints east of tower

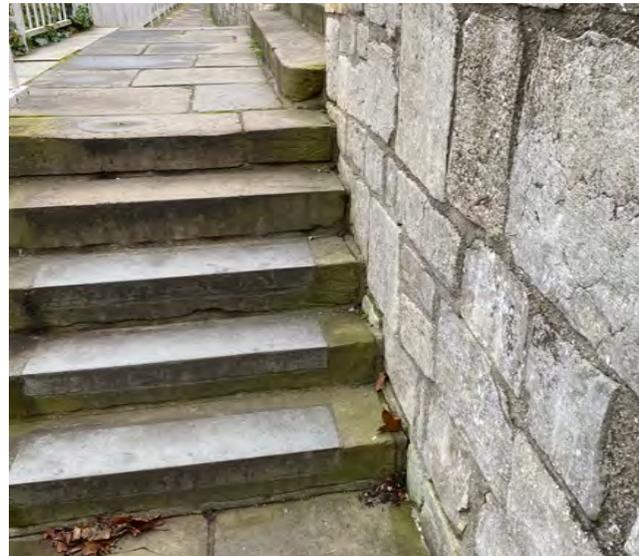
Walkway steps, enlarging joints against parapet wall

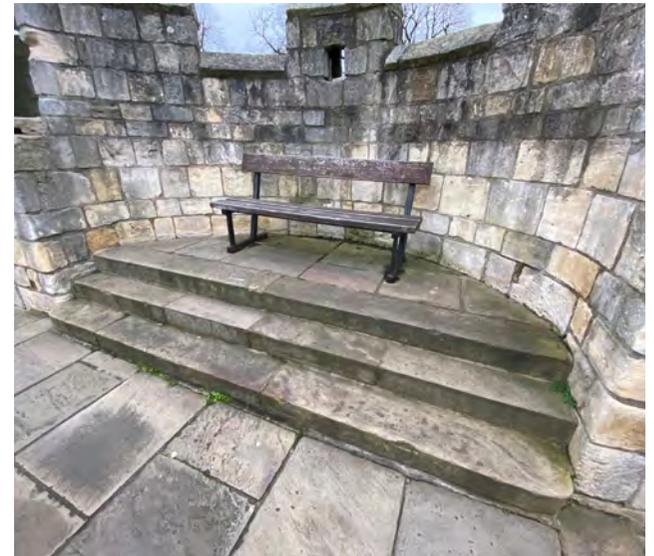
Walkway, few open joints

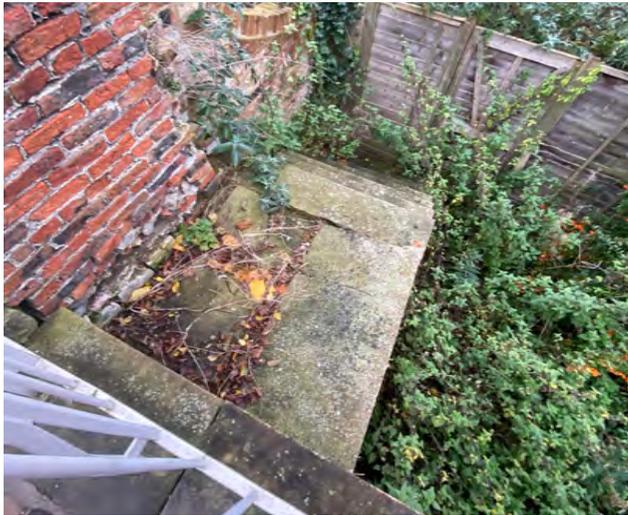
Broken steps into Treasurer's House Gardens

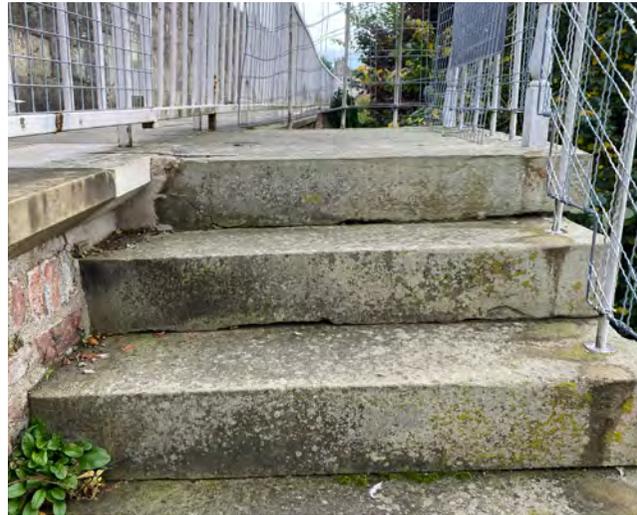
Element	Rating	Comments
External Masonry		As wider Section 10.
Internal Masonry	M4	Greys Court brick steps: bricks weathering. Top landing stone of stair has rotated separating it from brick wall beneath.
External Mortar		As wider Section 10
Internal Mortar	P1	Fair condition. See Section 10 notes
Flagstone (walkway)	F4	Top landing stone of Grey Court steps is rotating. Currently held in place by cramp. Steps within Deanery garden have collapsed and are overgrown. Large open joints between steps on walkway and parapet wall.
Railings	RA2	Square section railings, rusting. Older railings to steps now rusting with a failed paint finish.

Fractured rotating top stone landing slab with cramp and cracks

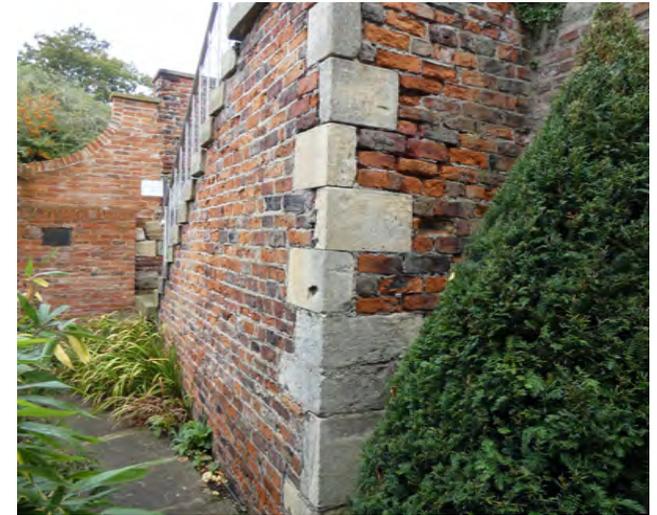
Open joints and raised stone landing slab away from supporting brickwork beneath

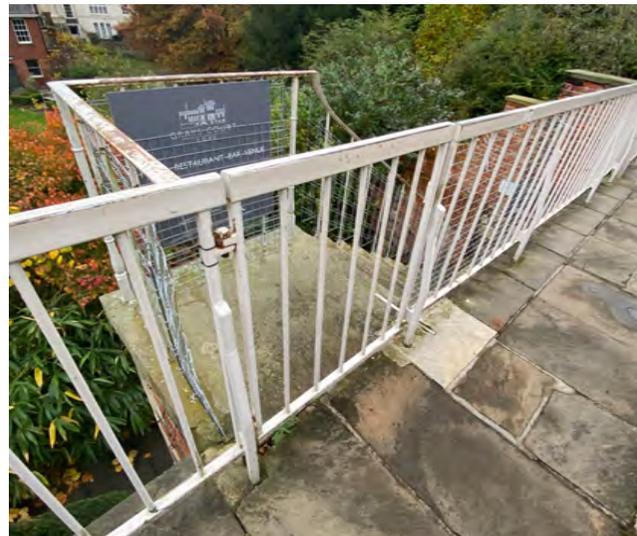
Top landing slab rotating

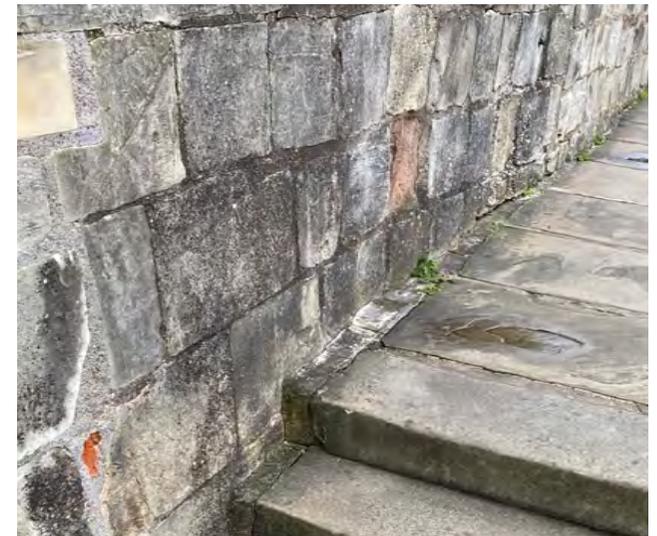
Wide joints to steps

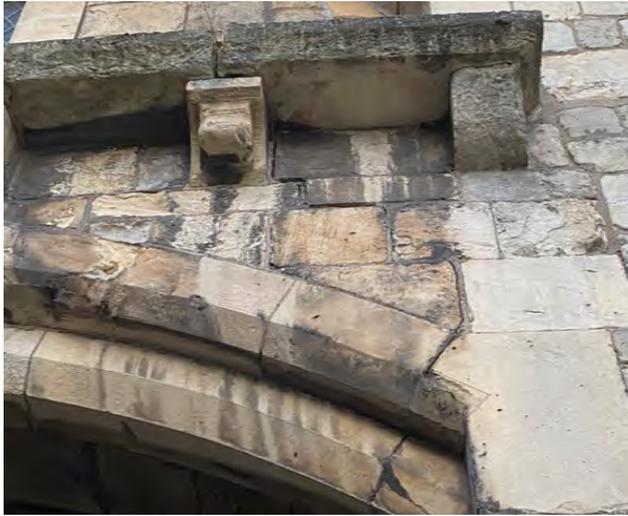
Crack to arch over carriageway on south side

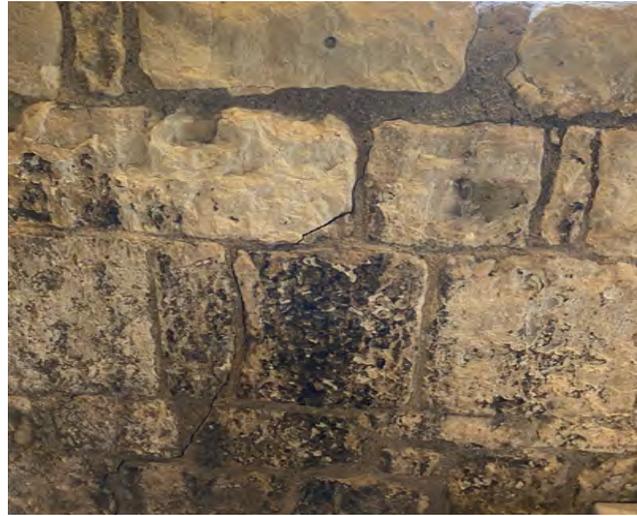
Cracks to east wall of top floor

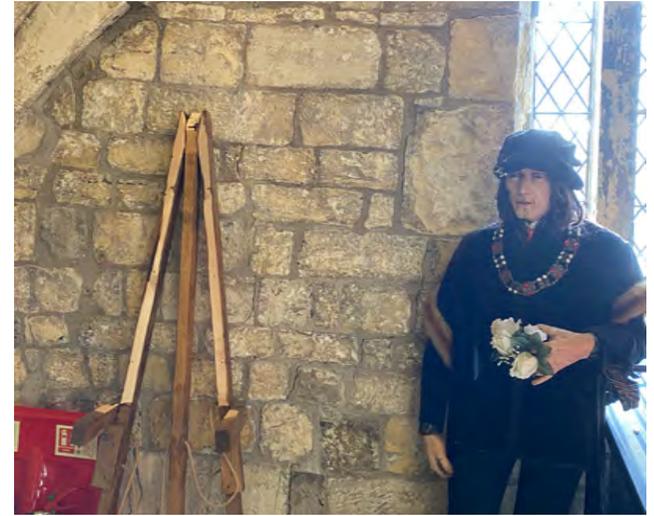
Internal cracking to walls

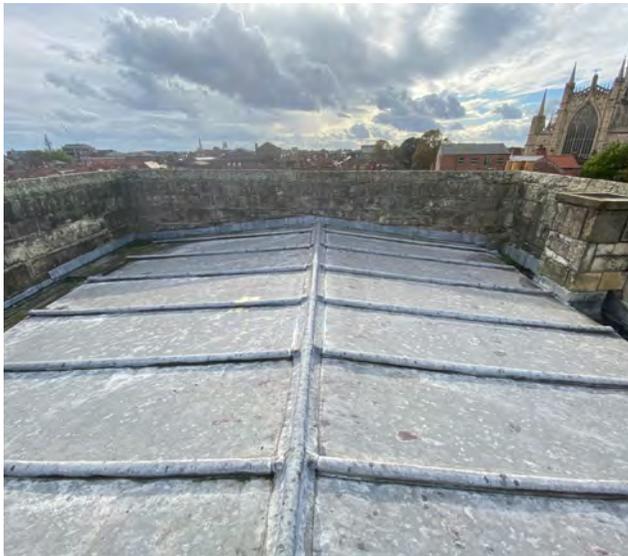
Leaking lead roof

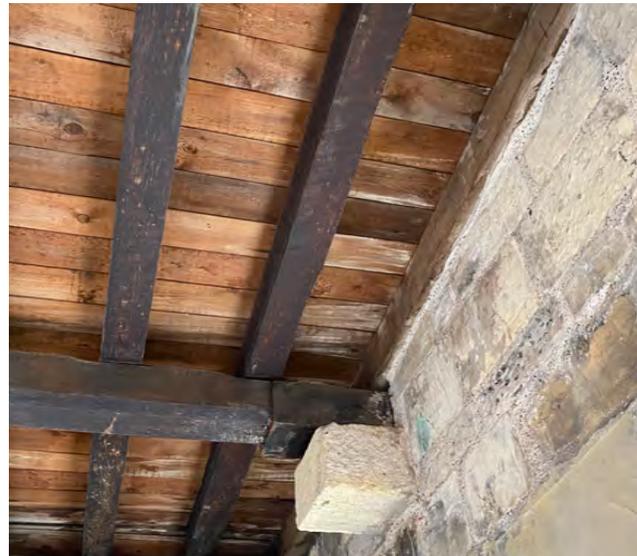
Rusting metal joist pockets

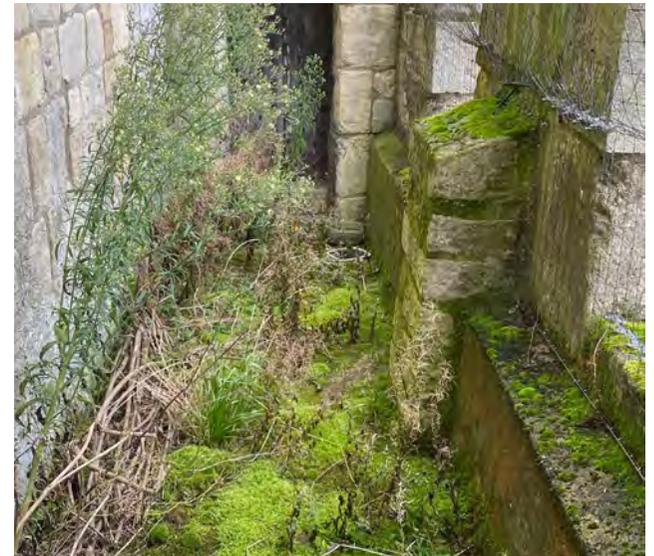
Vegetation growth to high level external gallery to north

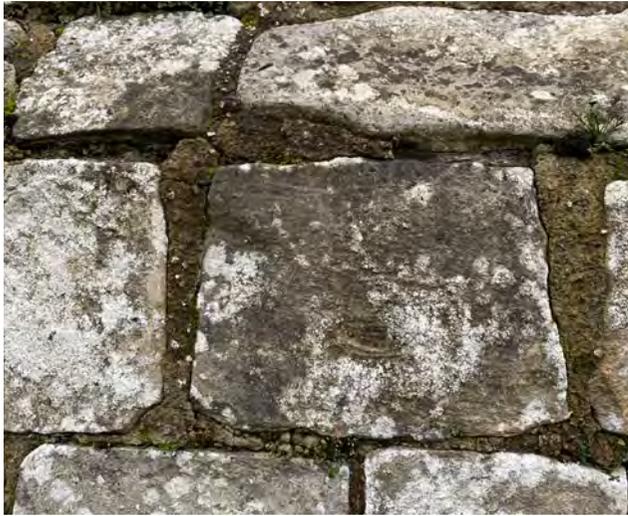
Cementitious mortar

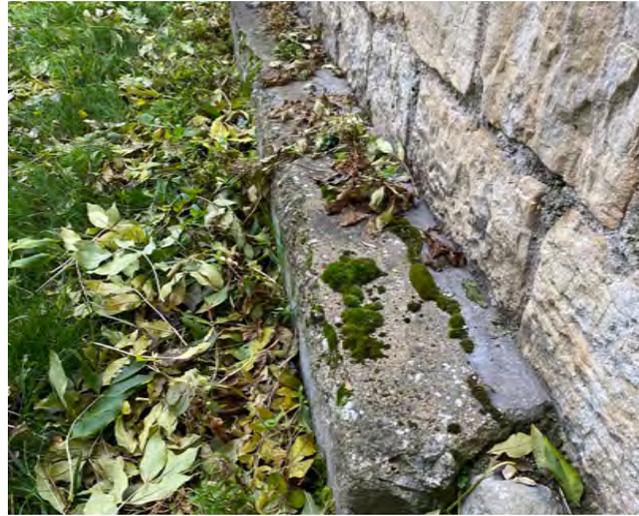
Concrete foundations to wall near Monk Bar

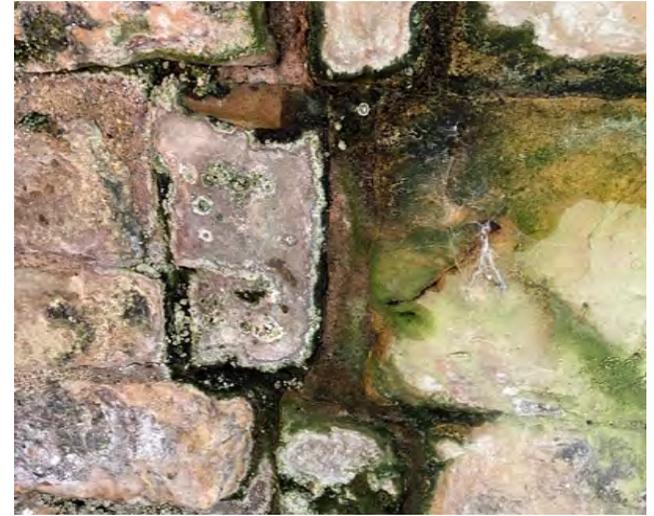
Saturated structure below arches

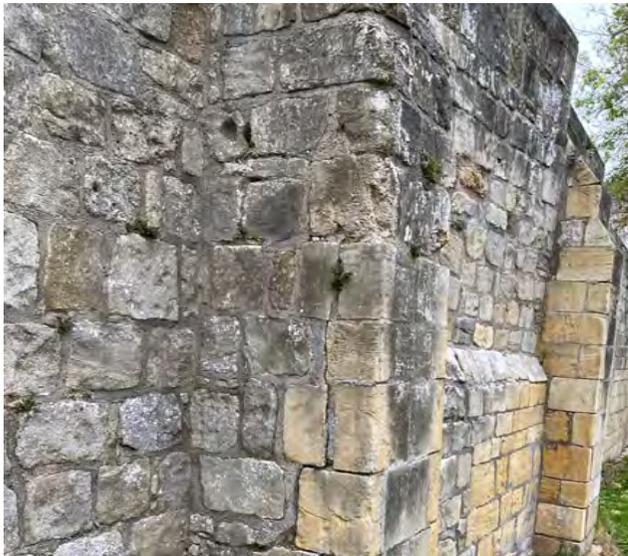
Structural movement to buttresses

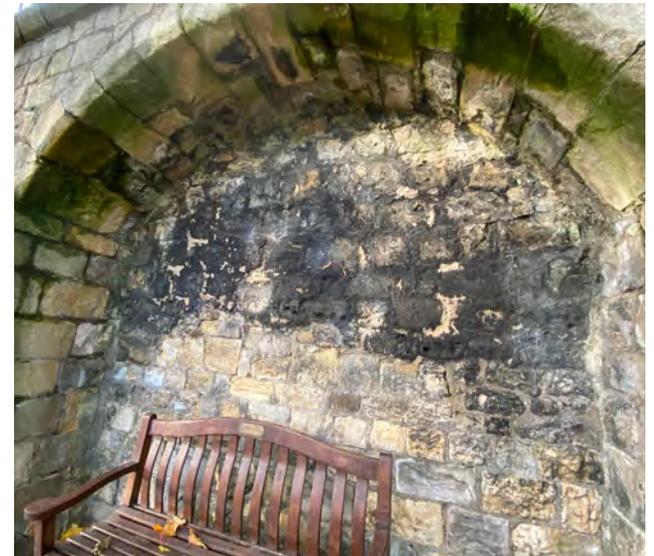
Sulphuric crust to interior of arch

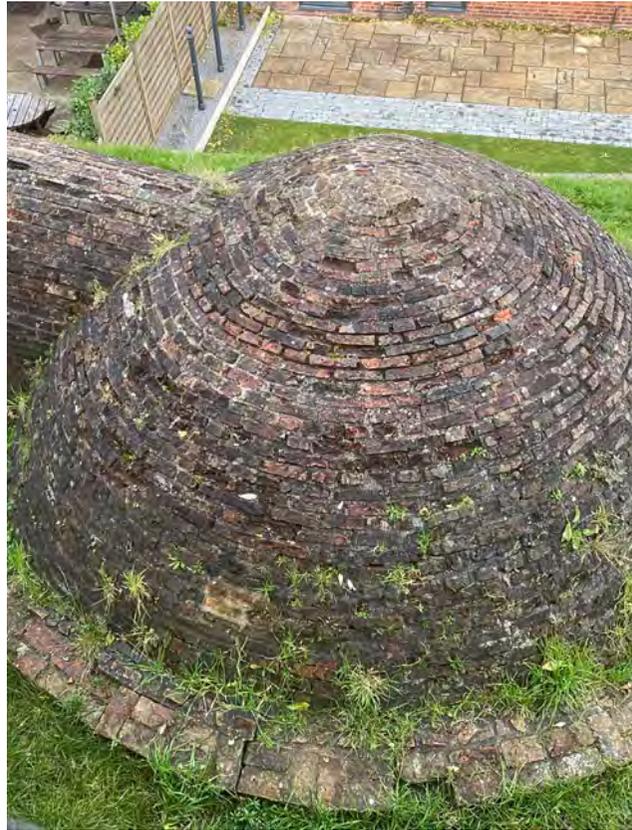
Falling mortar joints to uncovered exterior

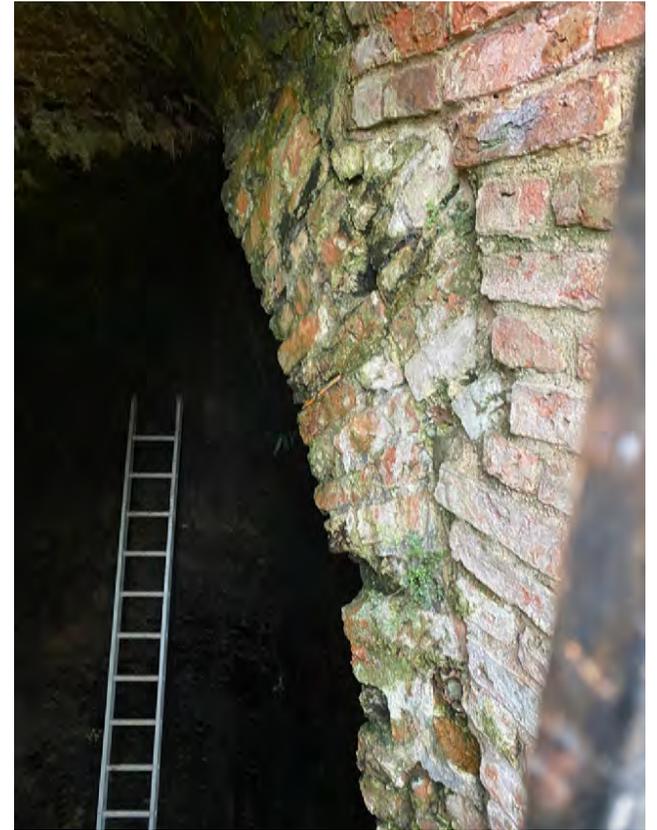
Water ingress and salk movement to interior

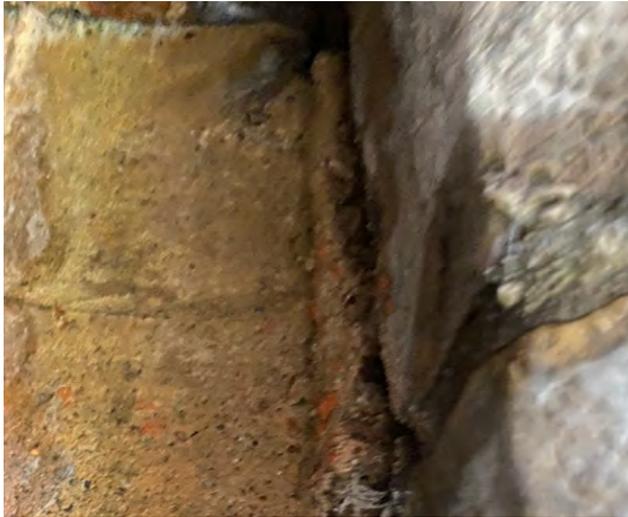
Concrete beam coming out of bedding position

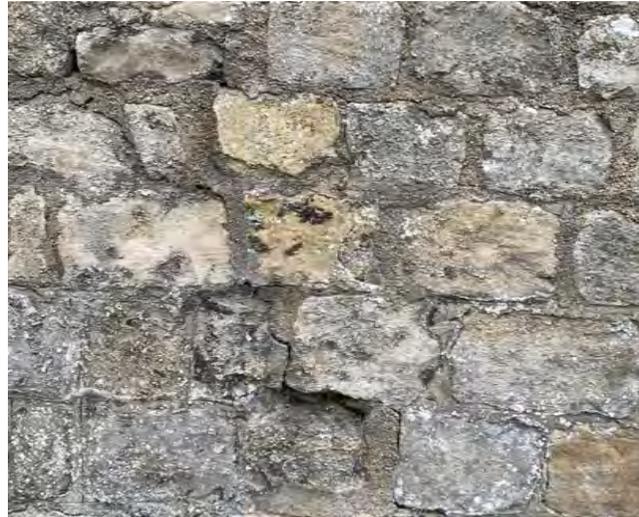
Diagonal cracking to wall on the west side of tower

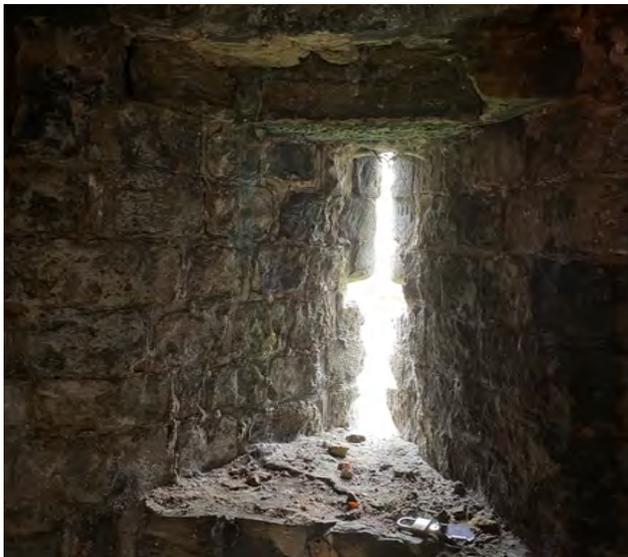
Missing stone lintel from northern arrow slit

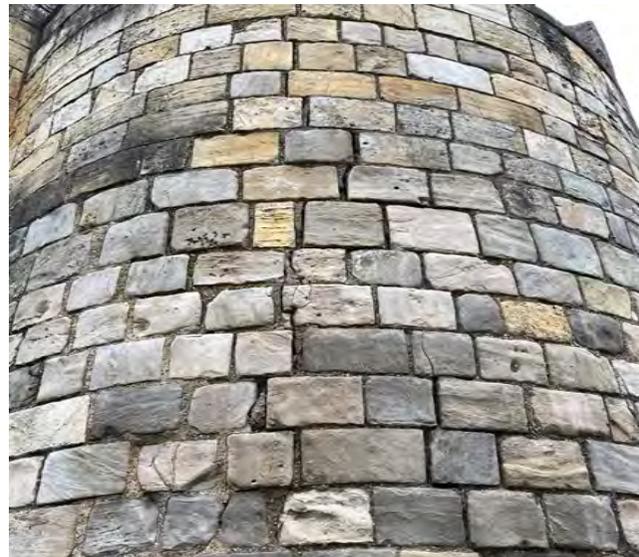
Structural movement cracks to north east side of tower

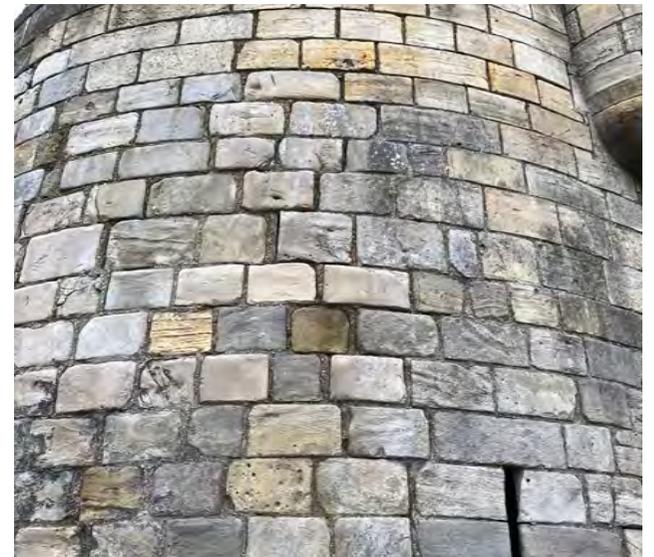
Structural movement to north west side of tower

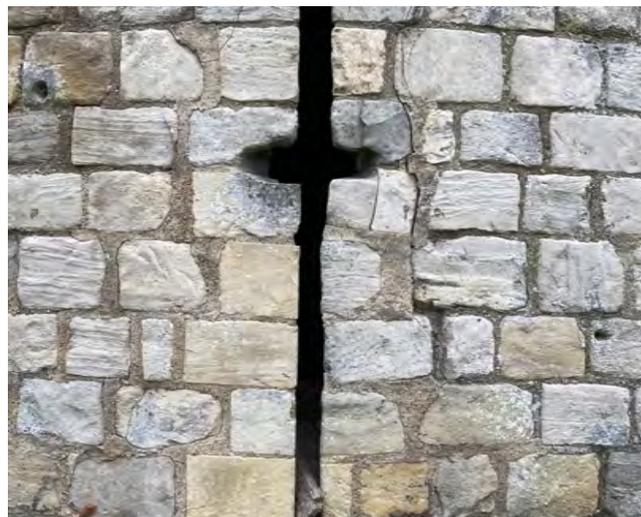
Fractured stones to perimeter of arrow slit

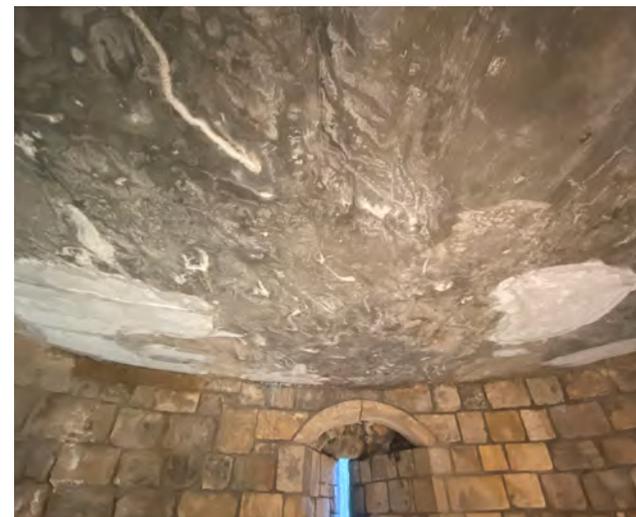
Internal ceiling showing water ingress

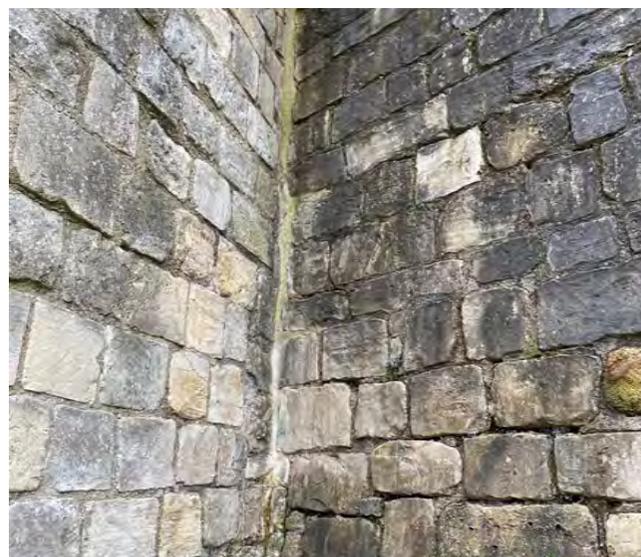
Structural movement at joint with west wall

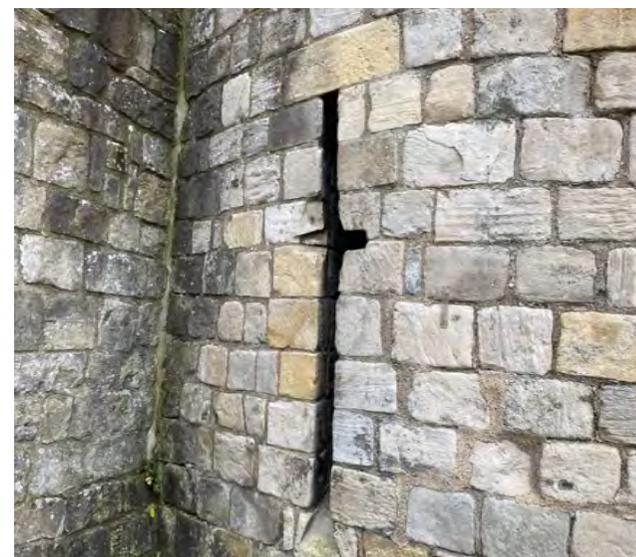
Structural movement to joint with east wall

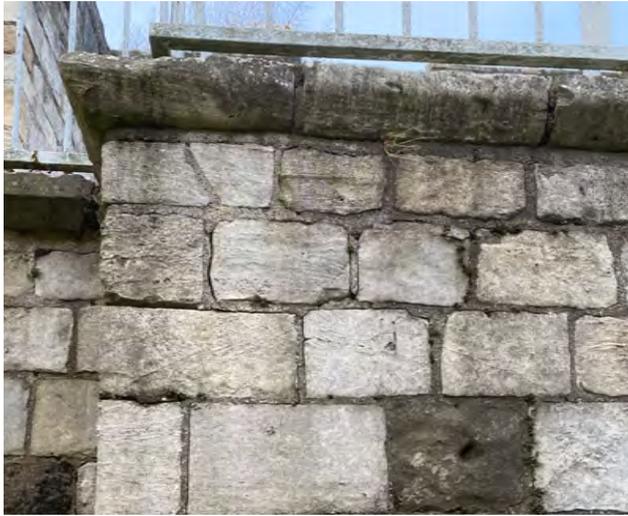
Cracking and open joints to western walkway structure

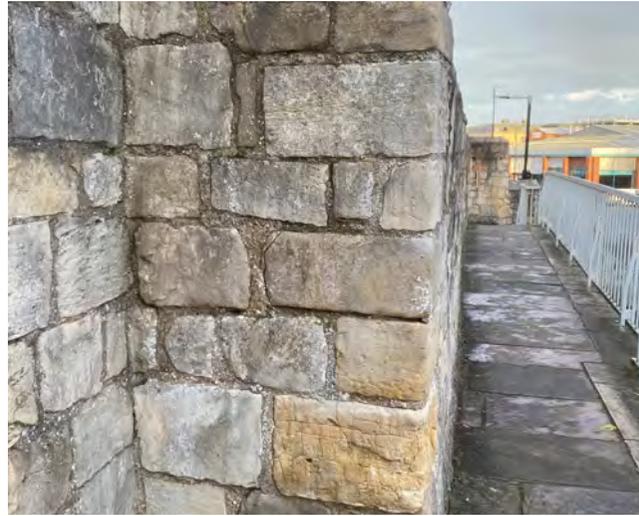
Cracking to eastern side

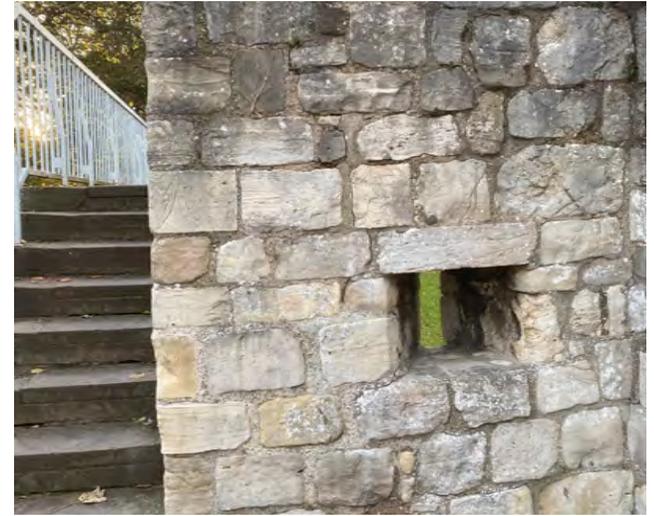
Cracking to western side

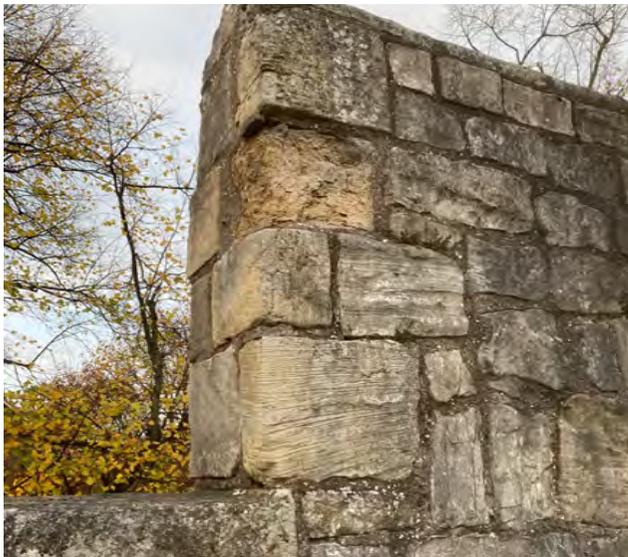
Eroding stone to merlon

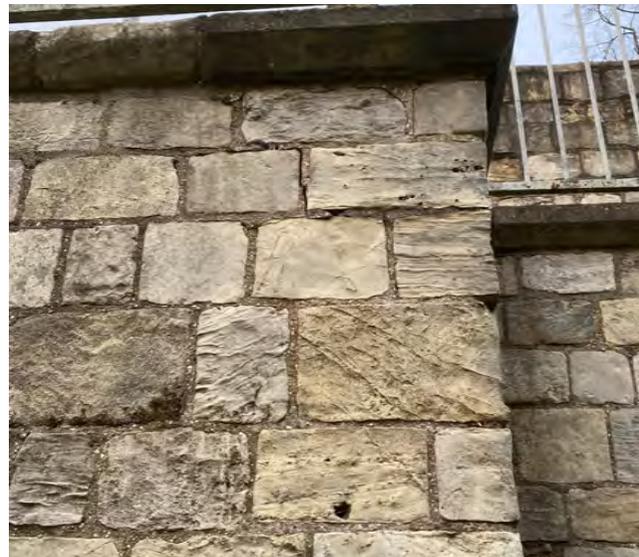
Movement crack to eastern walkway structure

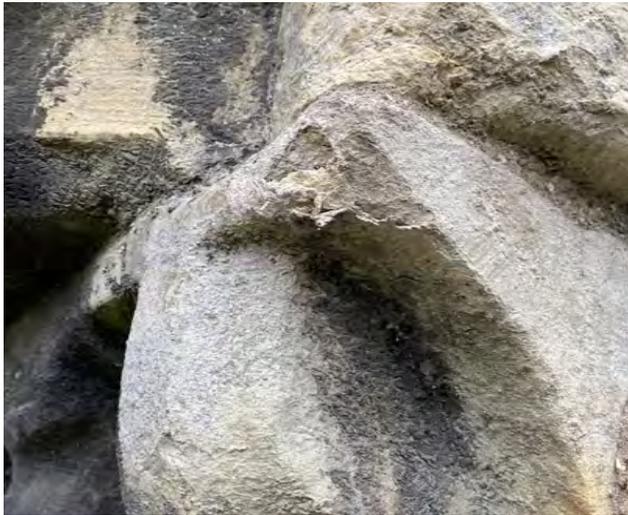
Friable surface near sulphuric crust

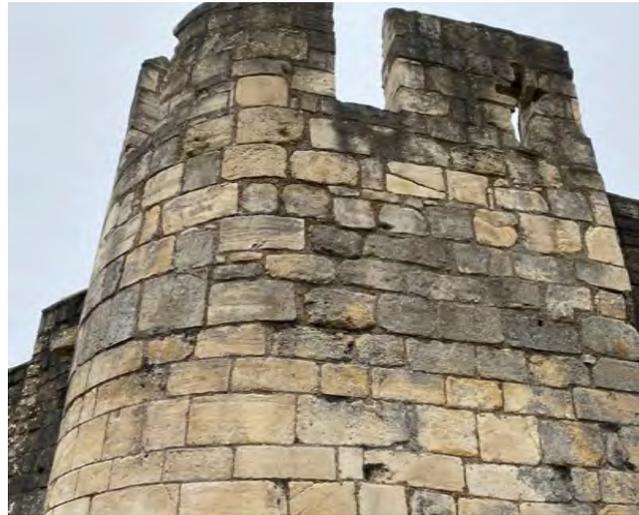
High level cracking and movement below crenel sill

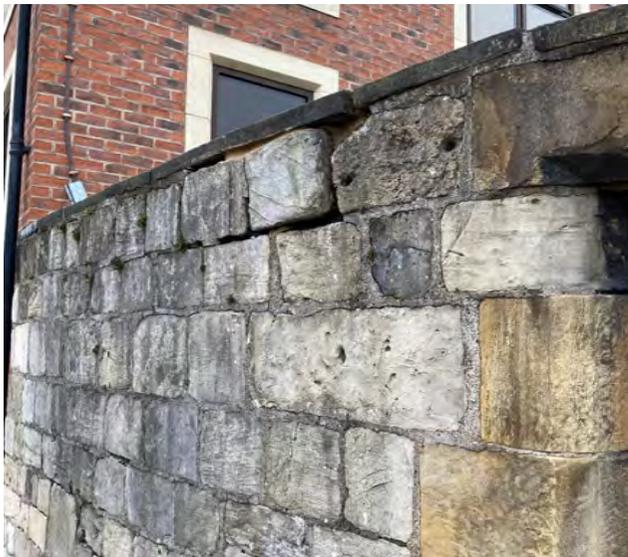
Open joints to low perimeter wall

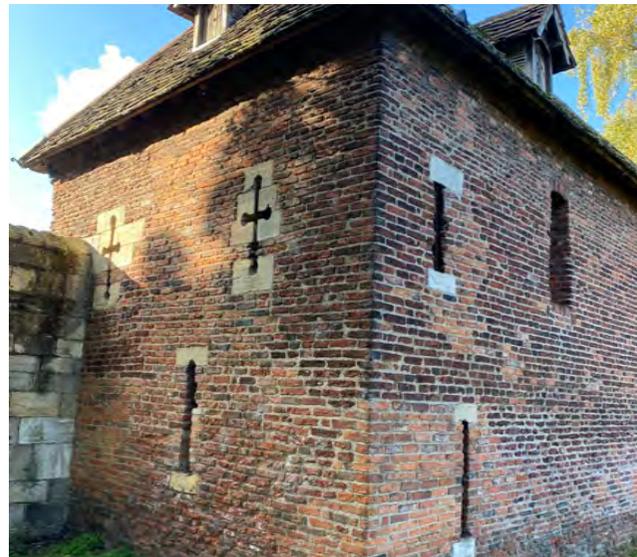
Low level decay to south eastern corner

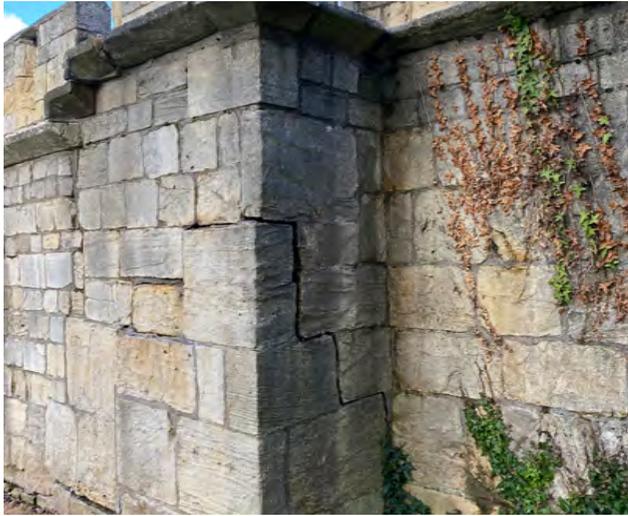
Cracking below steps and railings

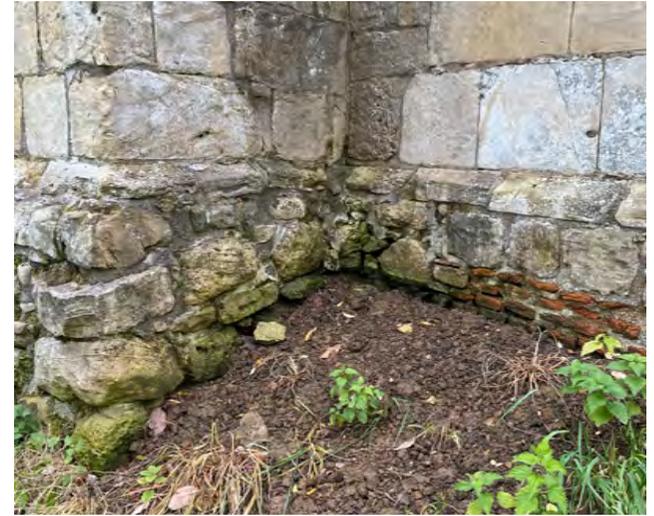
Rubble foundations are failing

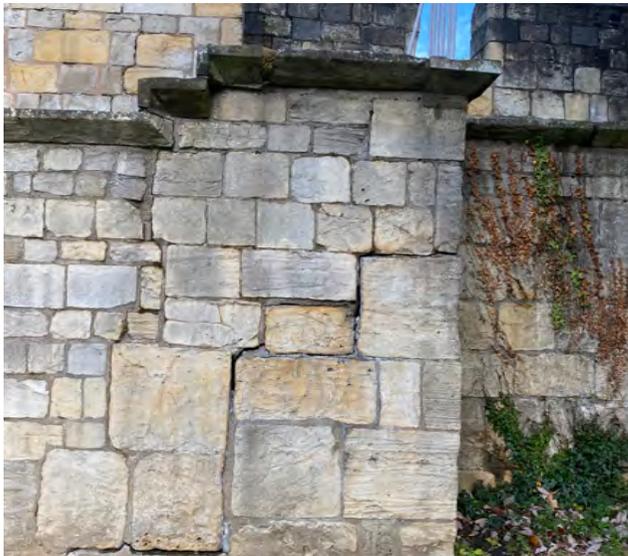
Structural movement below steps

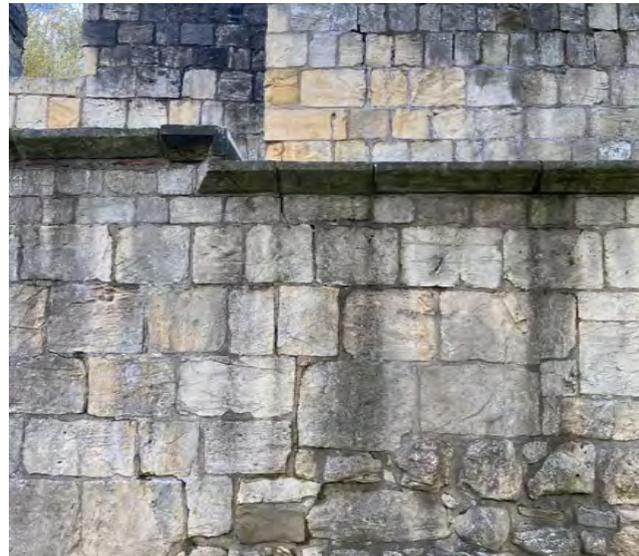
Structural movement to southern end of tower

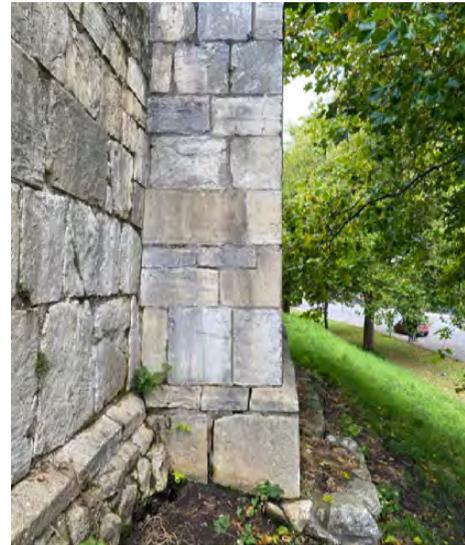
Movement to south west corner at plinth level

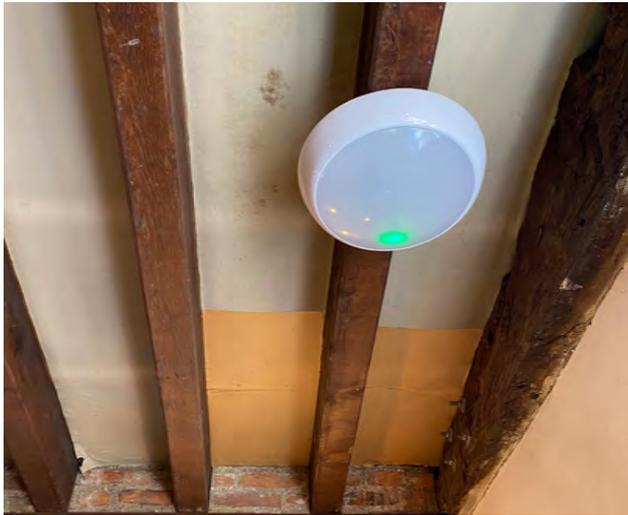
Evidence of water ingress to south west corner

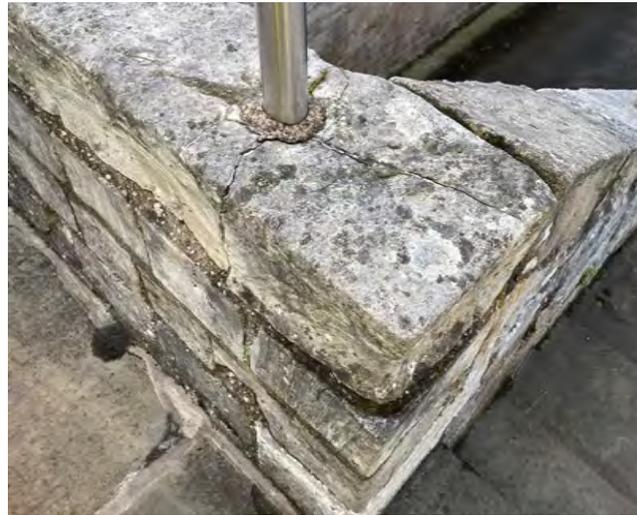
Fractured stone to north east corner of barbican walkway

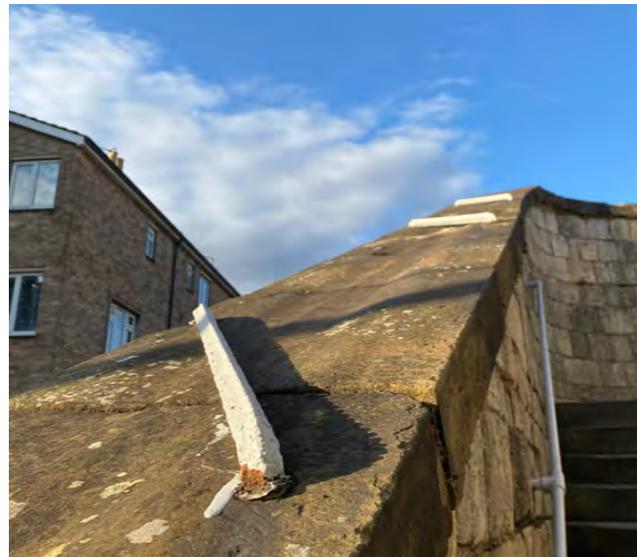
Structural movement to northern walkway stairs

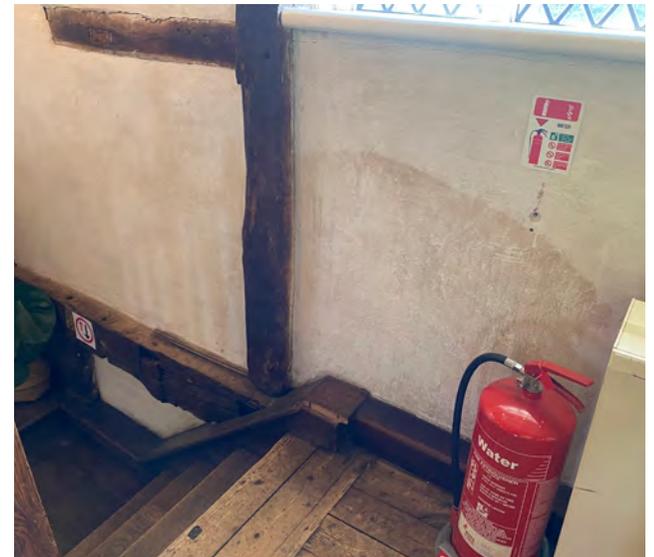
Water ingress to west elevation

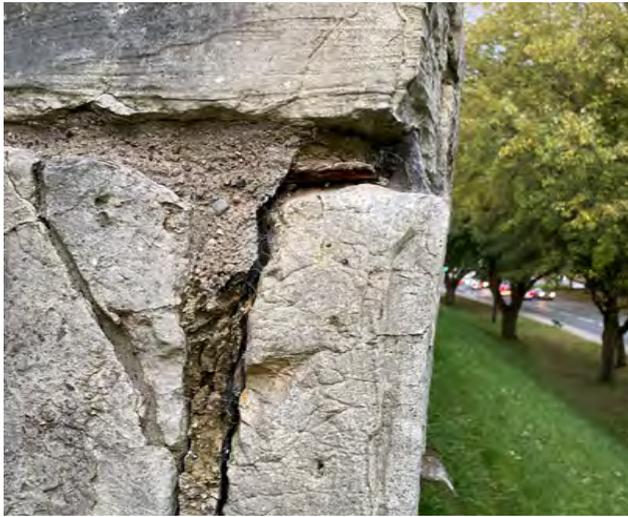
Movement to corner Chainage 3150

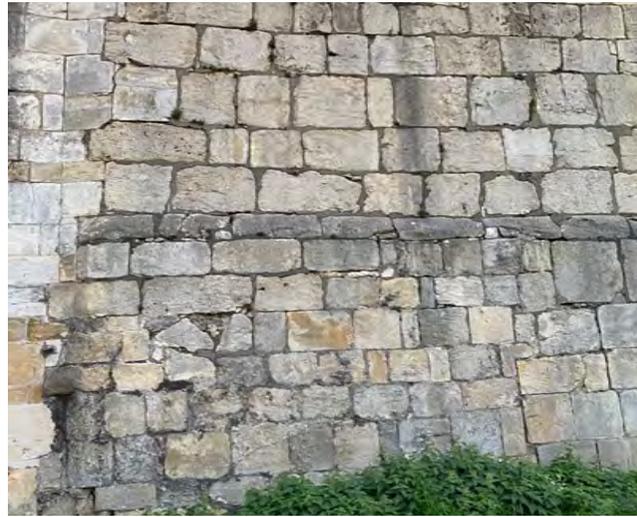
External wall by Fishergate Postern Tower with failing mortar joints

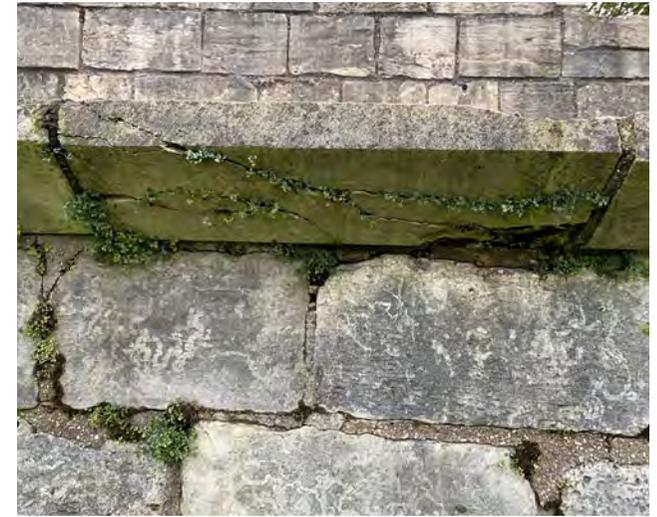
Failing new edge stones

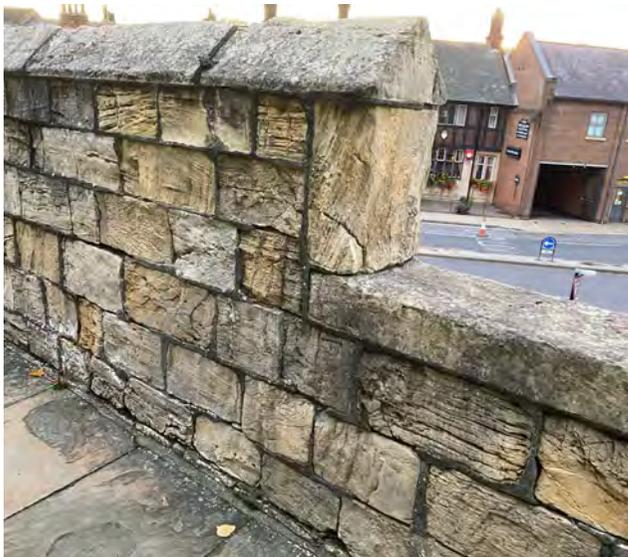
Fishergate Postern Tower end poor parapet wall condition

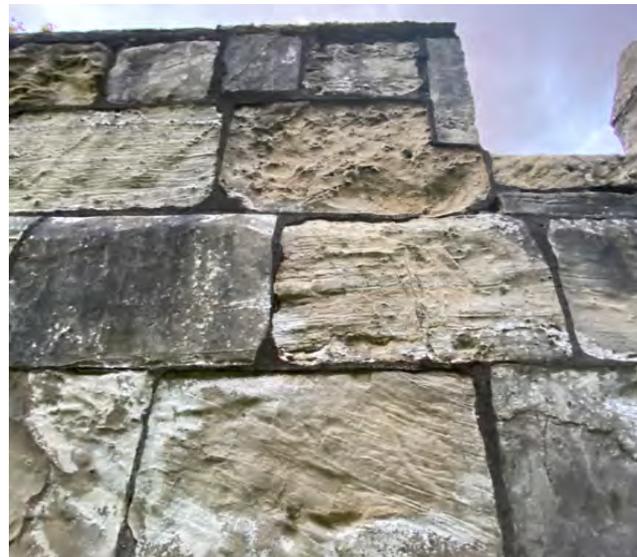
Poor hard cement mortar at Fishergate Postern Tower end
