York Walls

Conservation Management Plan
for the City of York Council

November 2021

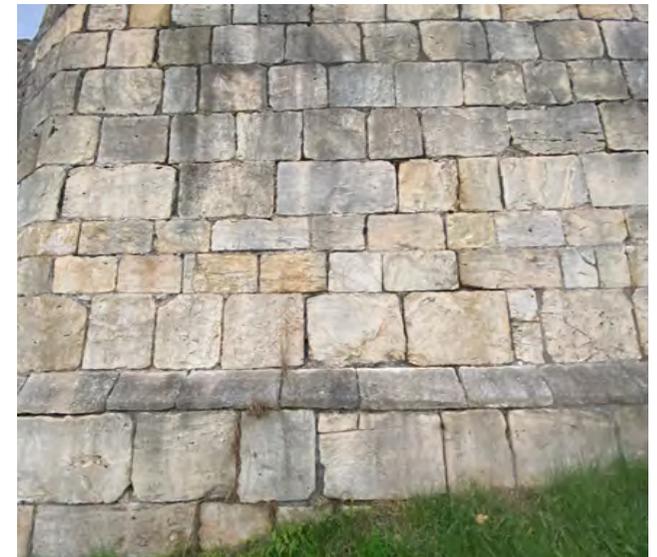
Structural movement to corner between Fishergate Postern and Tower 39

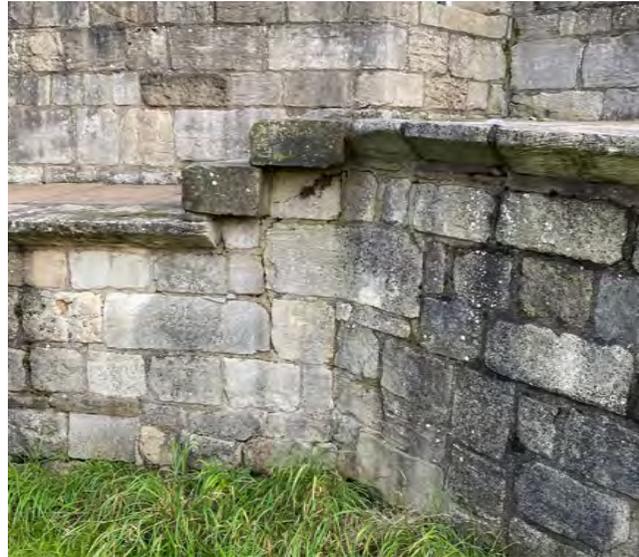
Movement around steps

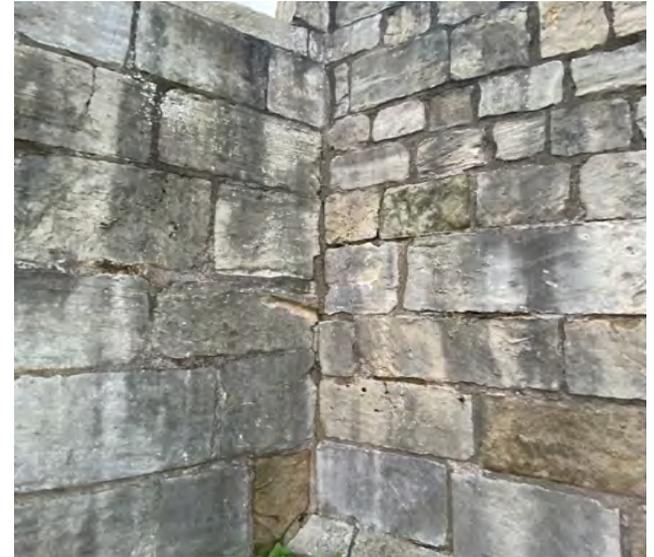
Movement crack to eastern junction with wall

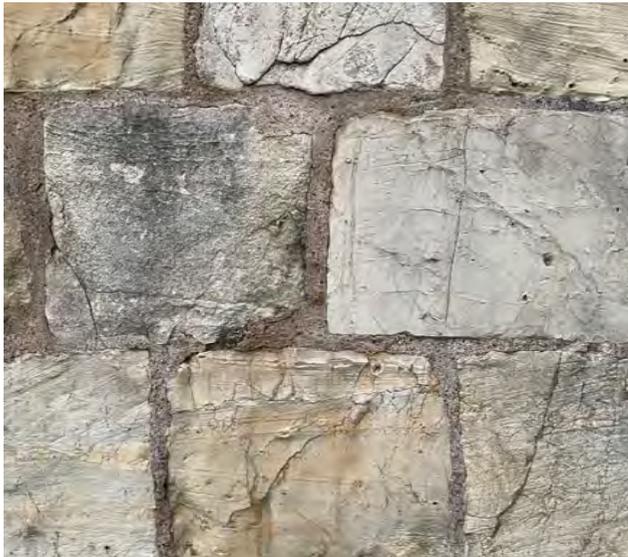
Movement crack to south elevation

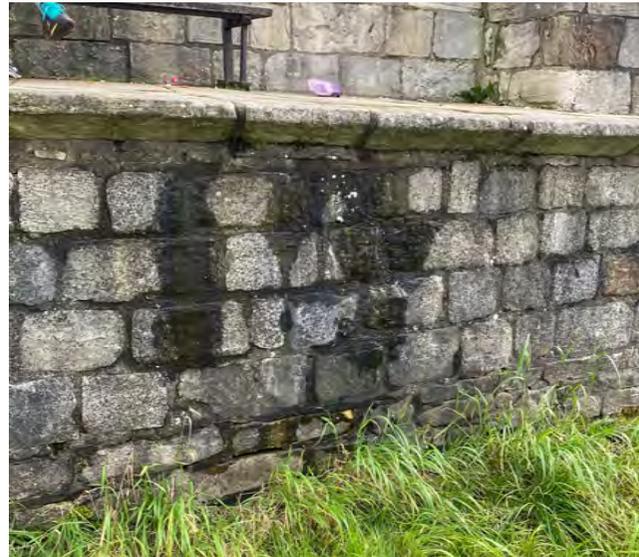
Water concentration to internal wall

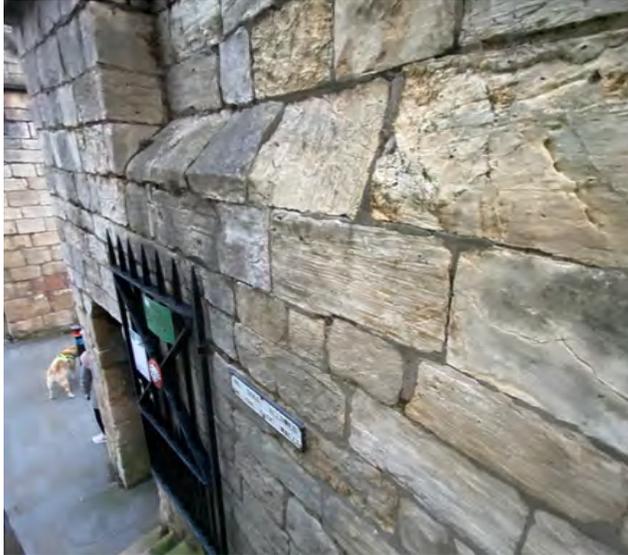
Cement mortar to western stair

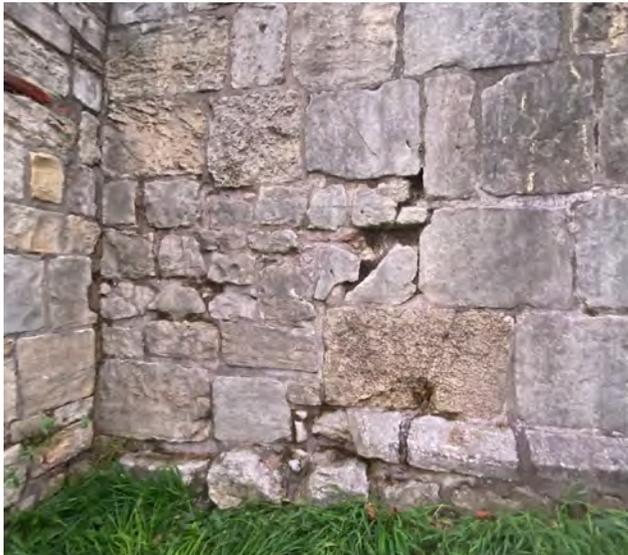
Movement to eastern junction with wall

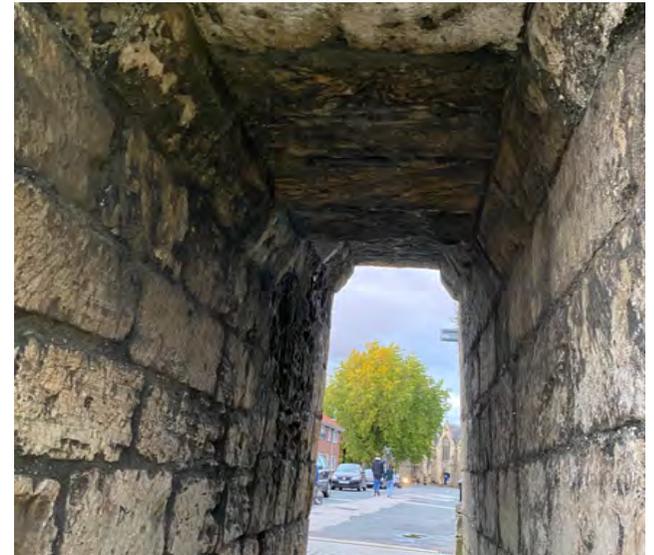
Water saturation to pedestrian walkways

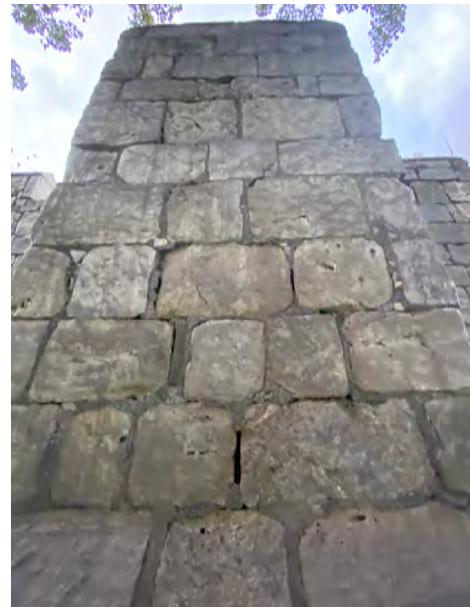
Structural cracks and open joints to southern elevation

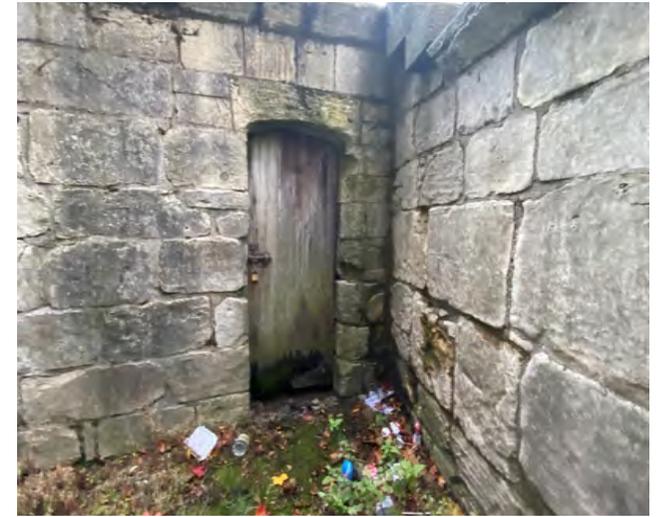
Rotting timber entrance door

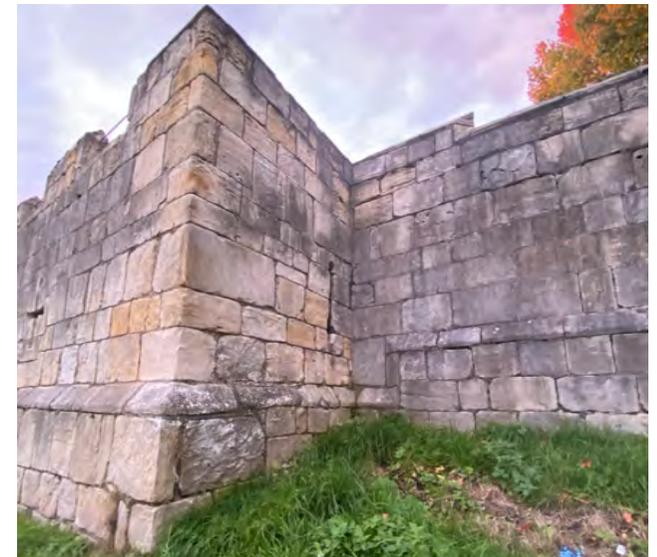
Features	FE2	Hole in chimney flue to external arrow slit. Modern plasterboard (assumed) cap is visible at the top of the flue (above opening to arrow slit) assume installed when walkway was reconstructed. The existing chimney flue has been capped with a modern material (assume plasterboard) at walkway level were perhaps it might have extended up to be a chimney. Perhaps it should be painted black so that the modern material is not so obvious or visually jarring if people look up the chimney flue.

Western junction with wall with arrow slit open to chimney flue

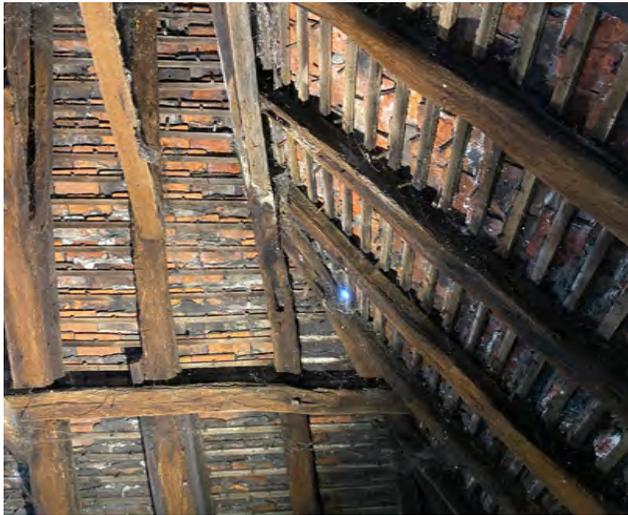
Holes in clay tile roof and rotting timber roof structure

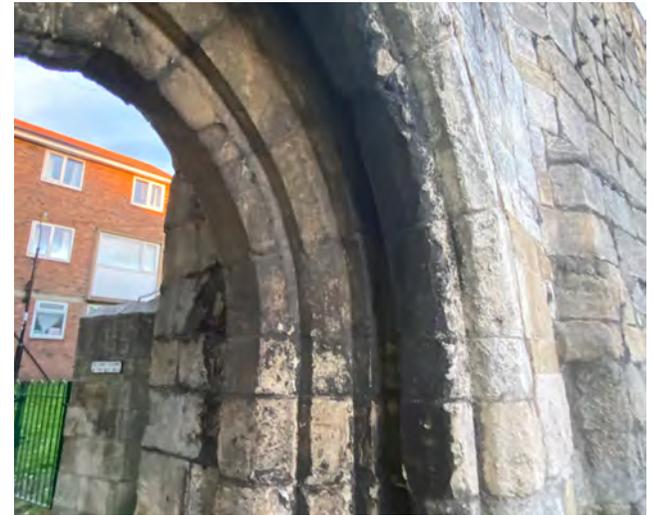
Sulphuric crust to arch (missing portcullis)

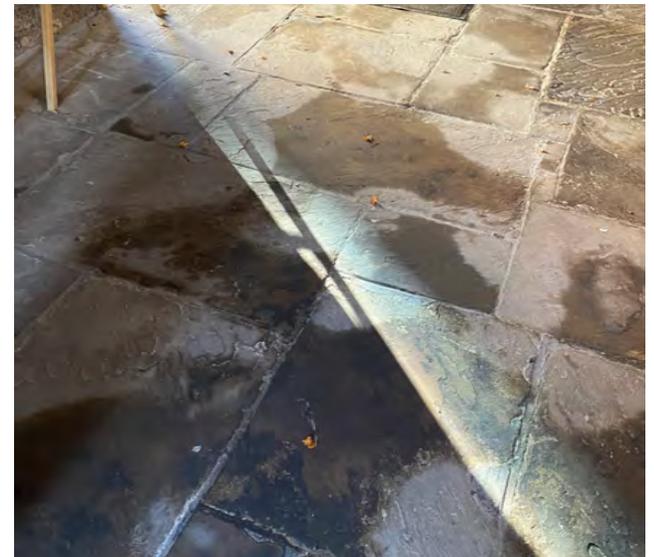
Water ingress to ground floor

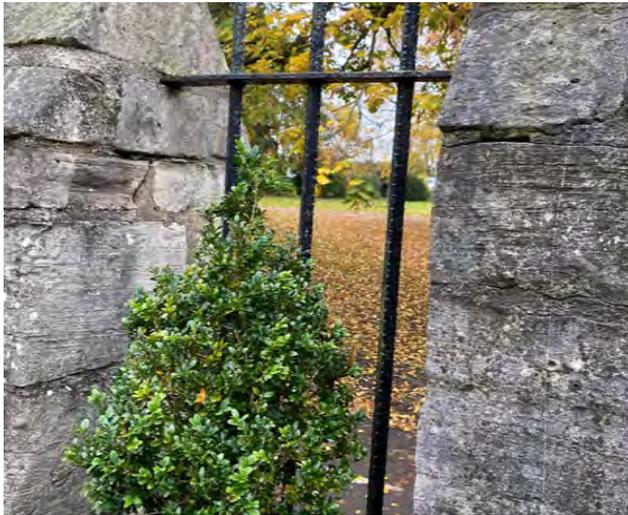
Element	Rating	Comments
External Masonry	M2	Wall covered by planting and ivy. Where wall is visible appears to be in a fair condition. Appears to be filled in crenels. Existing crenels with railings
Internal Masonry	M1	Fair condition. Algae growth. Few fractured and spalled stones but in stable condition.
External Mortar	P1	Cementitious mortar
Internal Mortar	P2	Open mortar joints with cement mortar accelerating erosion to surrounding stones.
Flagstone (walkway)	F2	Large stones that appear to match the wall geology (not flagstones). Open mortar joints against parapet wall with cement mortar accelerating erosion to surrounding stones. Stone has weathered away next to hard cement mortar leaving open holes for water to collect within and accelerate decay.
Railings	RA2	Railings within crenels are rusting with failing paint finish.

Crenel with railings

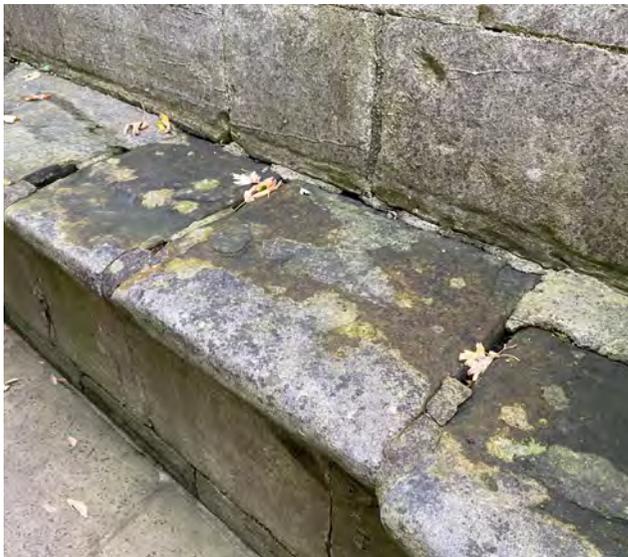
Failed concrete mortar and open joints to walkway

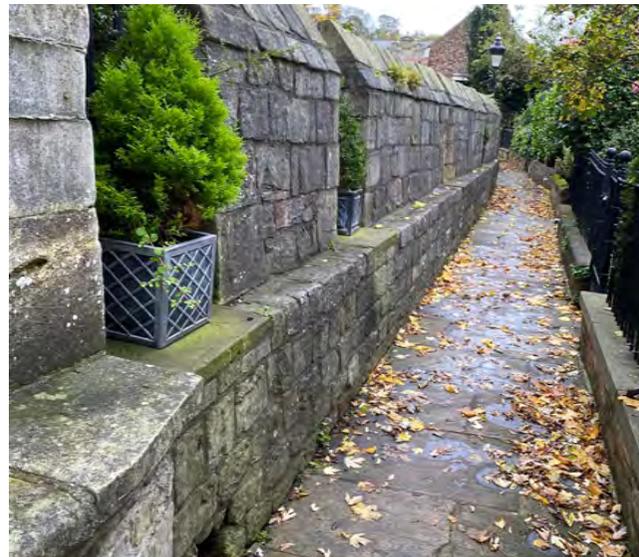
General interior view of river end

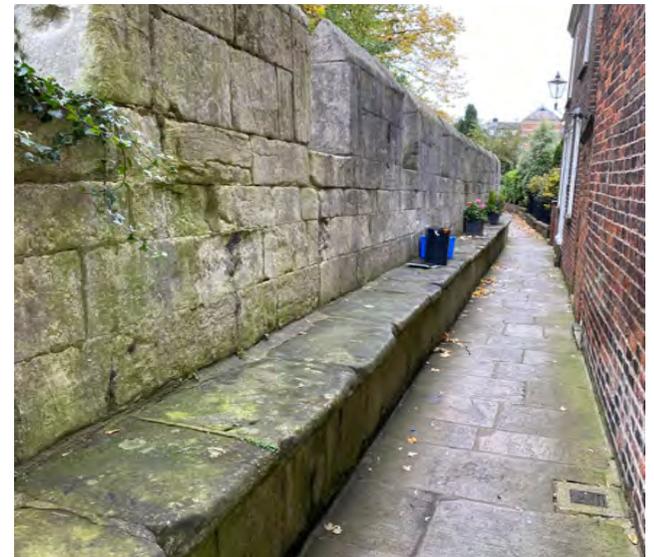
General internal view

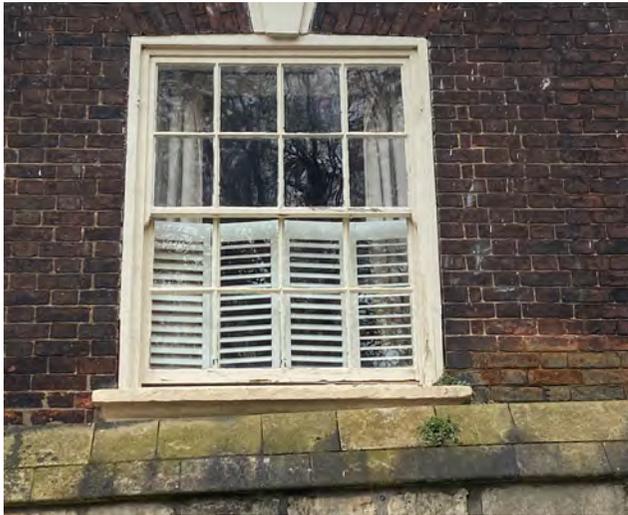
Element	Rating	Comments
External Masonry	M2	Stone wall to ground level and brick to first floor. Spalling brickwork within cement mortar. Fractured stones from ferrous fixings (south west corner), cement mortar and structural movement. North west rain water pipe is currently directing water into stone wall at low level rather than away from the building. Signs of saturation where the brick structure meets a horizontal stone surface that collects water and splashes the bricks above - assumed to be causing internal damp issues. Spalling brick below western window of south elevation. Vertical joint to western elevation is moving. Eastern chimney and elevation has extensive ivy growth. Stone at low level has suffered from saturation from rain caused by adjacent tarmac and flood damage.
External Mortar	P3	Hard cement mortar to stone at low level and brick at high level. Open joints where mortar has failed or become separated from surrounding masonry. Vertical joint to western elevation has failed cement mortar that has fallen away leaving exposed joints.

Erosion of water within brick above low level stone

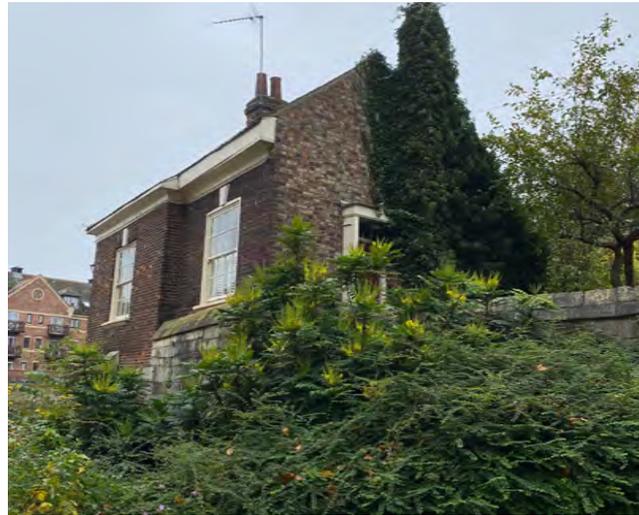
Roof	RO2	Slate roof. Ivy growth over eastern chimney. Failing cement flaunching to central chimney. Painted timber coving to eaves has peeling and failing paint.
Doors	D1	Painted timber to entrance door up external steps to assumed raised ground floor above the wall.
Windows	W2	Painted timber 6 over 6 sash windows. Paint failing. Cracks through sills and brick lintels to south western window on southern elevation.
Interior		No Access. Residential

Ivy covered eastern chimney

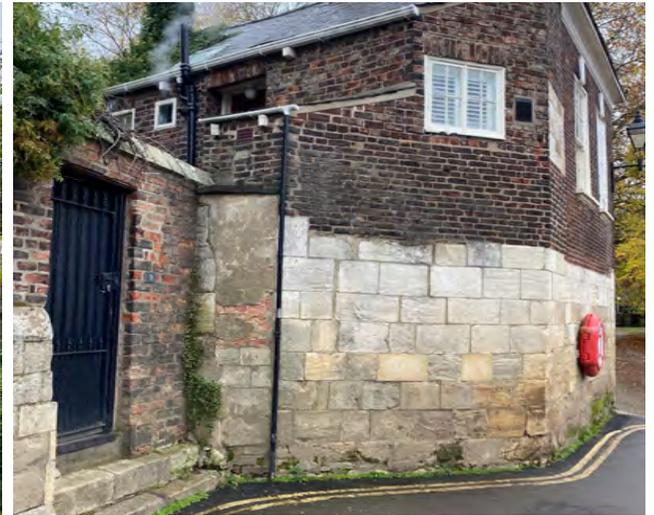
North western elevation

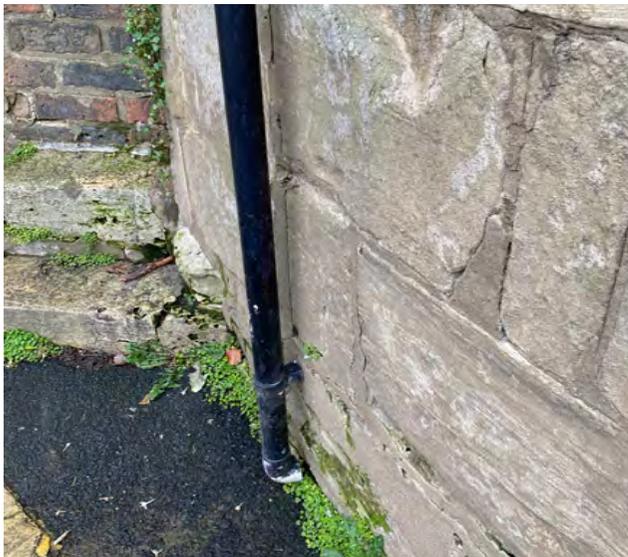
Northern rainwater pipe discharging into building

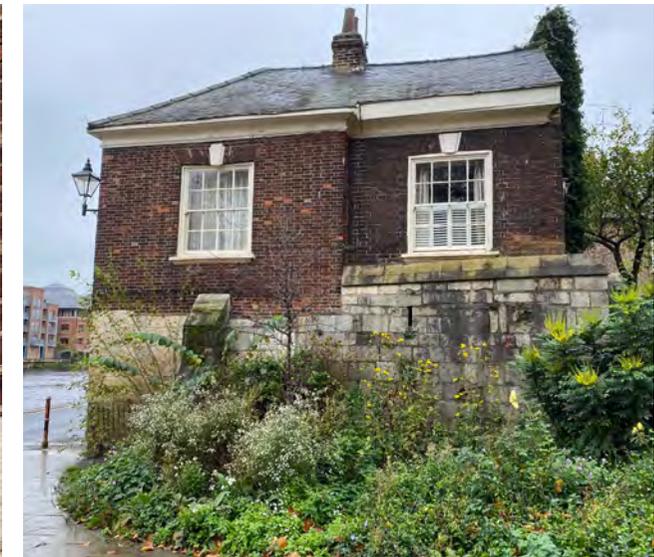
Southern elevation

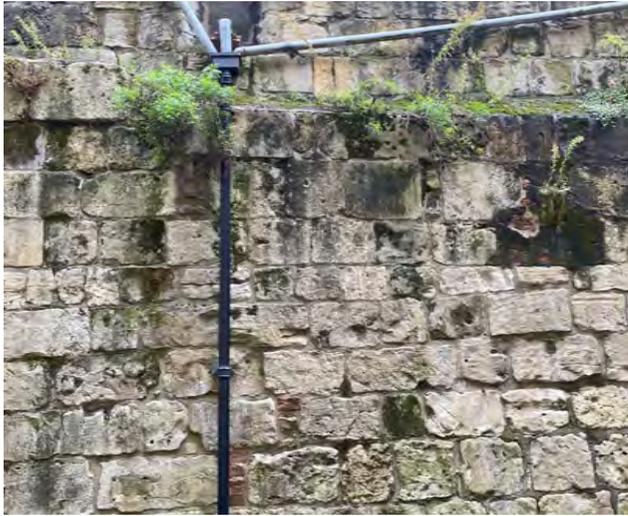
Internal Masonry	M2	Water Tower end: 2 movement cracks to low wall near Intermediate Tower A, assumed to be caused by tree root movement. hard cement mortar. Poorer condition of wall between Gate House and the black gates. Large section of concrete mortar repair above (non accessible) walkway. North of St Olaves wall has been built upon in brick with collapsed sections with vegetation growth. From Intermediate Tower C to St Mary's Tower the cement flaunching is failing allowing vegetation to grow. Large vegetation growth in same area. Note, timber hatches within crenels (2no.). Northern run from St Mary's Tower to St Margaret's Postern Tower has brick buildings that abut the wall with lead flashing at joints. Few number heavily eroded stones revealing core of wall. Large area of new stones integrated into fire damaged area adjacent to Intermediate Tower D. Number of fractured stones by Art Gallery, vegetation growth and areas of exposed core. Failed cement flaunching. Next to Art Gallery area very saturated causing algae growth. Failed cement flaunching and extensive vegetation growth. Rain water pipes from neighbouring property descends down wall.

Adjacent building drainage running over the walls

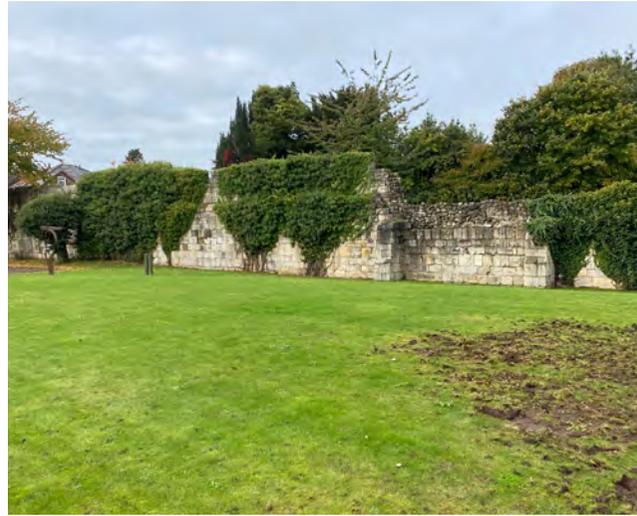
Extensive vegetation growth

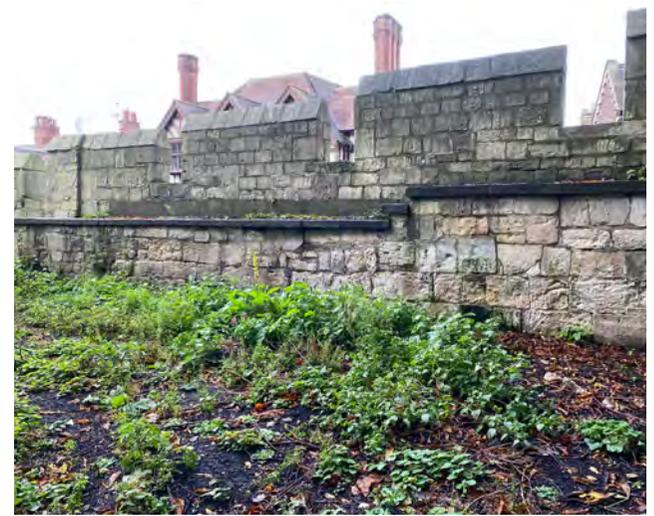
Large cementitious repairs

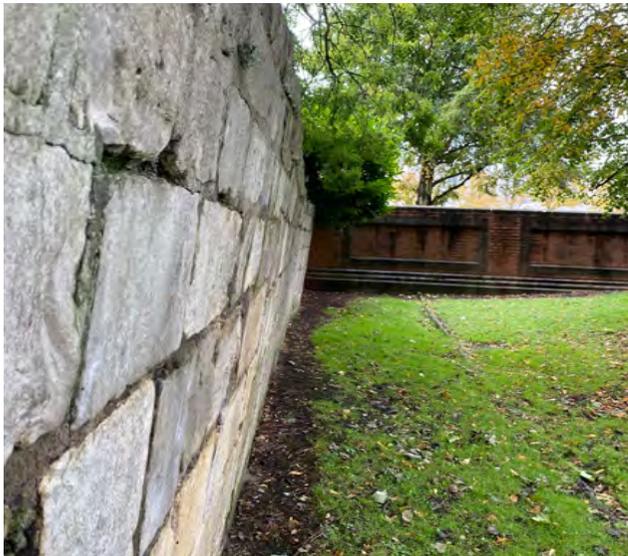
Leaning wall near IT A

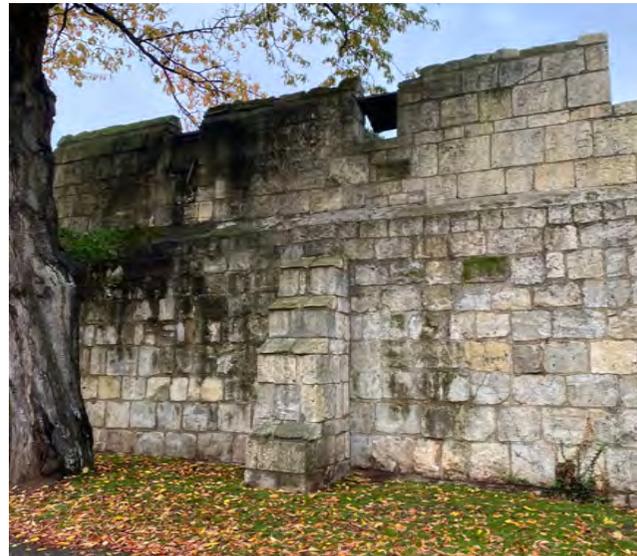
Timber crenel hatches

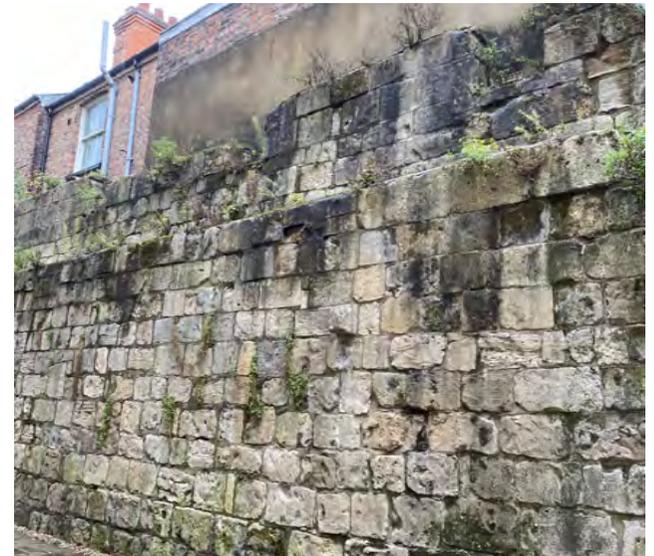
Wall north of Art Gallery saturated and covered externally by buildings

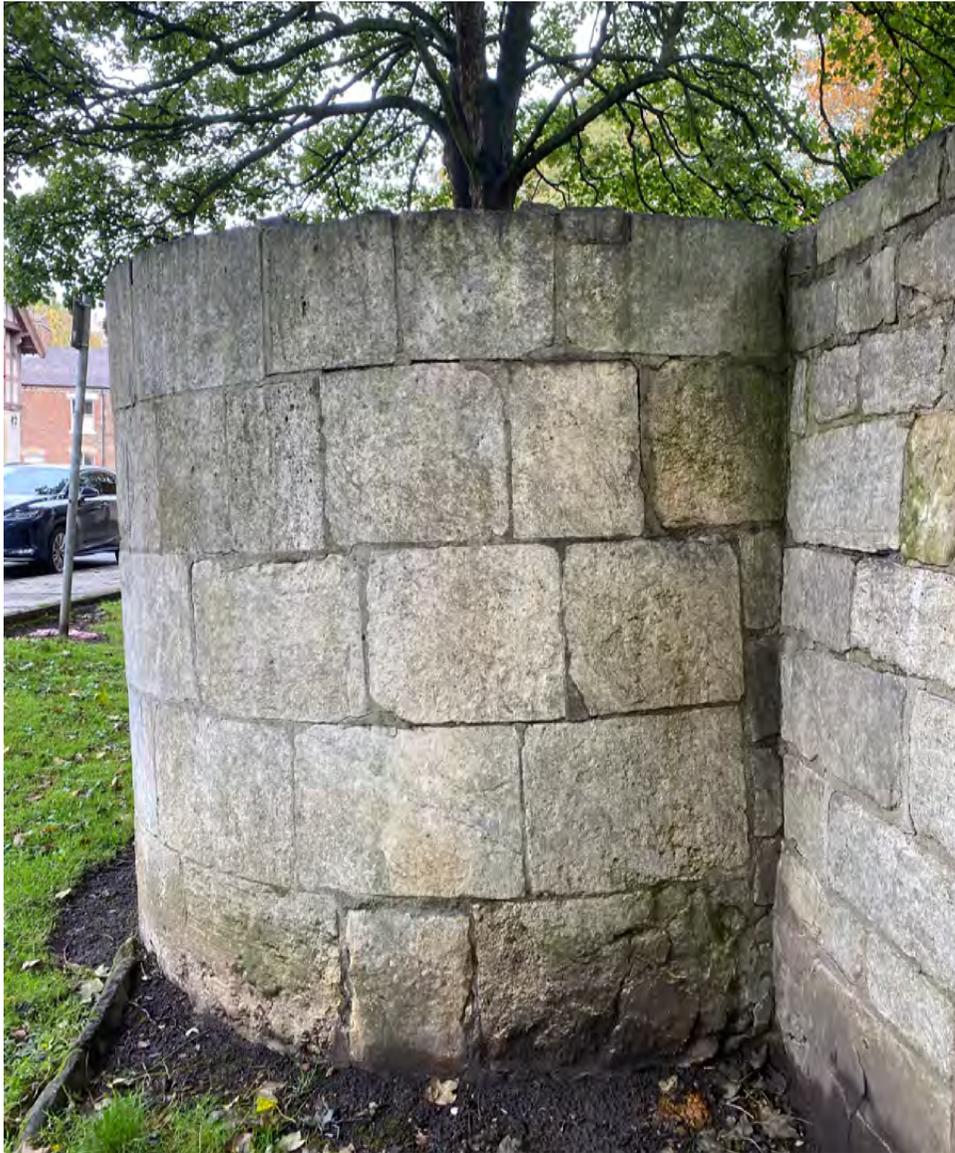
Element	Rating	Comments
External Masonry	M3	Small low round tower with upper section of stones missing as per the surrounding area of wall. Movement cracks through structure assumed to be caused by tree roots from adjacent tress.
Internal Masonry	M2	Low masonry with exposed core. Movement cracks from tree.
External Mortar	P2	Cracking cement mortar.
Internal Mortar	P2	Hard cement mortar. Movement cracks from tree.
Flagstone (walkway)		No walkway
Railings		No railings
Interior		No interior

South elevation

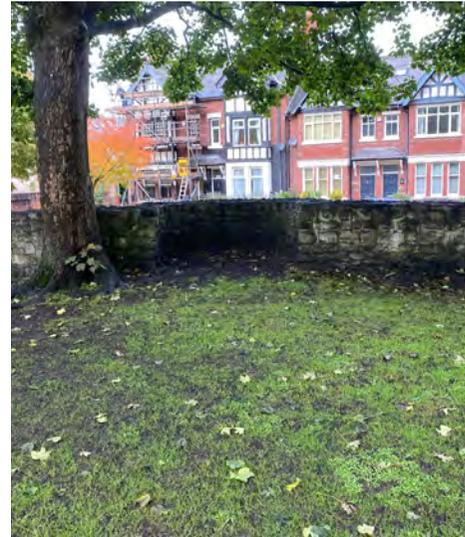
Interior with proximity to tree

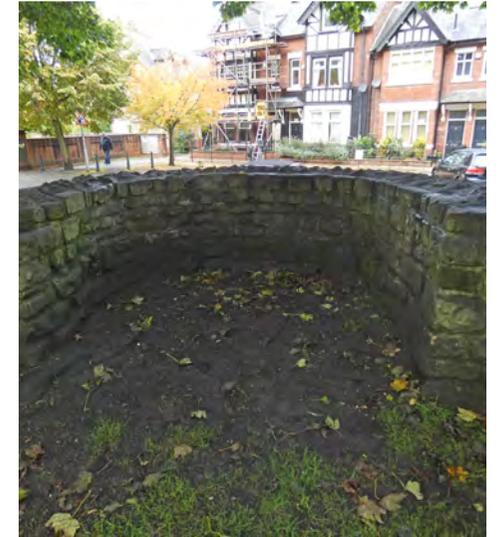
Internal

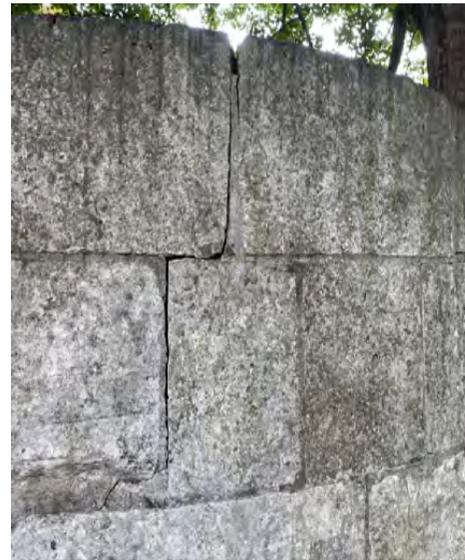
Movement crack

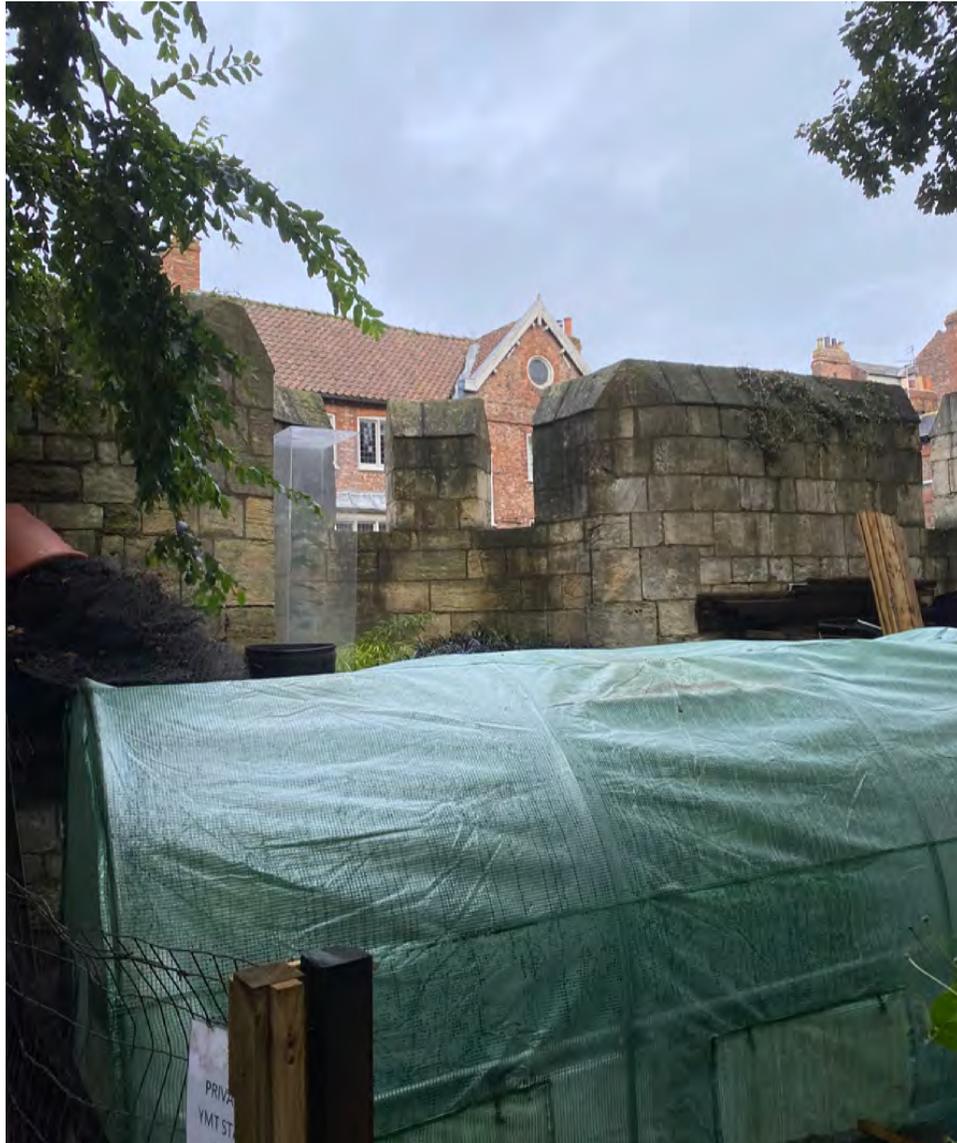
Element	Rating	Comments
External Masonry	M1	Good condition. Some fine movement cracks and fractured stone. Algae growth at base.
Internal Masonry	M1	Appears sound but access was not possible as structure is covered by poly tunnel from occupiers of Gate House.
External Mortar	P1	Tight joints with some movement cracks. Mortar has weathered back in places to no longer be flush.
Internal Mortar	P1	Appears flush from a distance.
Flagstone (walkway)		No access
Railings		No railings
Interior		No interior

Access restricted

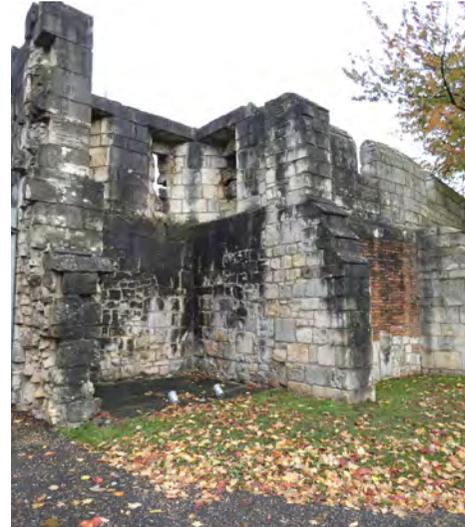
Interior, vegetation growth to horizontal surfaces

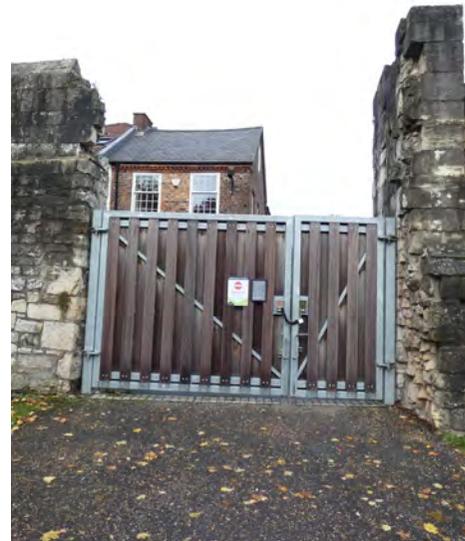
Modern gate internal view

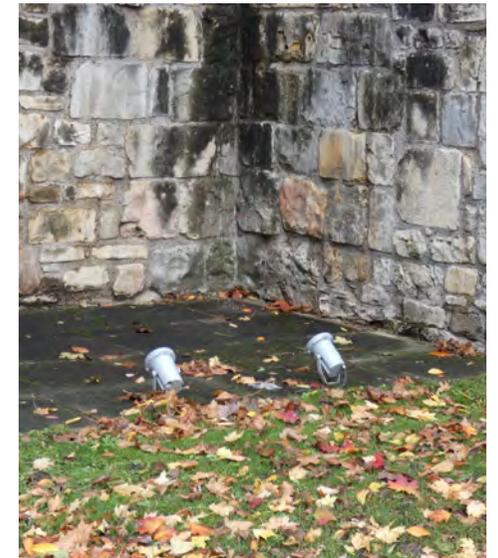
Modern paving to base of IT C

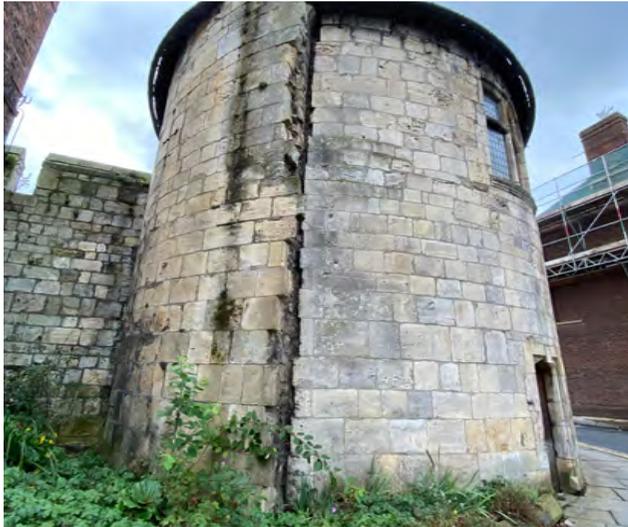
Exposed core to north east

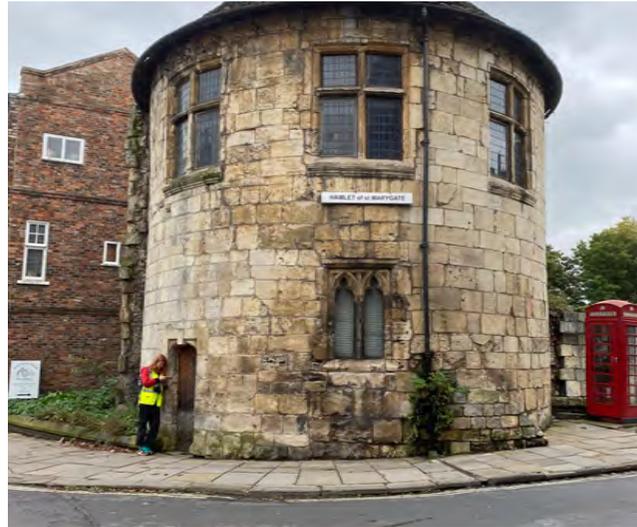
General external view

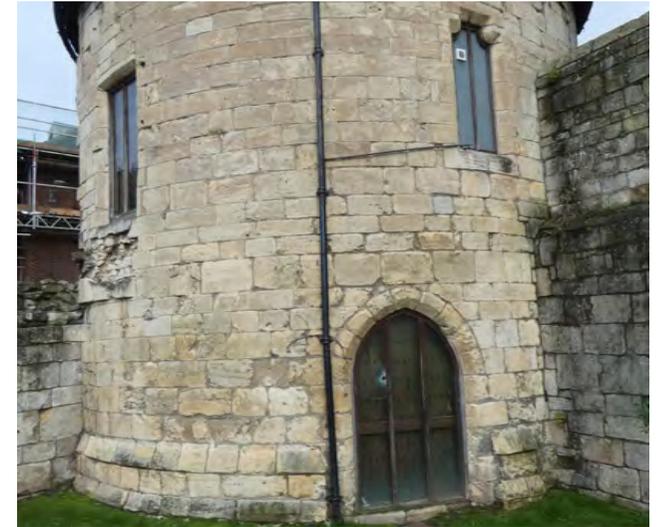
Internal elevation with broken door

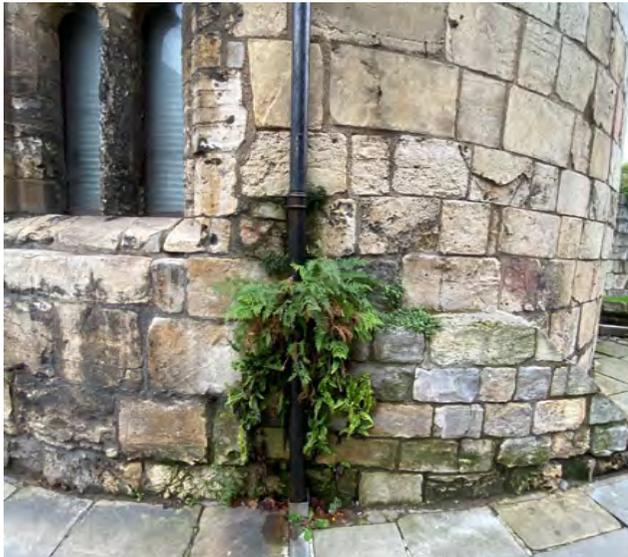
Leaking rain water pipe

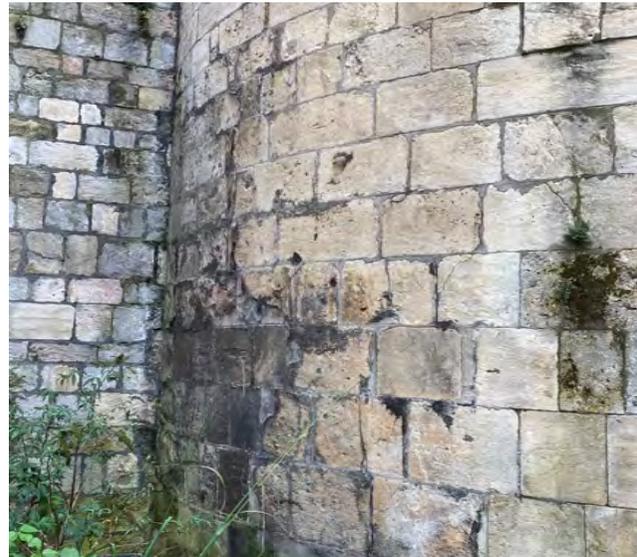
Structural cracks, fractured stones and failing cement mortar to eastern junction with wall

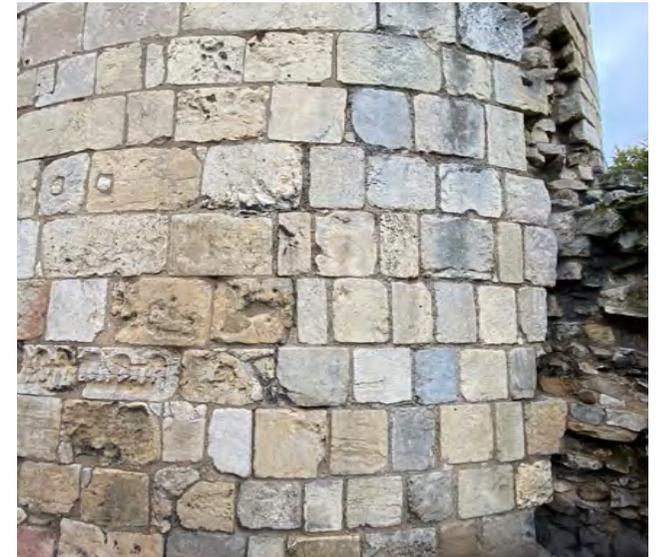
Structural movement cracks to south west corner

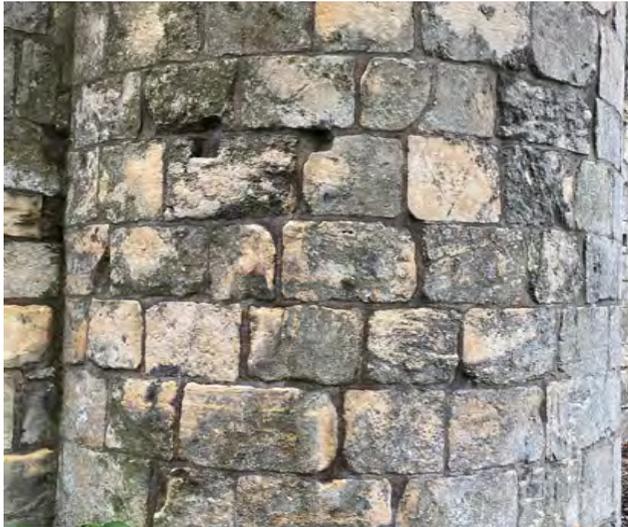
Cracking along mortar joints to exterior

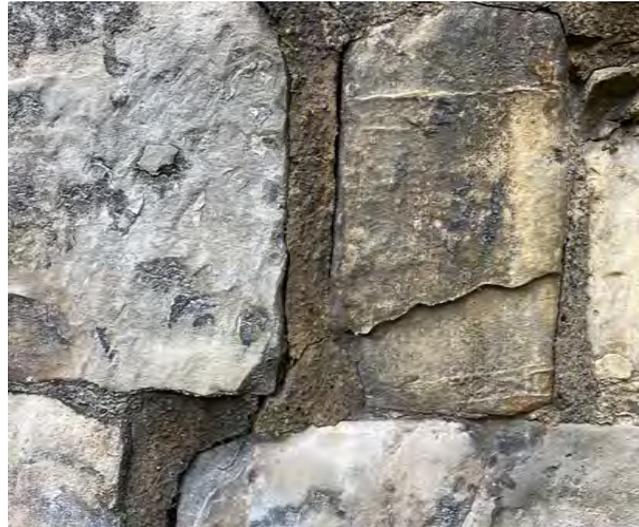
Element	Rating	Comments
External Masonry	M3	Movement cracks causing fractures to stones. 2 number significant cracks. One has been historically monitored. Movement through cementitious pebble dash mortar.
Internal Masonry	M1	Fire damaged stones (pink in colour) have recently been repaired with small pins. Vegetation growth. Painted steel structure over east window overpowers the tower visually and should be removed with more visually sensitive solution.
External Mortar	P3	Failing cementitious mortar with pebble dash finish has opened up around movement cracks.
Internal Mortar	P1	Recently repointed.
Flagstone (paving)	F1	Square paving slabs give a juxtaposed modern look.

External structural movement cracks

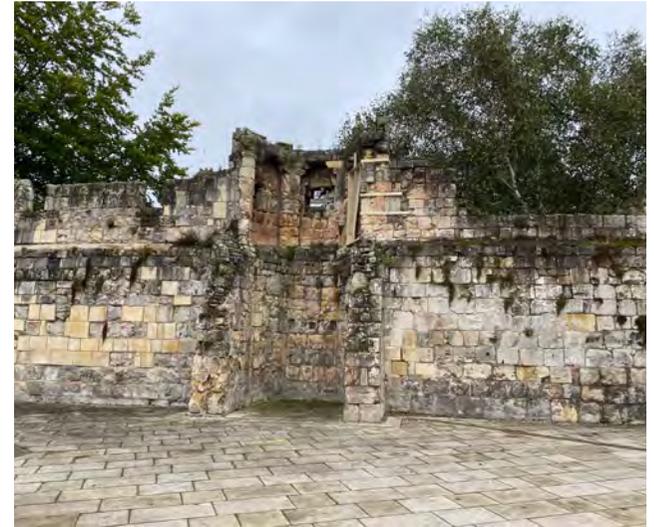
Internal view

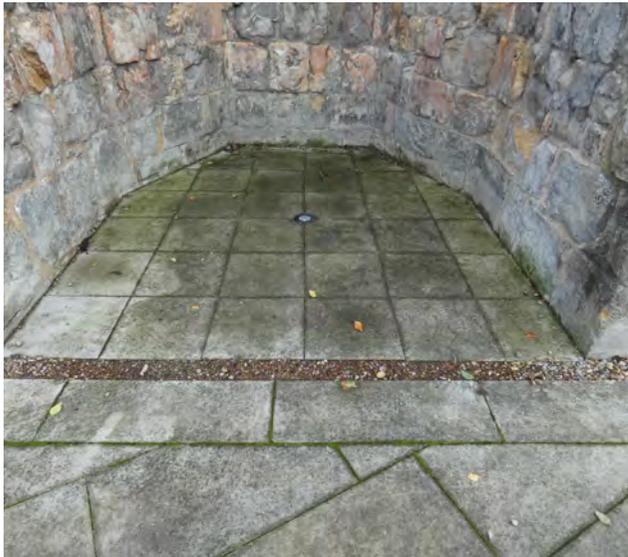
Modern base to IT D

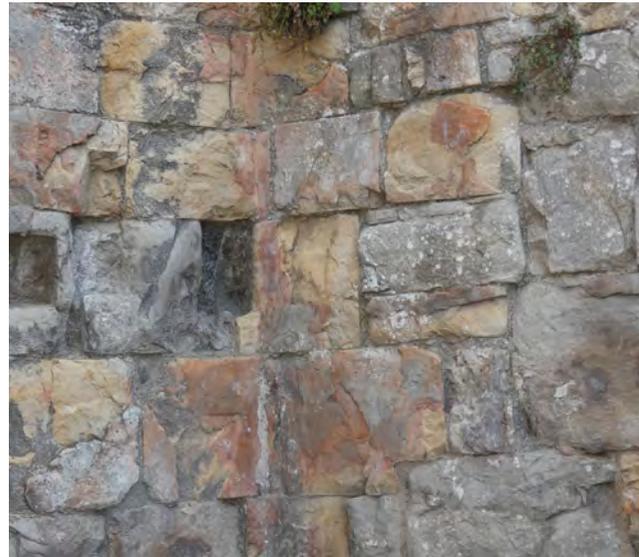
Pink fire damaged stones pinned

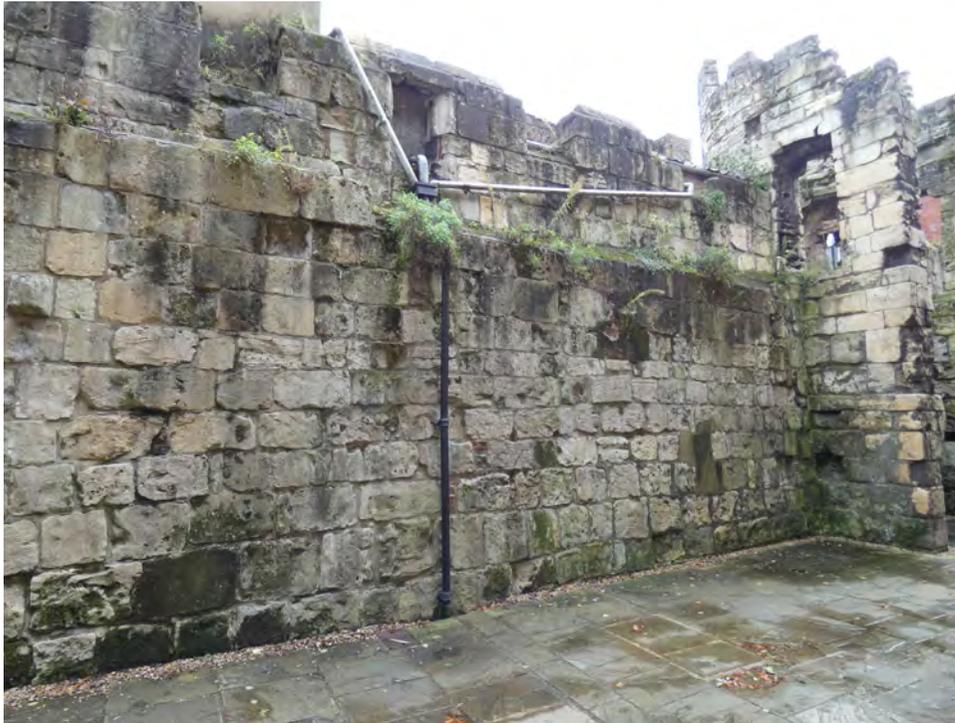
North west elevation

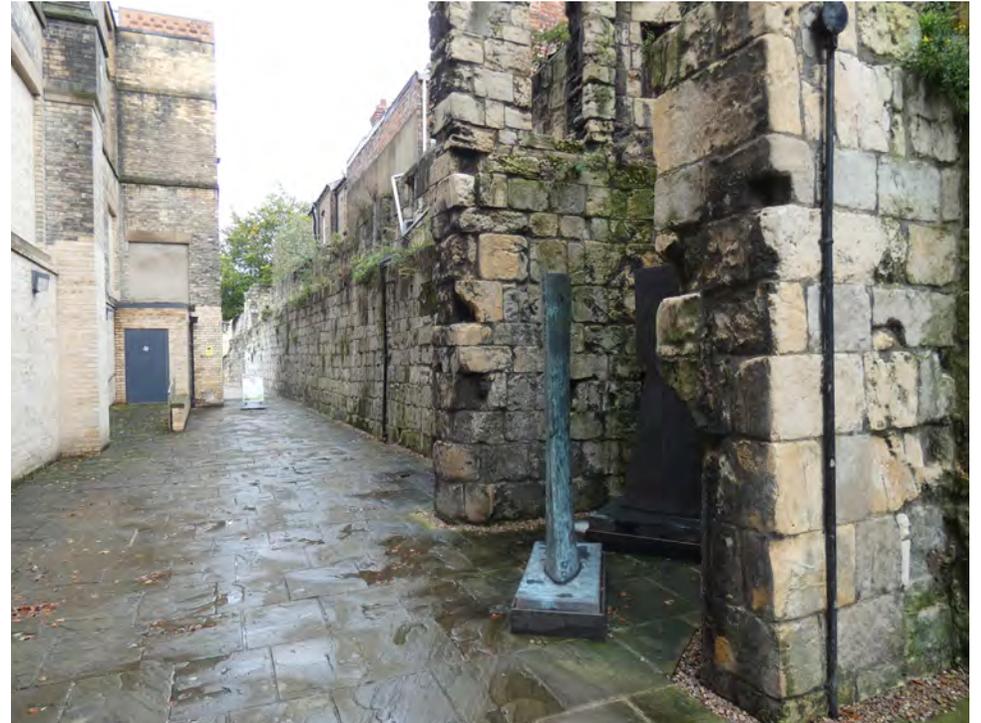
Saturated walkway north of Art Gallery

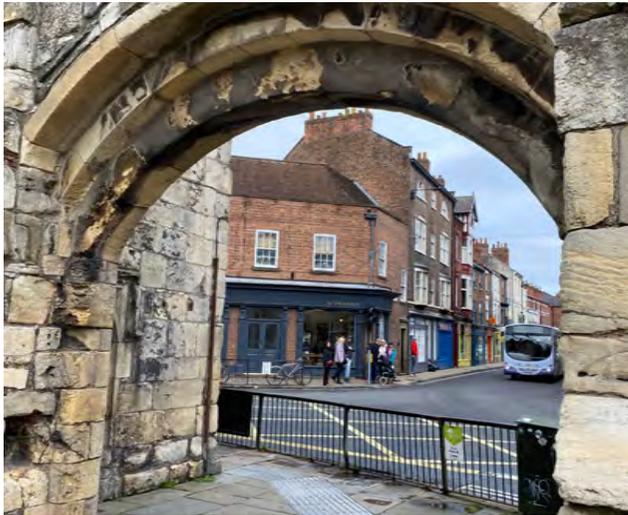
Element	Rating	Comments
External Masonry	M2	High level saturation over arch with vegetation growth. Loss of detail to hood moulding to arch.
Internal Masonry	M3	Cables hanging over facade. Crack through window lintel. Heavily weathered stone to springing point of arch. Arch suffering from sulphuric crust and cementitious repairs trapping mortar and accelerating decay. SVP and RWP blocked on south west side with vegetation growth.
External Mortar	P1	Fair condition.
Internal Mortar	P2	Open joints at low level. Heavily eroded stone at base of arch. Open joints and vegetation growth over arch.
Roof	RO1	Clay tile roof. No reported leaks.
Doors	D1	Double timber door. Minor graffiti damage.
Windows	W1	Leaded light windows with timber shutters.
Ceiling	C2	Exposed timber with 2 water stains from leaking WC. Modern plaster ceiling to top floor hiding timber roof structure with no access hatch to allow inspection or maintenance.

Erosion of stone from water getting trapped behind sulphuric crust

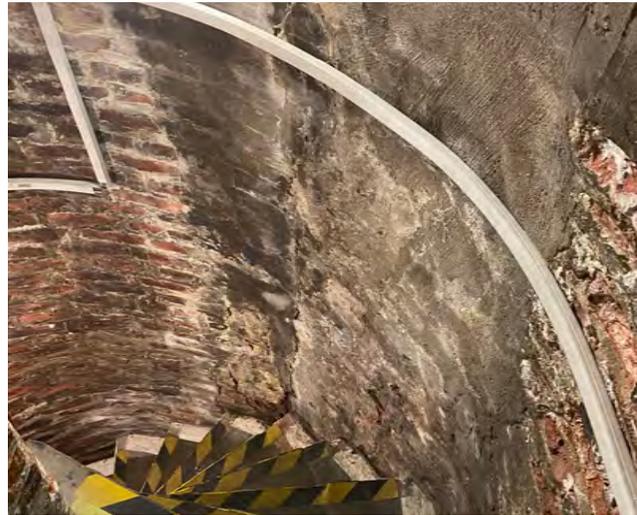
Internal Walls	I2	Exposed bricks. Evidence of salt movement. Damp to spiral stair external wall in location of external RWP and SVP.
Internal Floors	FL1	Carpet. WC to top floor.
Features	FE1	Brick arched reveals, stairs and windows.

Internal water ingress through cementitious render to spiral stairs from external down pipes

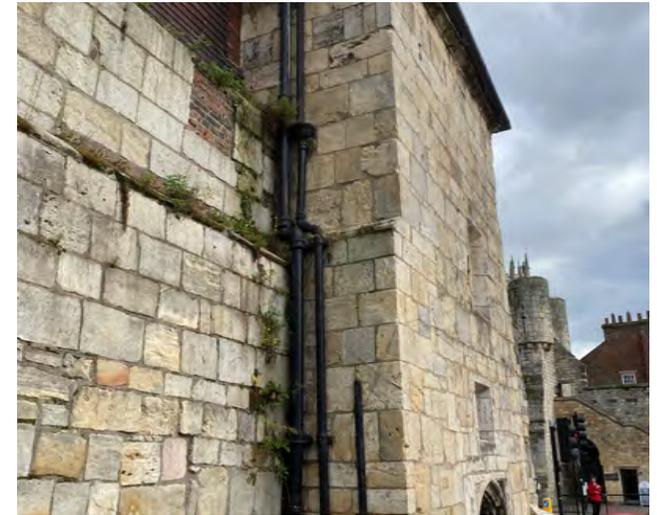
Rain water and soil pipes to north western elevation causing water ingress

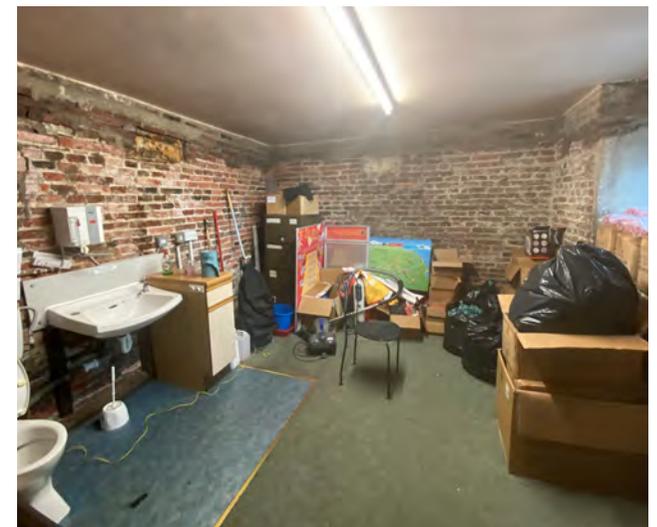
Top floor modern ceiling with no access to roof void, cement mortar to bricks
