York Walls

Conservation Management Plan
for the City of York Council

November 2021

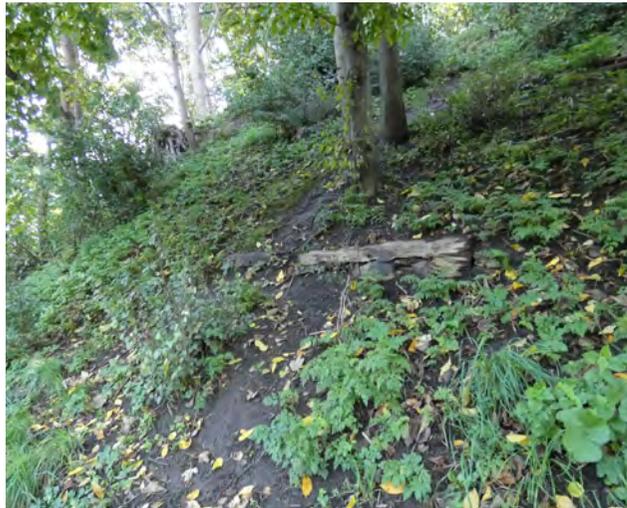
Ramparts	R2	<p>The outer ramparts are steep with grass, planted with some mature trees lining the roadside. Access to the base of the rampart is easy, via a low dwarf brick and stone wall.</p> <p>There is some erosion to the first section, between Towers 1 and 2 and there is street furniture / clutter near Tower 1.</p> <p>Top is low where movement is taking place; generally steep with trees at east end. There is a rotting stump under first corner, which could cause issues in future. By Tower 1: Height against stone wall should be monitored. Perhaps has lowered to reveal rough foundation stones?</p>	The opportunity to supply ground source energy to nearby residential properties as a low-carbon heat network should be considered. This would align with the Government's 2017 Clean Growth Strategy. It would also provide an archaeological opportunity to excavate within the ramparts, but could be costly. The stability of Baile Hill should be reviewed and again any proposals would be subject to an archaeological review.

Section 1 Erosion at Baile Hill

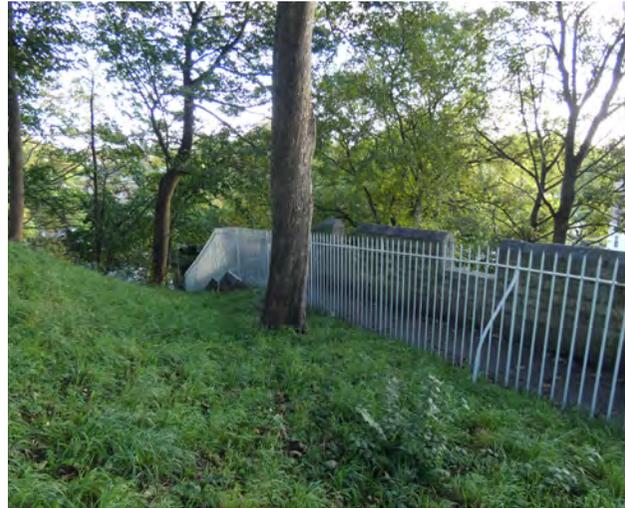
Theme/Criteria	Score	Comments	Threats / Opportunities for change / Recommendations ¹
Access	A3	There is stepped access to the walls, with removed Victorian railings to the access steps and modern railings (detracting) facing Baile Hill and the steps leading from Tower 1 to the wall walk. People can access the wall walk from an informal path adjacent to Baile Hill. A pavement, following the line of the walls, is provided internally and externally.	The modern railings between Tower 1 and 2 are visually intrusive; their replacement would enhance the appearance of this section of wall. Access to Baile Hill could be improved with a new level path from the walkway to the hilltop, sensitive landscaping and seating; subject to a review of the archaeological implications and other factors such as ecology. The wall walk comes very low to the rampart near to Baile Hill, which provides an opportunity for improving physical access to the wall walk by provision of ramp or similar.

Section 1 Modern railings between Baile Hill and the wall walk

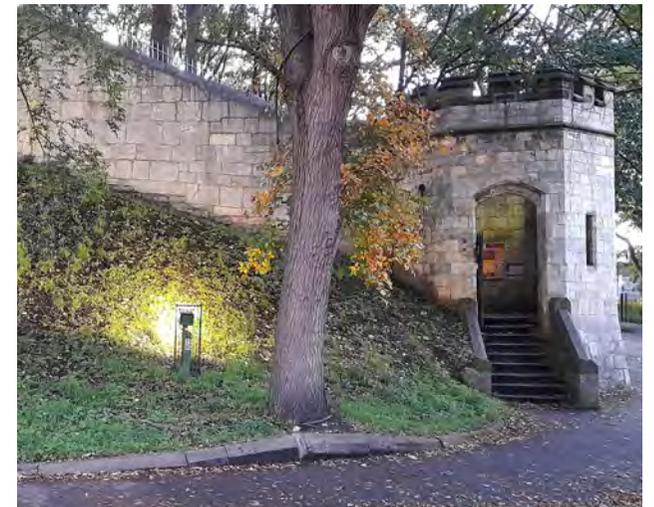
Section 1 Outer rampart lighting, Tower 1

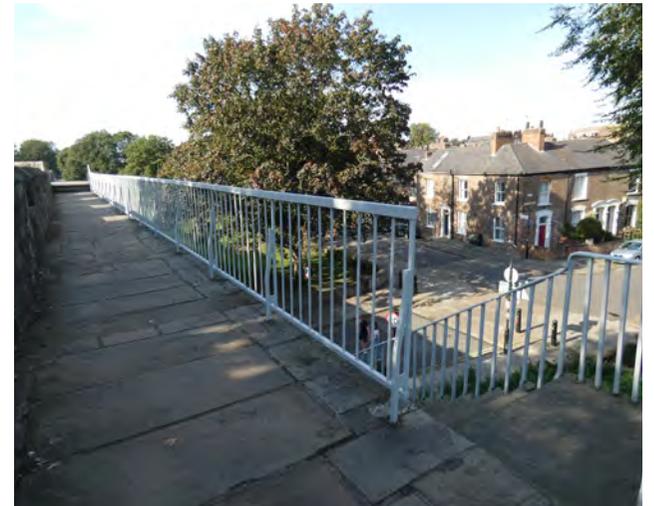
Theme/Criteria	Score	Comments	Threats / Opportunities for change / Recommendations
Access	A3	<p>Obtrusive modern railings and spikes to the southern steps at Victoria Bar, variety of Victorian railings lining the road and northern steps. The gate at Victoria Bar steps is closed at present due to the one way system. As with most of these gates - there is a City of York rose emblem attached.</p> <p>Road access at Victoria Bar is limited with bollards, providing access to card holders only.</p> <p>No railings to most part of wall walk.</p> <p>Modern brushed stainless steel rails to crenels of Tower 9.</p> <p>The gates leading to the outer ramparts off Nunnery Lane feature no signage.</p>	<p>Improving the appearance or replacing the modern railings would enhance the appearance of the walls. The paint scheme for metalwork across the walls should be reviewed and a new colour scheme could be based on historic paint analysis.</p> <p>Expansion of the playground facilities would supplement this section of walls as a visitor attraction. Information on the air raid shelters in this area should be provided through interpretation (virtual or physical) - the largest shelter in York was located where the playground now stands.</p> <p>The provision of a ramp up to the wall walk from the public gardens would improve access and, alongside improvements to the ramparts and playground and creation of resting stops, could enable this part of the wall to be promoted as a particularly family-friendly section.</p> <p>Victoria Bar gates should be opened to allow public access to the wall walk.</p> <p>As above, in interpretation, public access to the towers should be improved, potentially through controlled 'behind the scenes' tours. Currently towers are only opened for maintenance purposes.</p>

Section 3 Railings at Victoria Bar

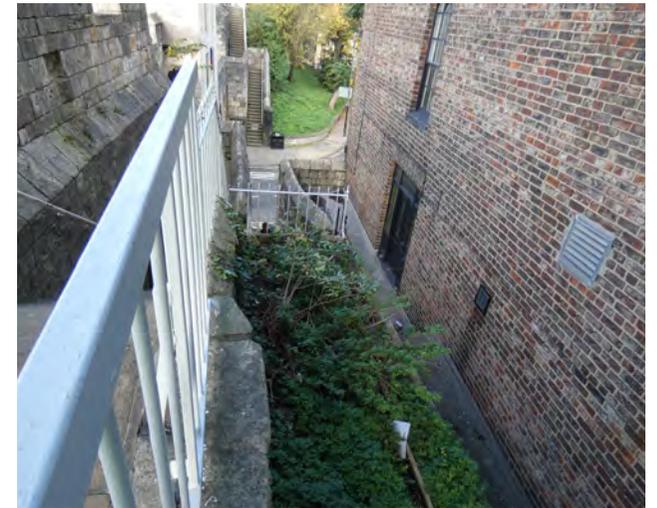
Section 4 Overgrown area adjacent to Micklegate Bar

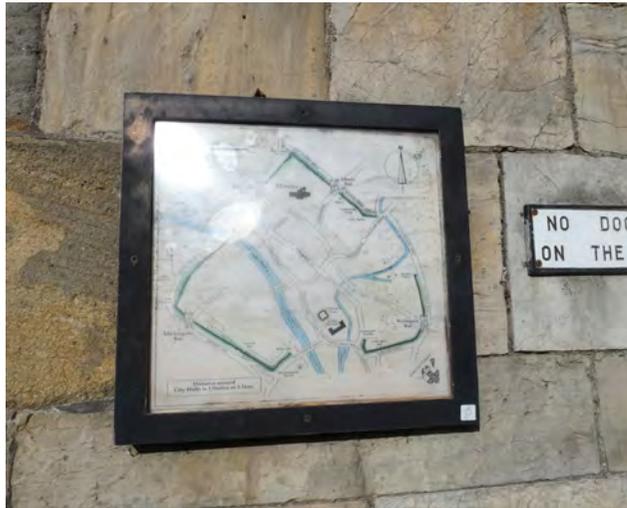
Section 5 Outdated sign near the Station Rise access steps

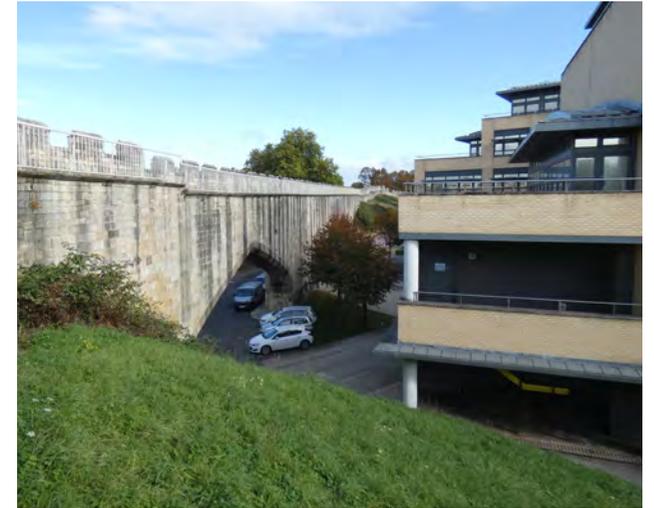
Section 5 Stephenson House and truncated ramparts

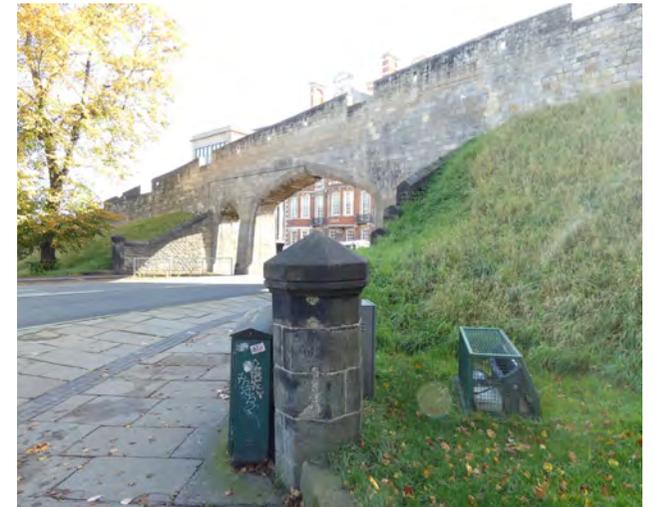
Section 5 Visual clutter at Station Rise

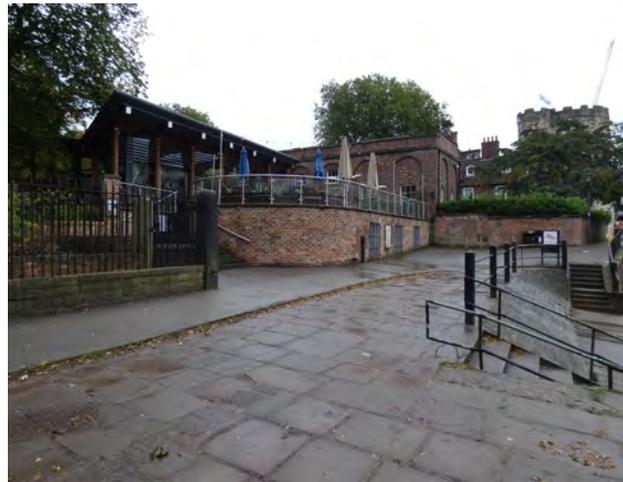
Section 7 Cluttered signage near Lendal Tower

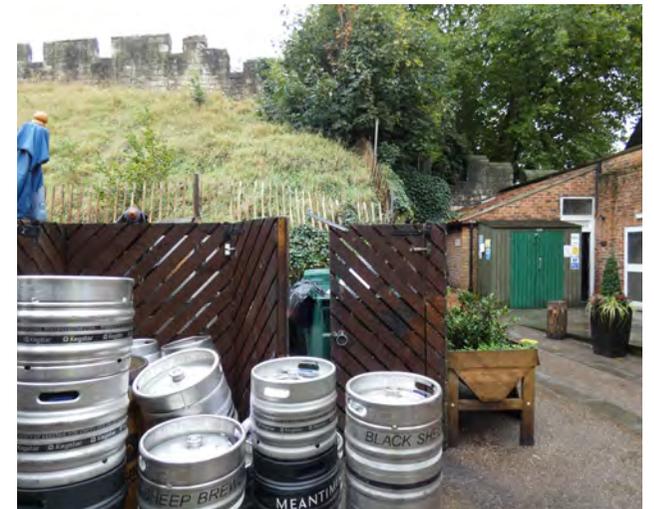
Section 7 Lendal Tower Service areas to the rear of The Star

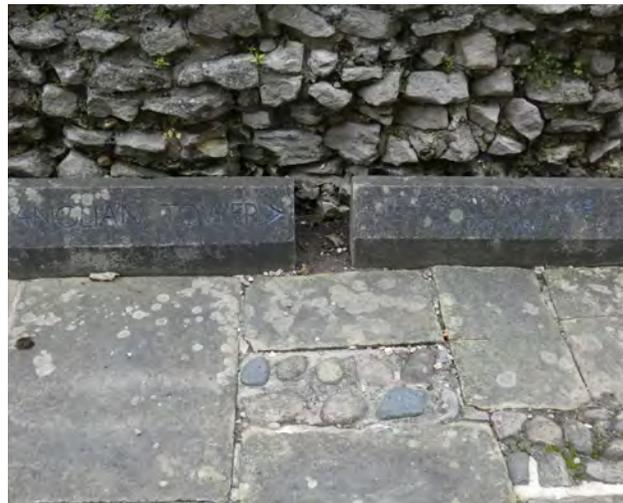
Section 8 Carved signage in need of maintenance

Theme/Criteria	Score	Comments	Threats / Opportunities for change / Recommendations
Signage, orientation, interpretation and lighting cont.	S1/S3		<p>The stone signs should be maintained and upgraded.</p> <p>Opening the Tower 19 (Anglian Tower) for use would enable further engagement with the public and prevent anti-social behaviour, this could be secured and managed. Information should also be provided about the Tower.</p> <p>Improvements should be made to the signage / interpretation and setting of the Roman section of the Walls and St Mary's Abbey Walls by the King's Manor / St Leonard's Place.</p>

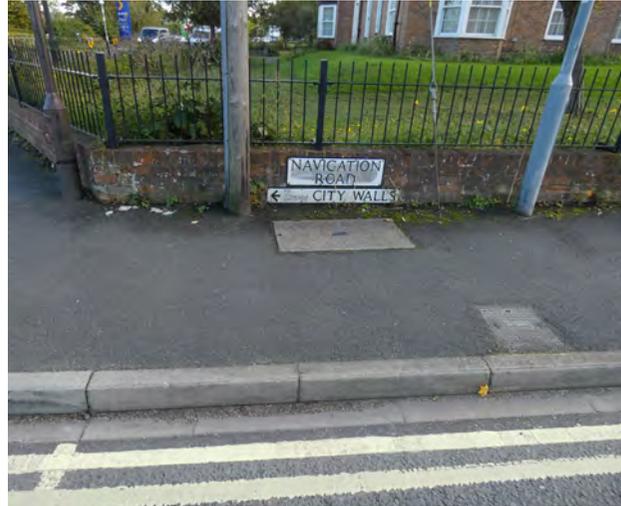
Section 13 Outdated Signage

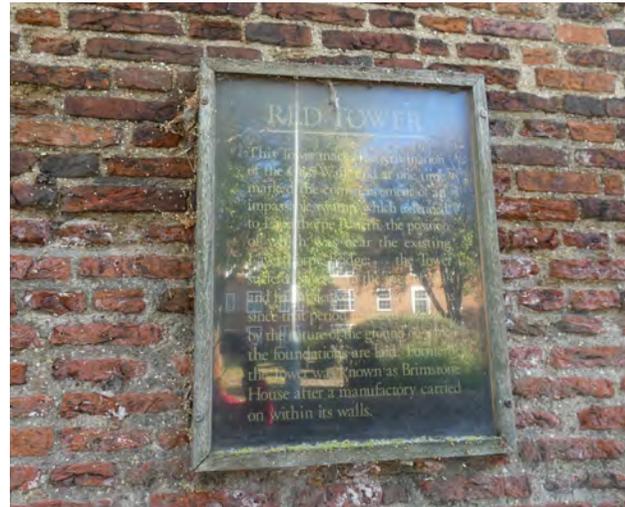
Section 14 Difficult to read board at the Red Tower

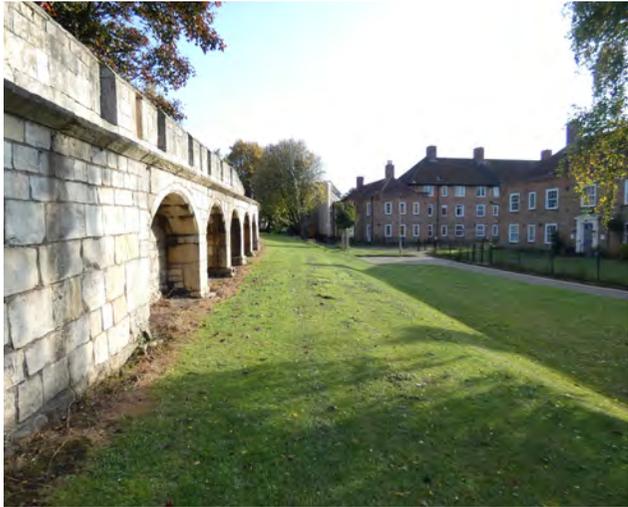
Section 15 View of the lowered inner ramparts and Rosemary Court Housing

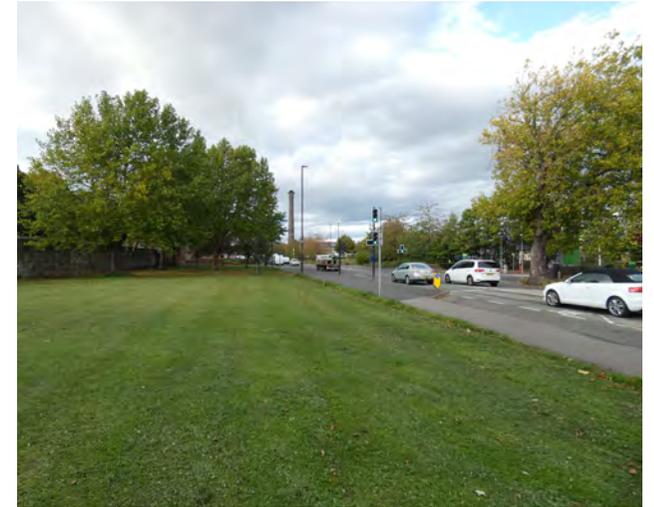
Section 15 Lowered outer Rrmparts

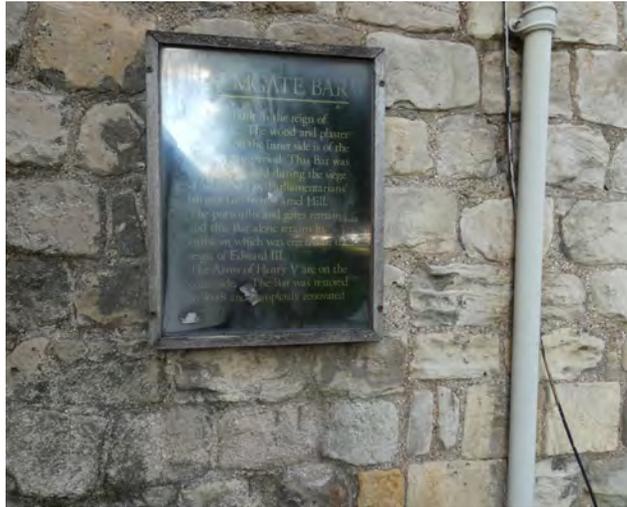
Section 16 Difficult to read board at Walmgate Bar

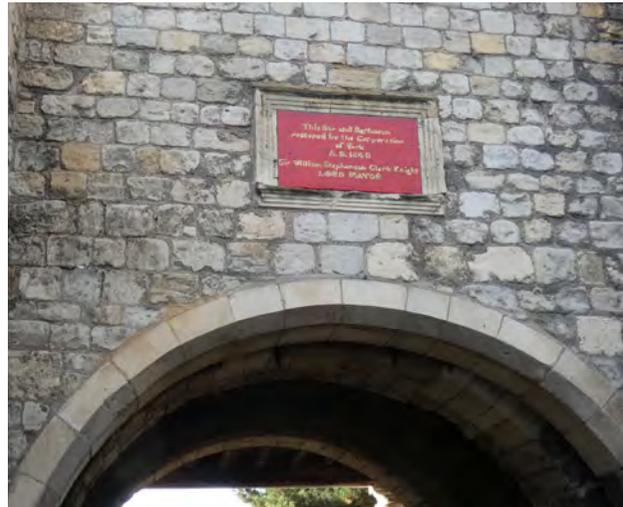
Section 16 Poorly repainted plaque at Walmgate Bar

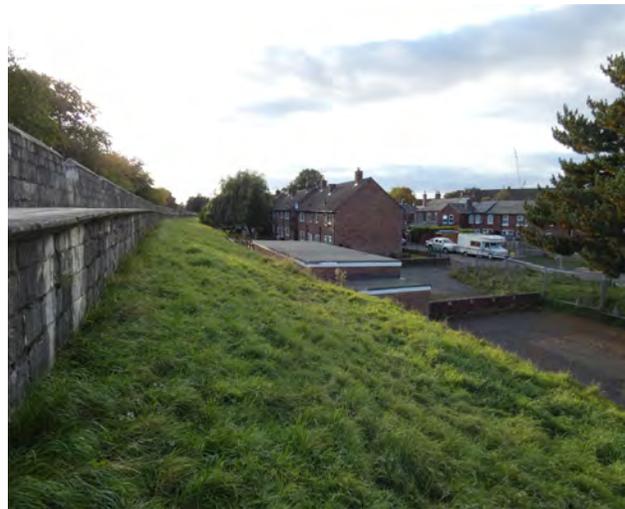
Section 17 Truncated inner ramparts

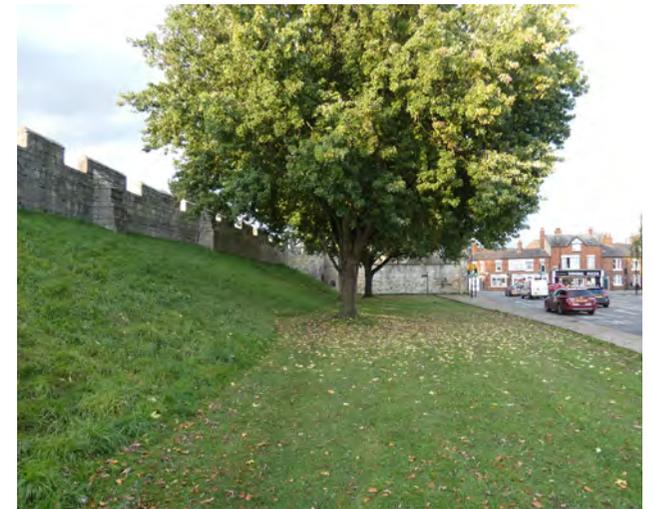
Section 17 Truncated outer ramparts

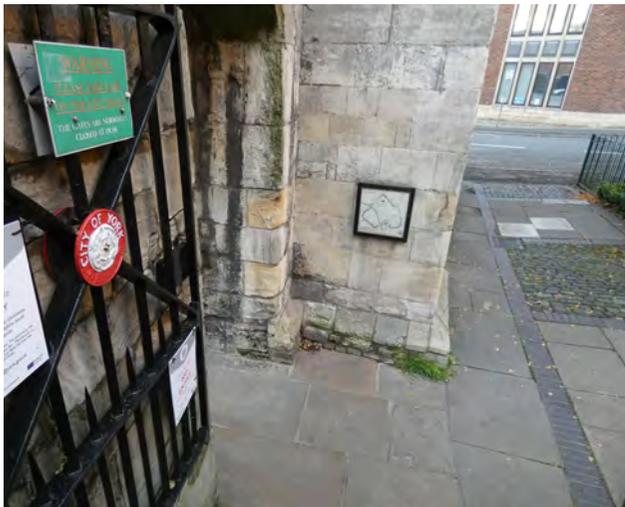
Section 18 Mixture of signage at Fishergate Postern Tower, including faded map

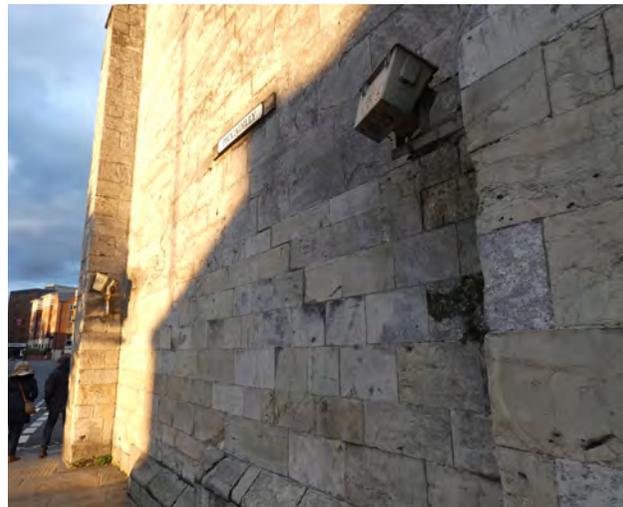
Section 18 Bulky lighting at Fishergate Postern Tower

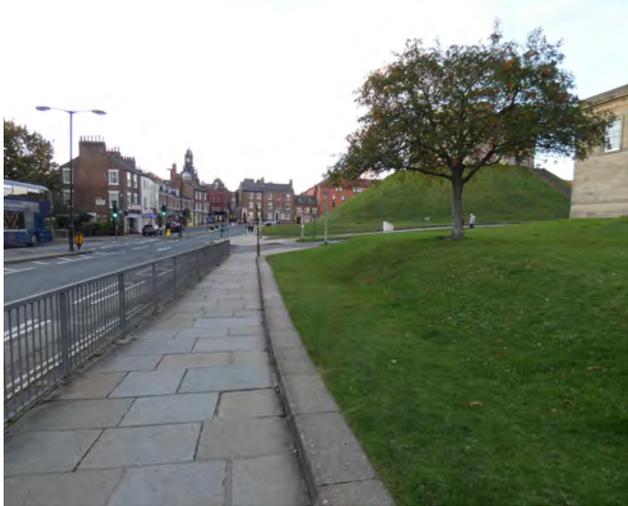
Section 19, View along Tower Street with heavy railings

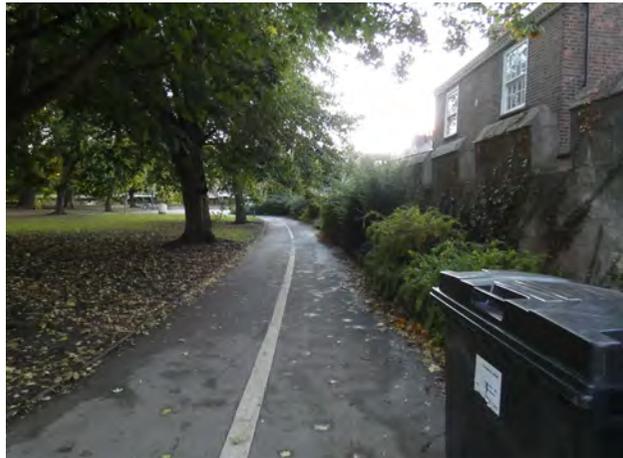
Section 19 View along outside of Wall, with tarmac and bin area in foreground

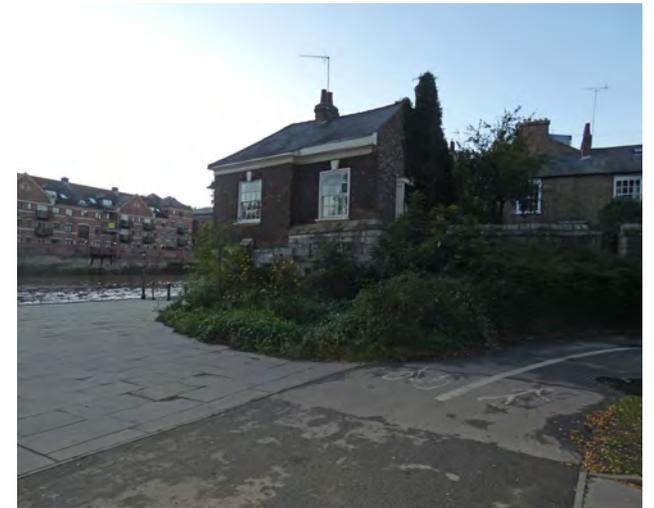
Section 19 Davy Tower, surrounded by a mixture of paving

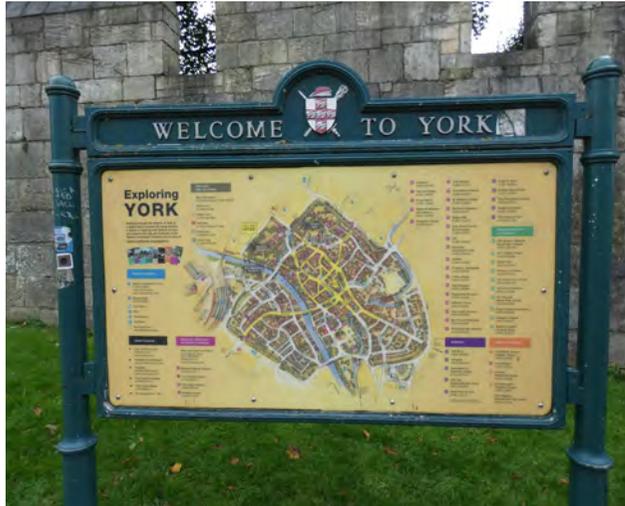
Section 20 Map on Marygate

Theme/Criteria	Score	Comments	Threats / Opportunities for change / Recommendations
Signage, orientation, interpretation and lighting	S3	<p>There is minimal signage, mostly related to the Abbey, Museum and Gallery. Some maps are outdated / shabby. Tour guides may cover this area, but self guided discovery is limited. No signage/ information relating to role of walls as defences for the Abbey. There is a tourist map/board near the Gatehouse on Marygate, which could be improved. There is some A-board signage to guesthouses near interval Tower C and a tourist board near St Mary's Gatehouse. St Mary's Tower is named externally, but not within the Gardens.</p> <p>There are timber shutters near interval Tower C, which have an interpretation board externally on Marygate (but nothing on the inside of the wall).</p> <p>The Gardens contain contemporary lighting set in hard landscaping to rear of the Gallery, some in ground spotlights upright the walls around interval Towers D and E. There is a large 'traditional lantern' on top of the arch at the Water Tower.</p>	<p>Discreet interpretation relating to the role of the Precinct walls in Museum Gardens at its entrances and potentially in-ground or using engraved stones used elsewhere in the Gardens, including at Interval Tower A, should be introduced to enhance public engagement and understanding.</p> <p>Access and interpretation should be provided to enhance public engagement and understanding to sections of wall with a narrow wall walk (between interval towers A and B); at the garden off Bootham (potentially images of properties which once stood here and highlighting of the limewash / paint on the walls); at the Water Tower; St Mary's Tower; interval tower D (to explain the intricate stone repairs and the history of fire here).</p> <p>Replace the light on the Water Tower's arch with a more sensitive solution, in order to improve the setting of the walls and tower - as part of a wider strategy to provide better architectural illumination of the walls, whilst being mindful of the ecological impact - particularly bats.</p> <p>The City map on Marygate should be updated.</p>

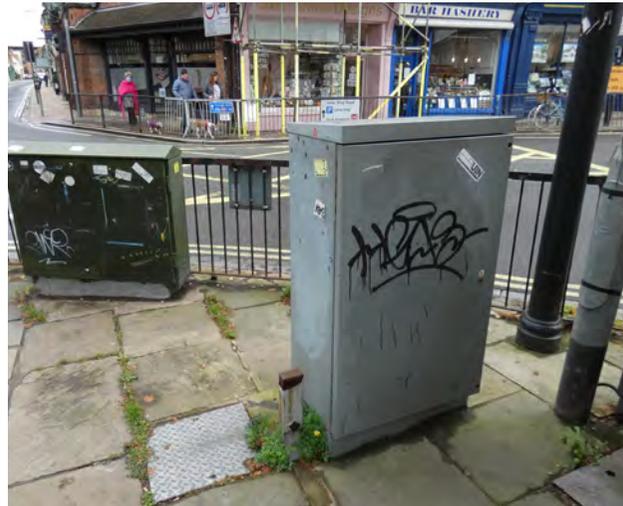
Section 20 Street furniture clutter at Postern Tower

Theme/Criteria	Score	Comments	Threats / Opportunities for change / Recommendations
		<p>Notes on St Mary's Tower: Hamlet of St Mary Sign, otherwise no information. There is a listed K6 red telephone box next to the Tower. Modern timber framed windows in Tower, at first floor leaded. Small garden adjacent to tower could be improved. Litter bin could also be improved.</p>	
		<p>Notes on Gatehouse: Interior not inspected. Museum Gardens signage and St Olave's A-board. No signage/information relating to role of walls as defences for the Abbey.</p>	
		<p>Notes on Interval Tower D: Very delicate and intricate stone repairs to demonstrate/salvage fire damaged stone, substantial metal propping (temporary - 5 years). No interpretation for repair works, history of fire etc.</p>	
		<p>Notes on Postern Tower and Interior: Contains Sightseeing York tour ticket office. Ground floor access only. A lot of street clutter at this corner, Gallery side and roadside. Poor external cabling and conduit.</p>

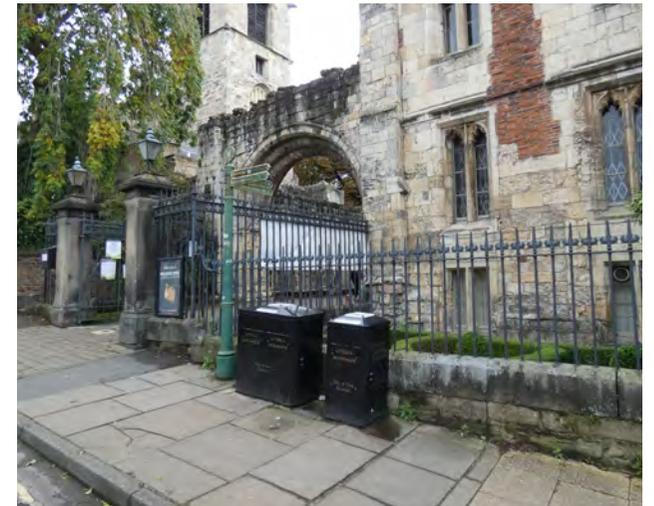
Section 20 Signage and clutter at St Mary's Gatehouse
